OD/TP Re-inspection Evaluation

Report Ref : TP19080078

THIRD PARTY SURVEY ACCIDENT OCCURED ON 24 AUG 2019

VEHICLE DAMAGE INSPECTION REPORT

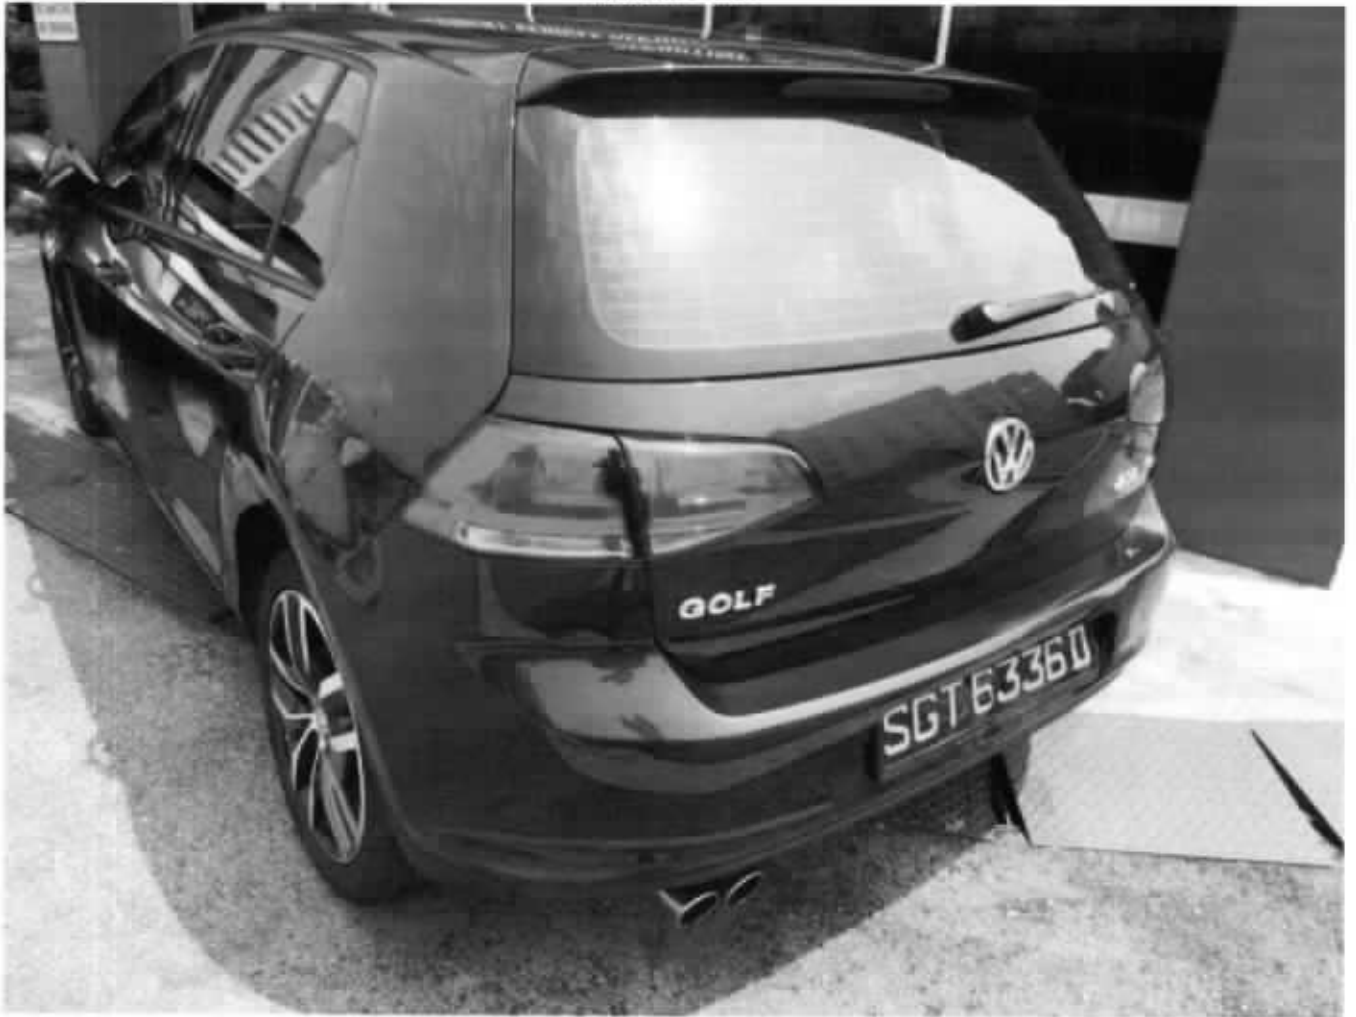
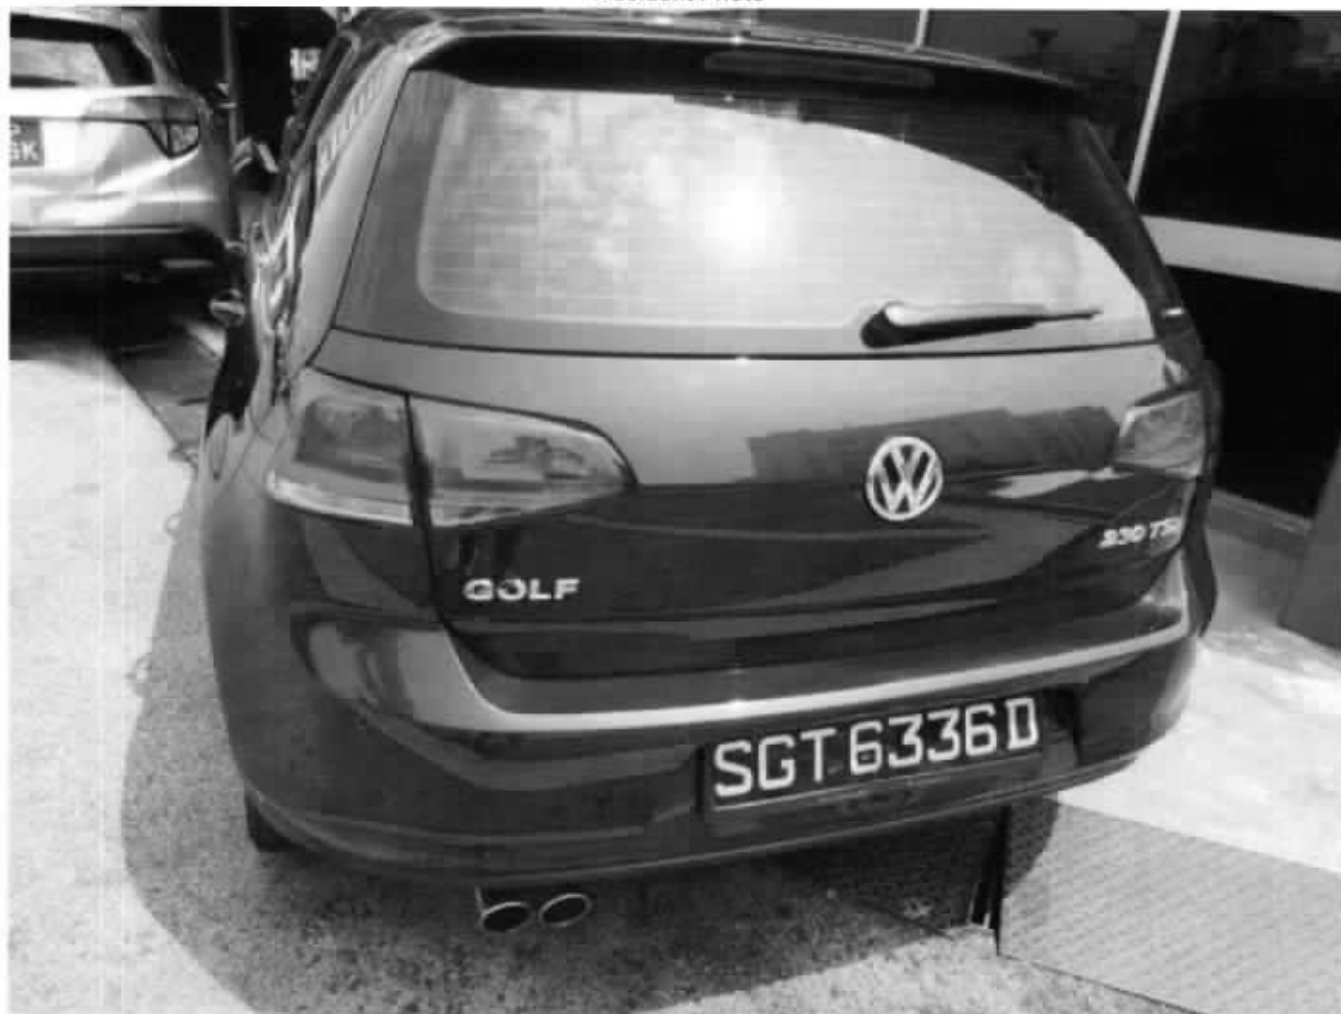
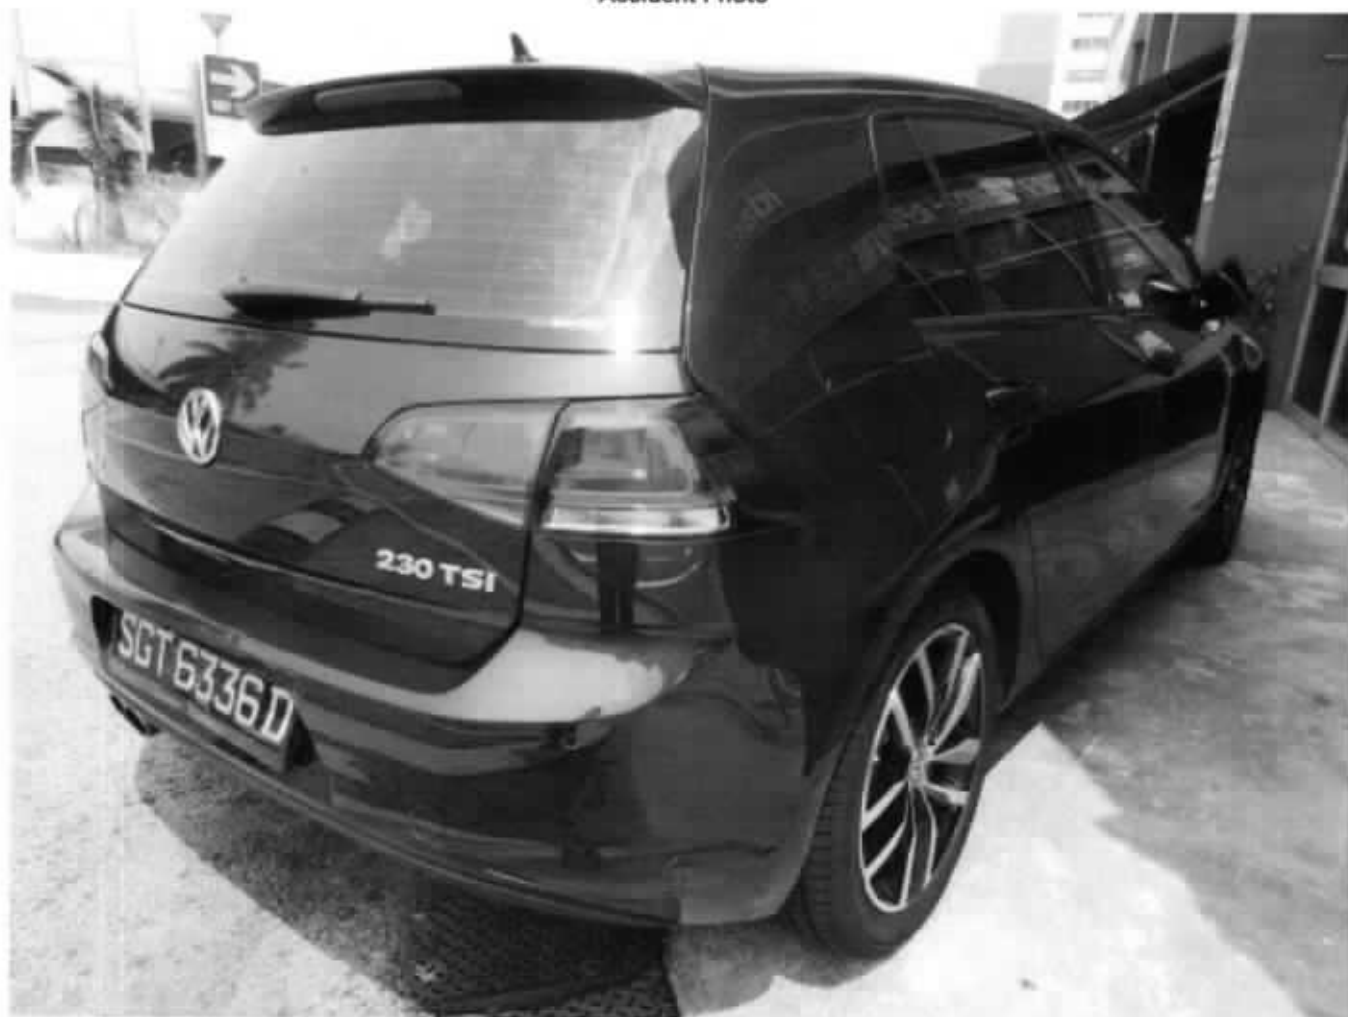
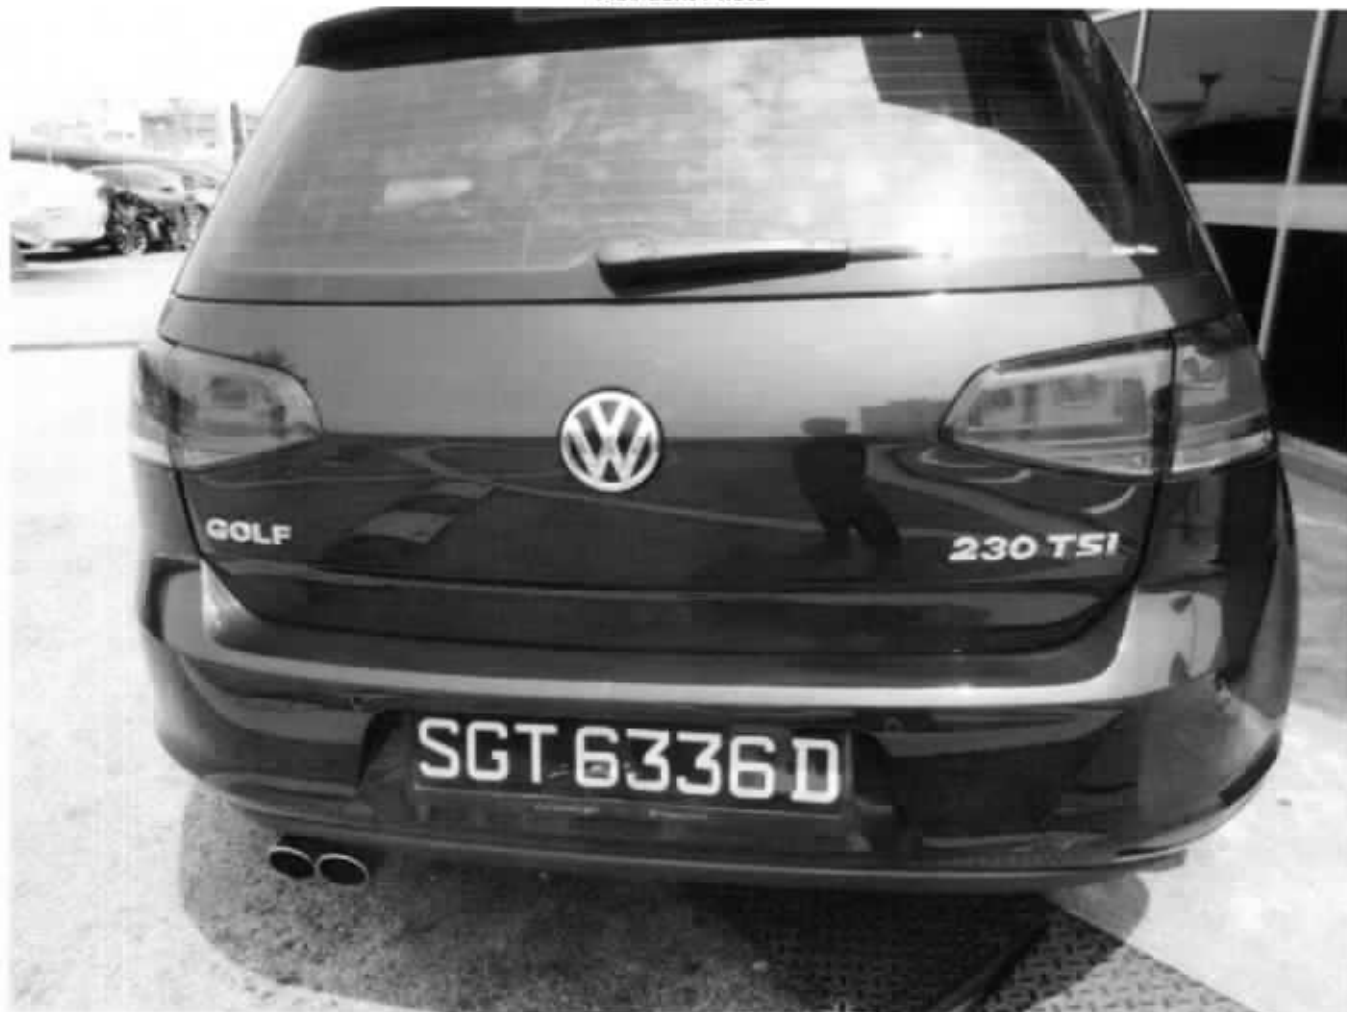
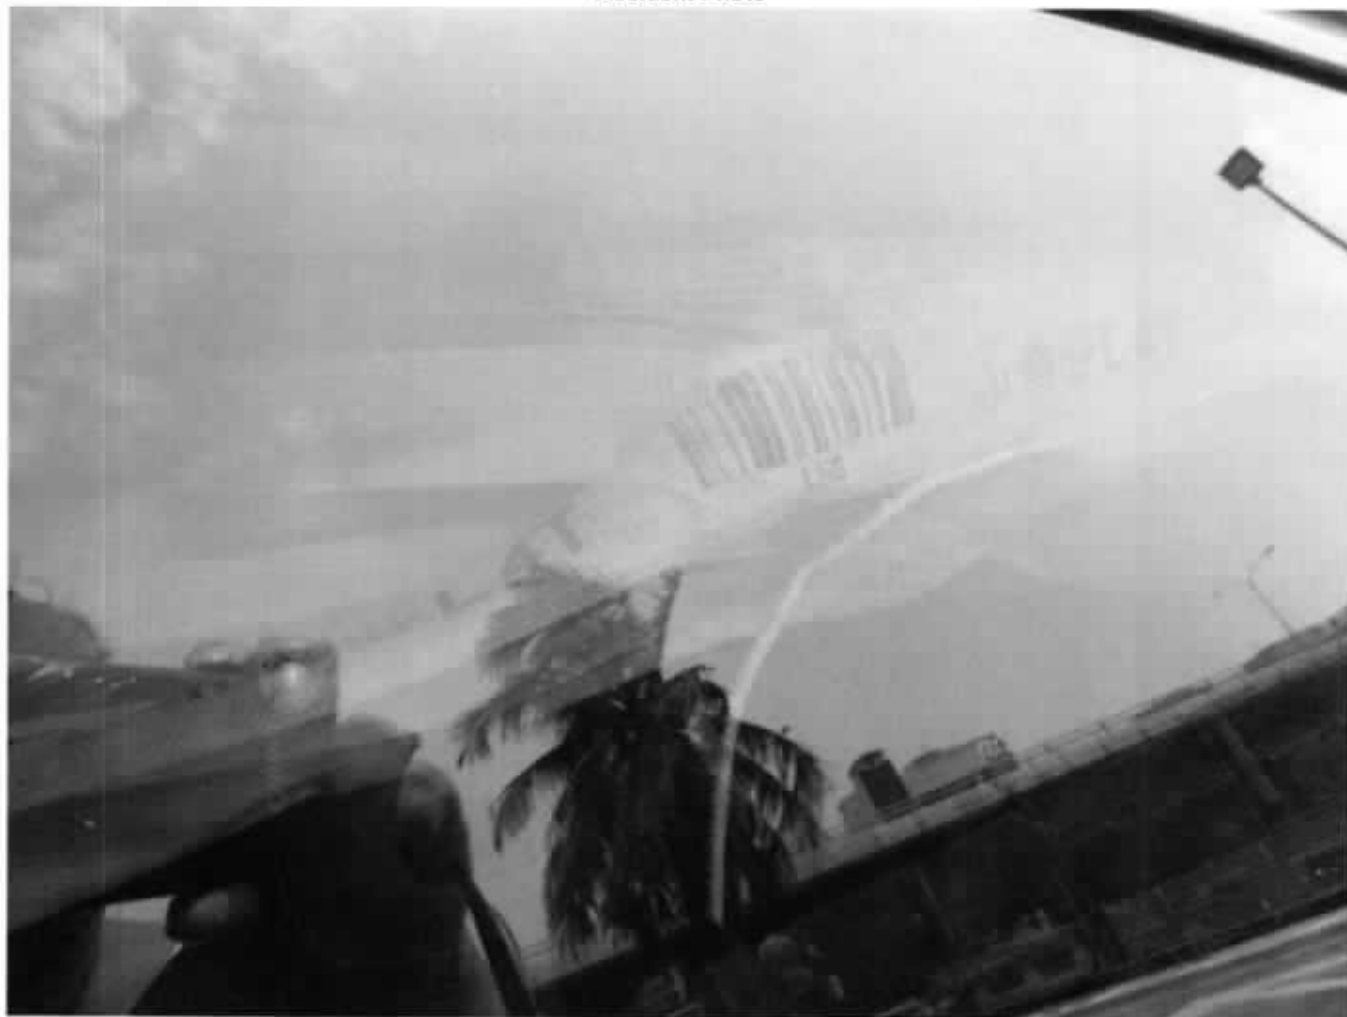
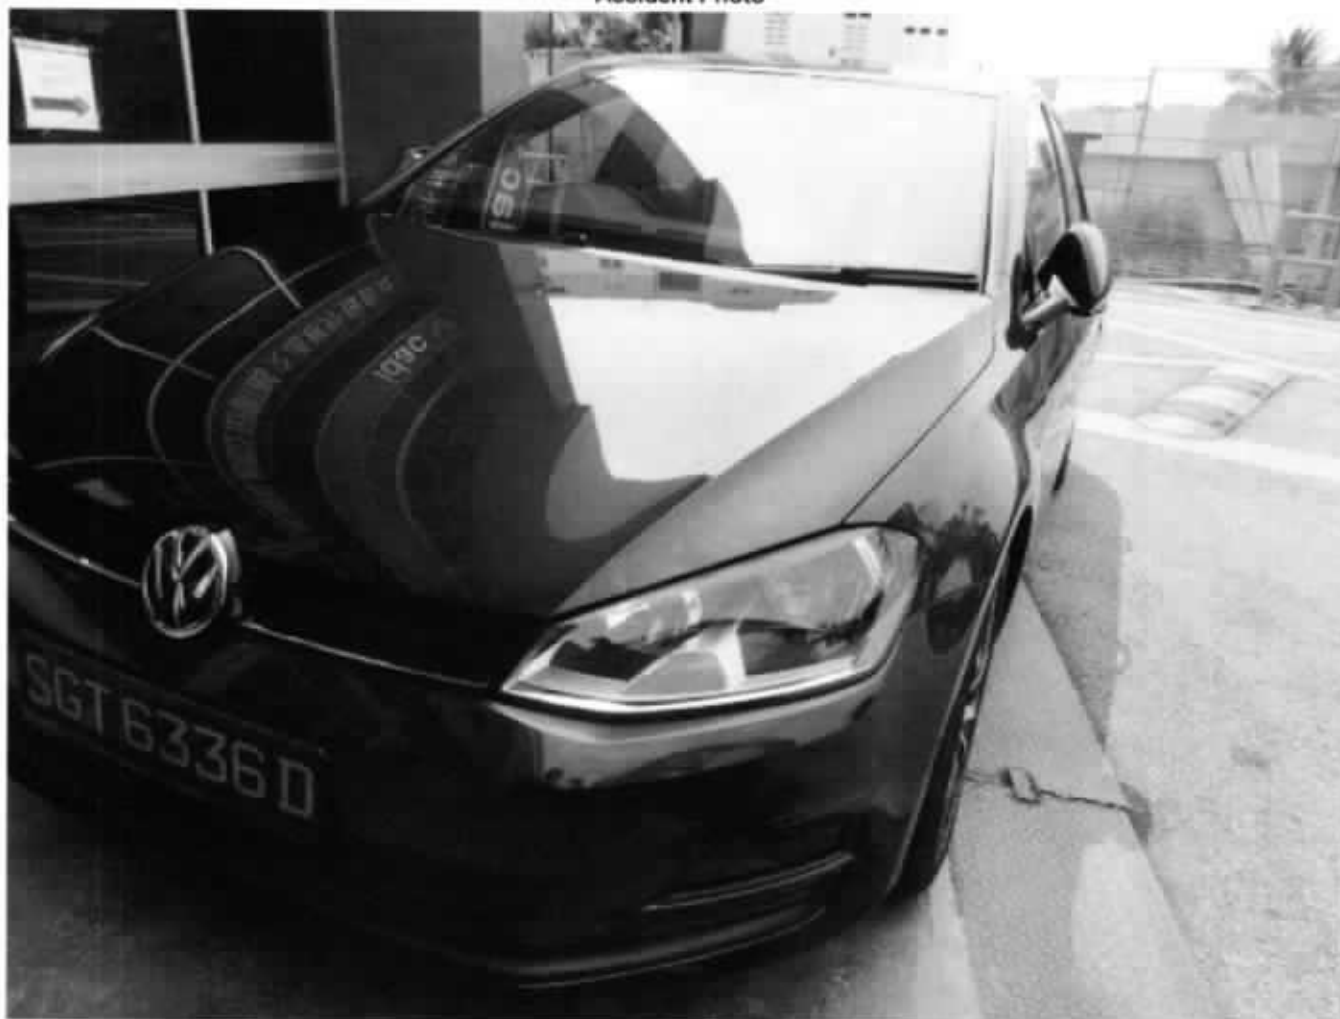
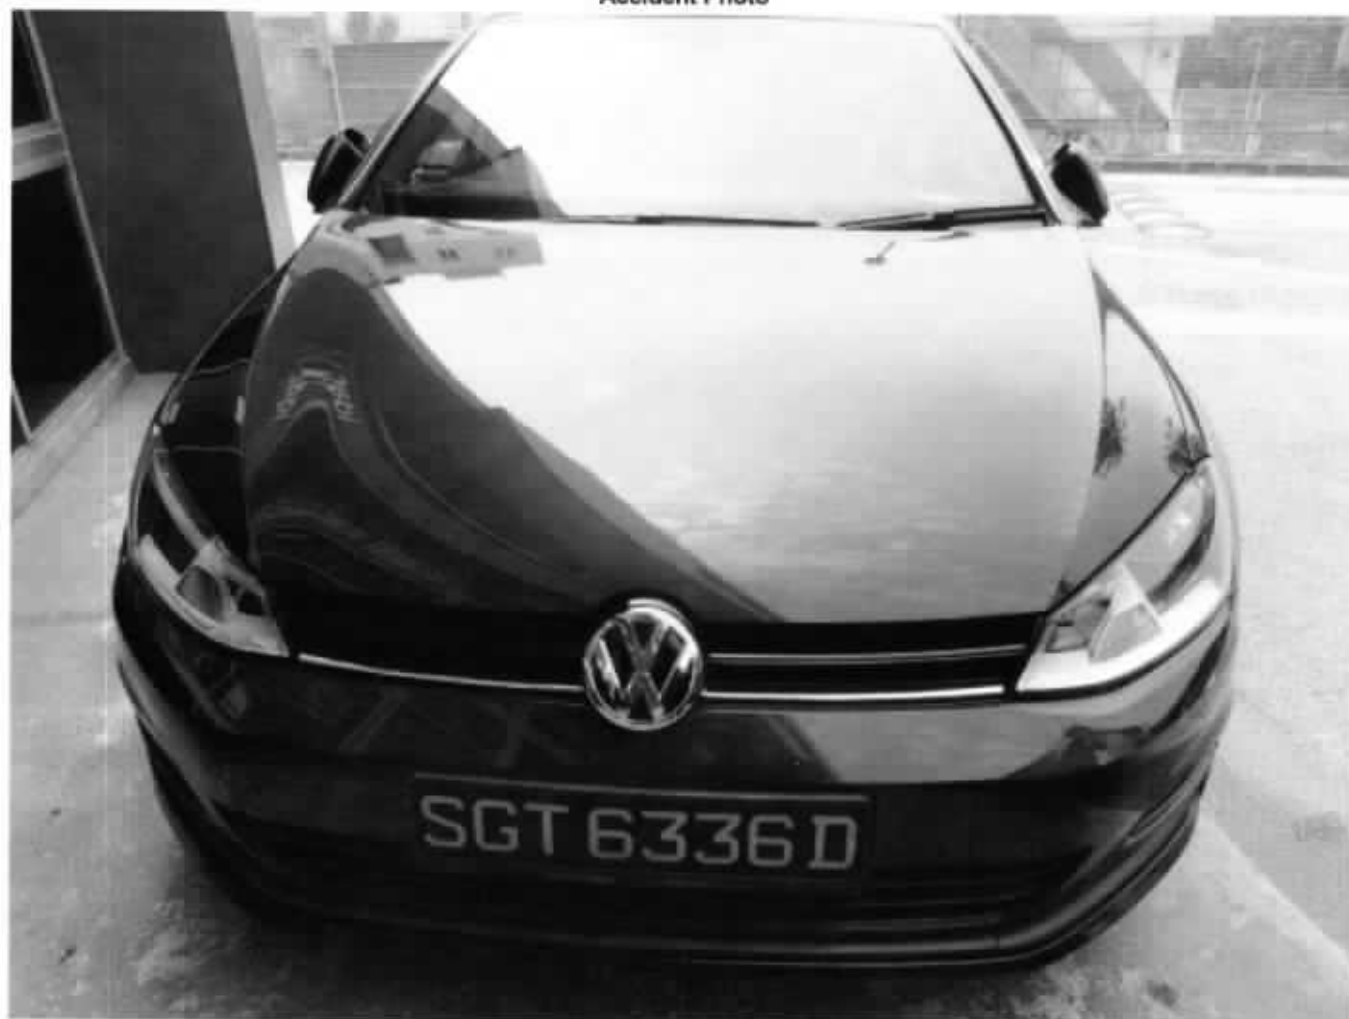
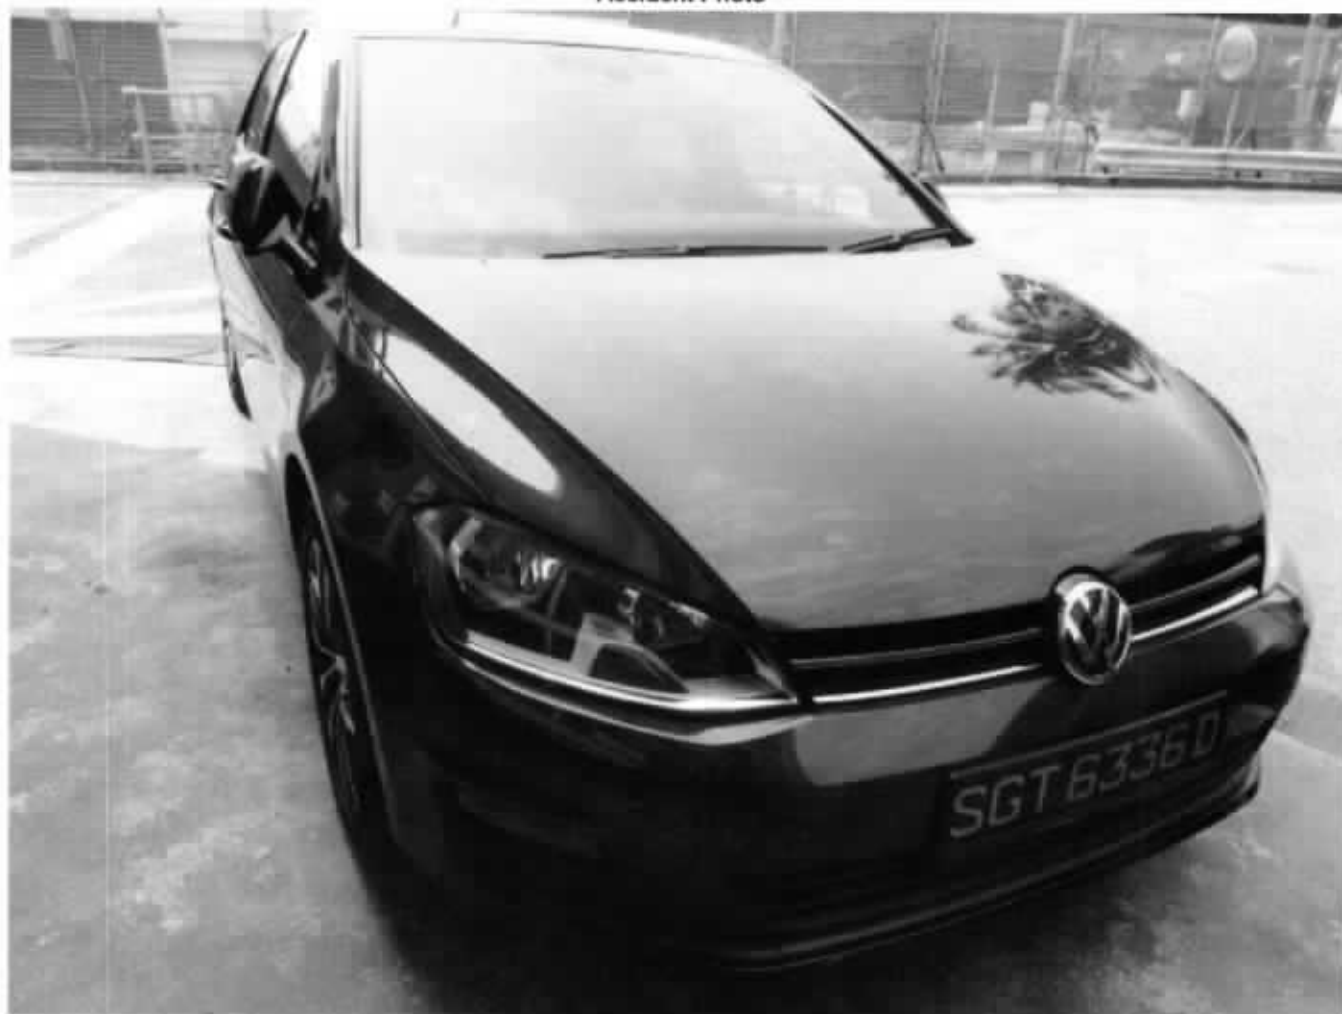
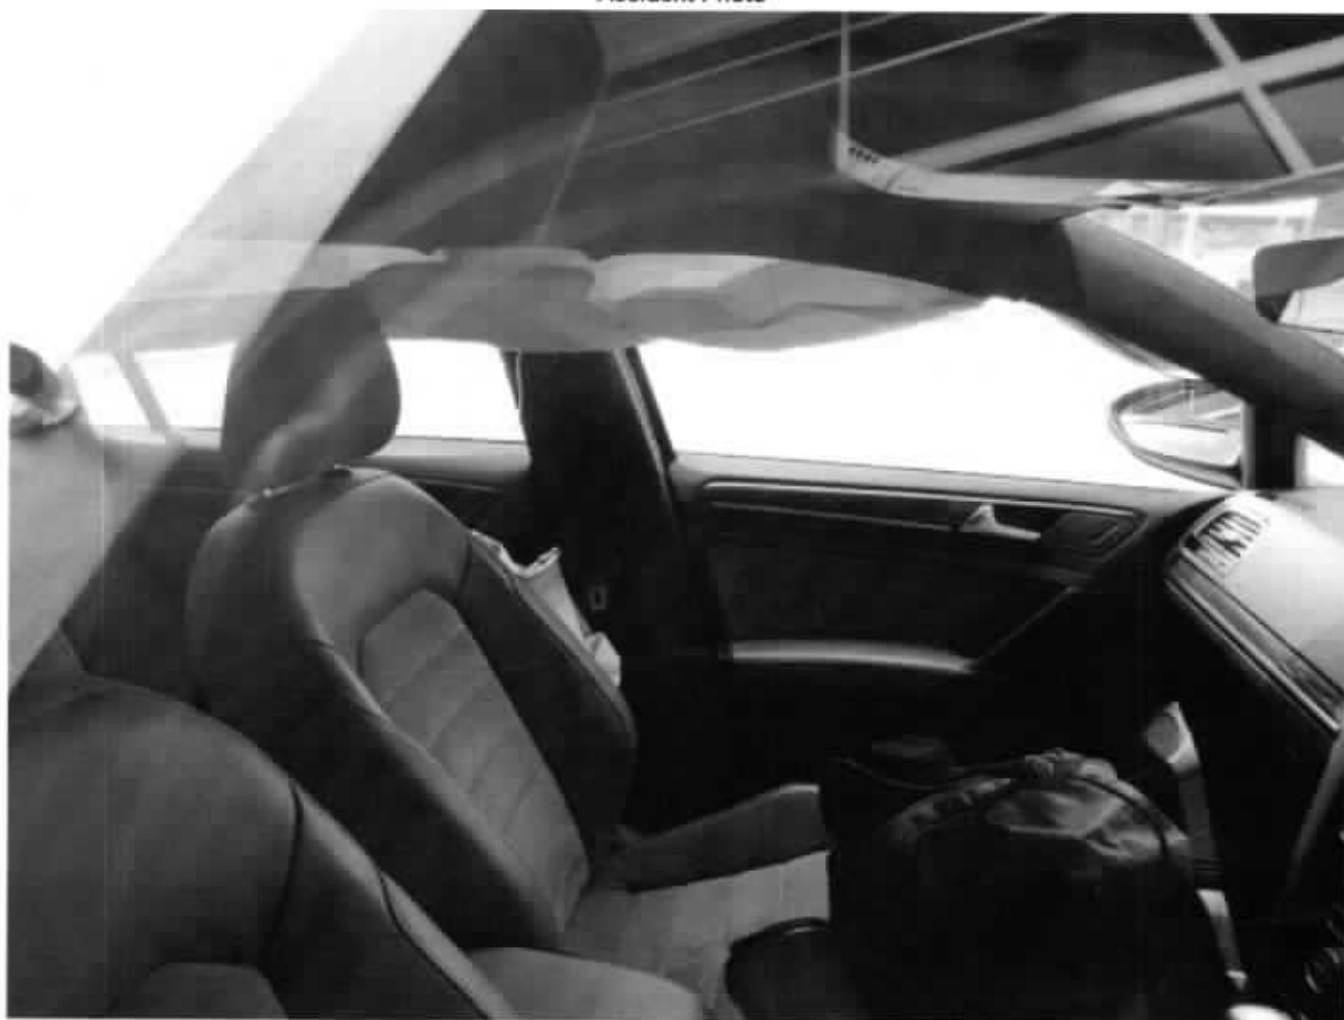
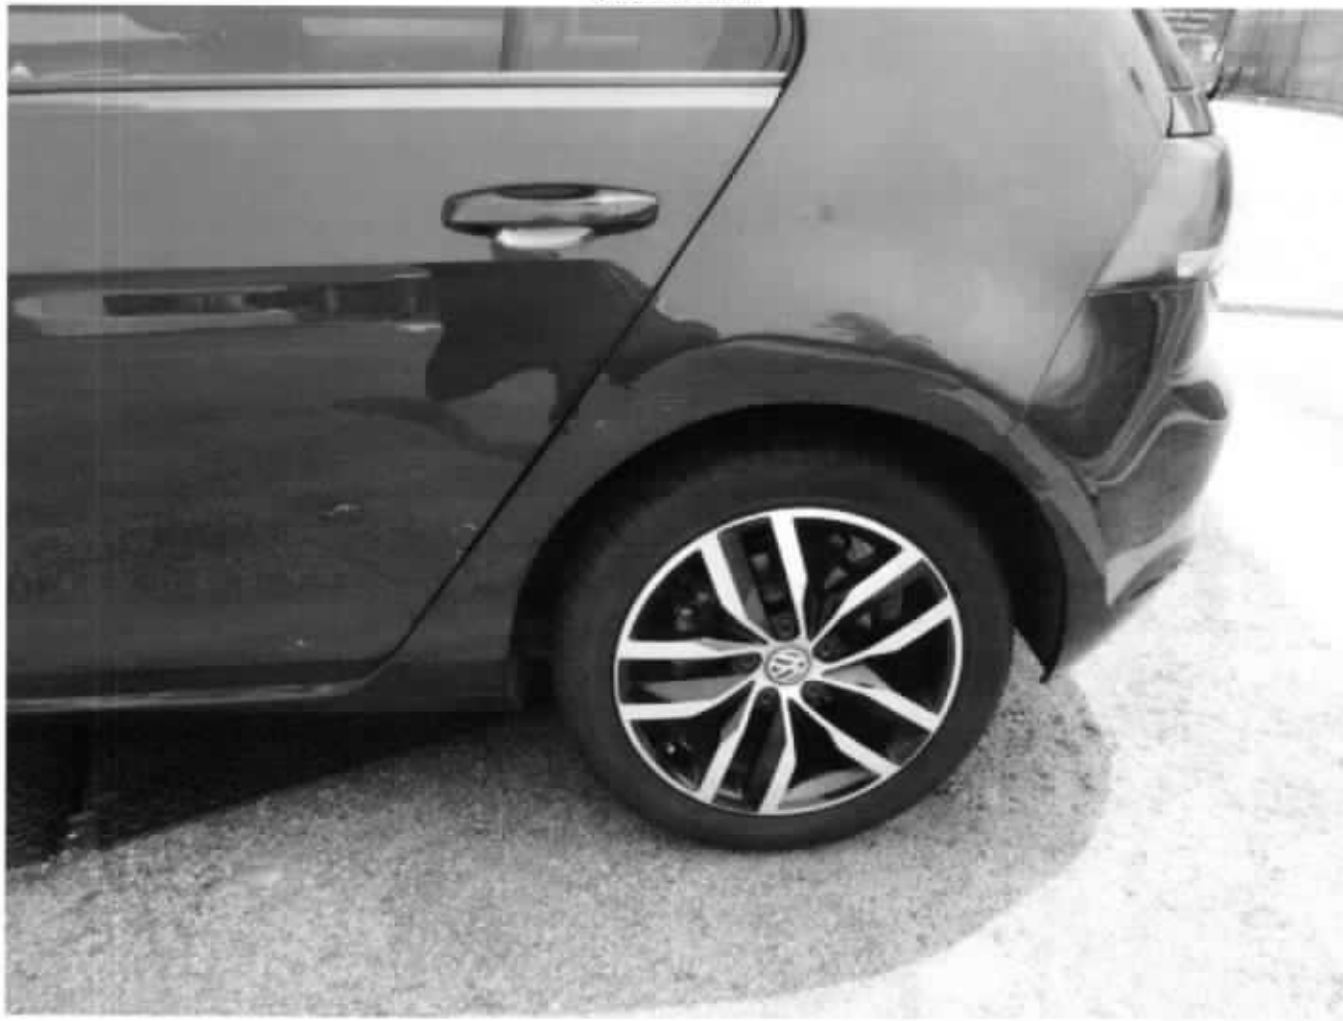
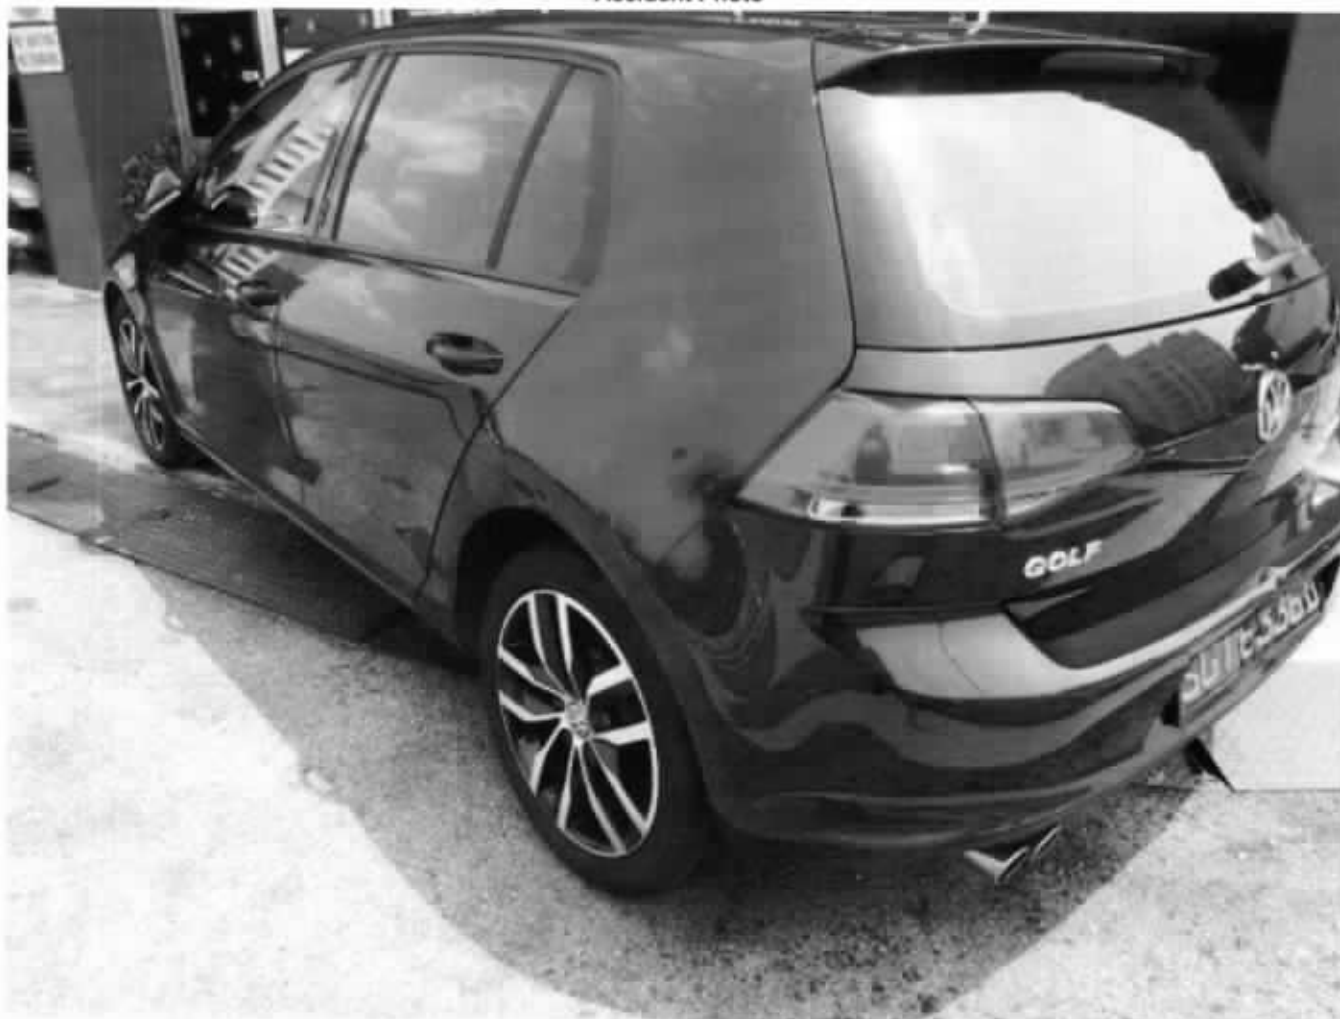
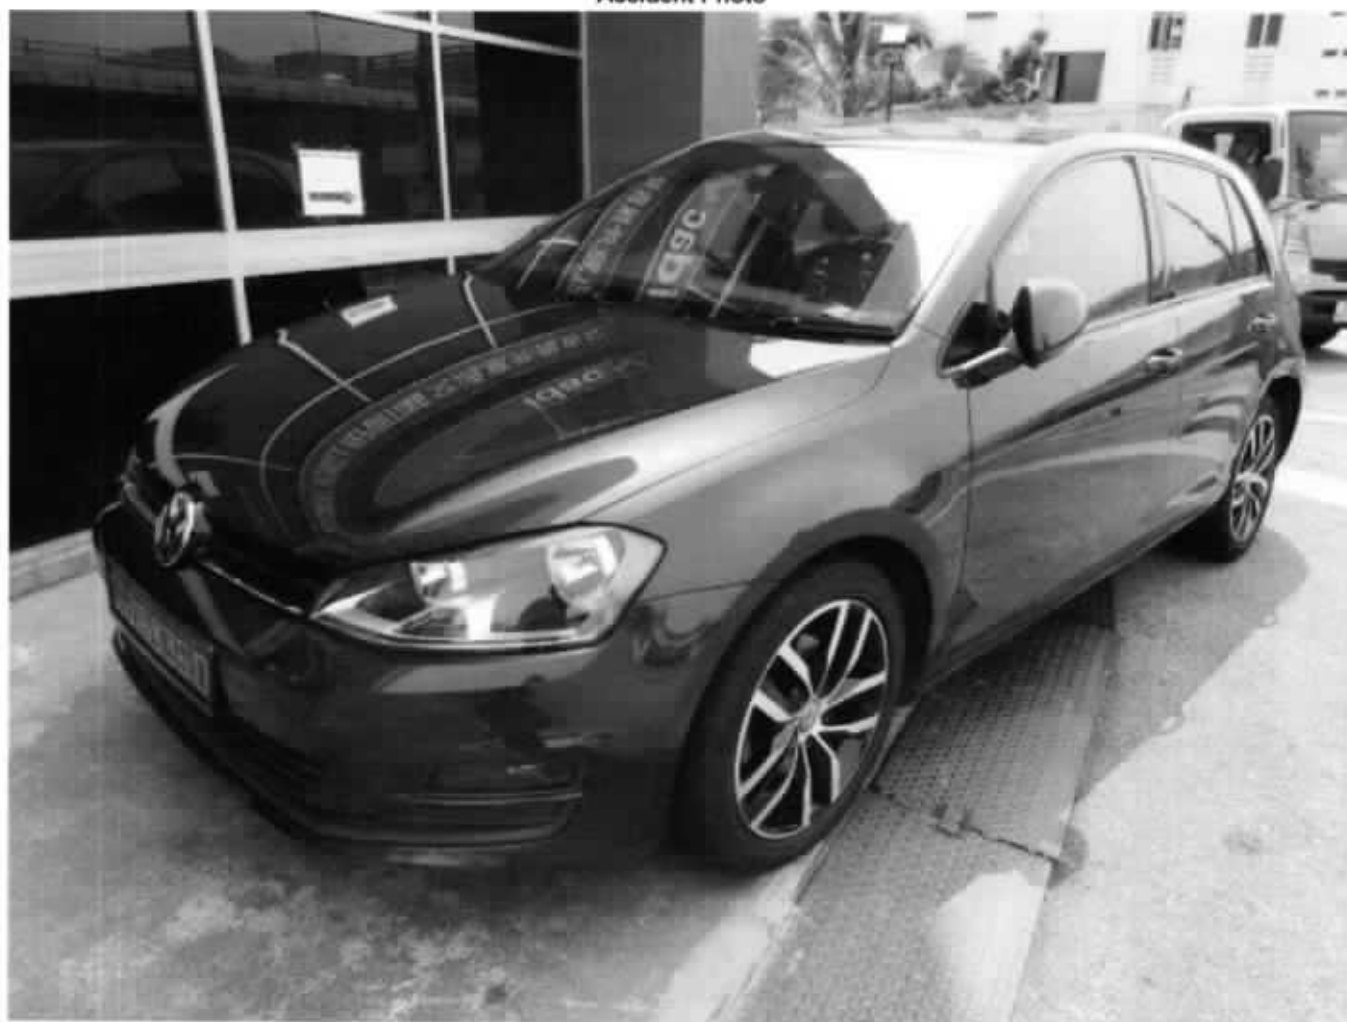
Accident Photo

At the time of inspection, we noted that the vehicle has sustained an impact damages on the rear side portion(s). For more detail of the damages, please see photograph attached.

4. Estimated normal period of repair : 12 working days to complete
