ASSIGNMENT

1. Policy Particulars :- THIRD PARTY CLAIM

4. Description of Damages

ADJUSTMENT ON REPAIR COST FOR VEHICLE NO. SHC 8015U

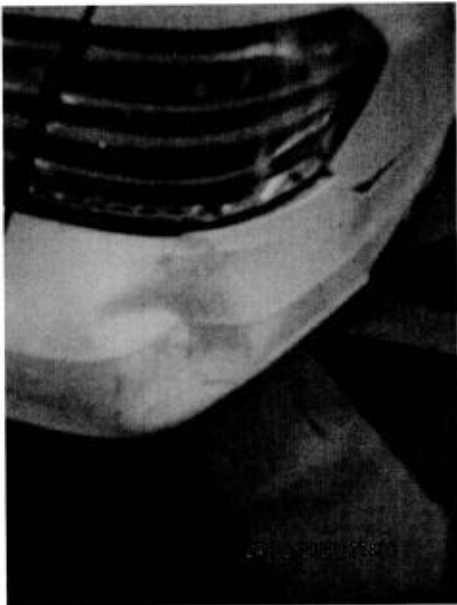
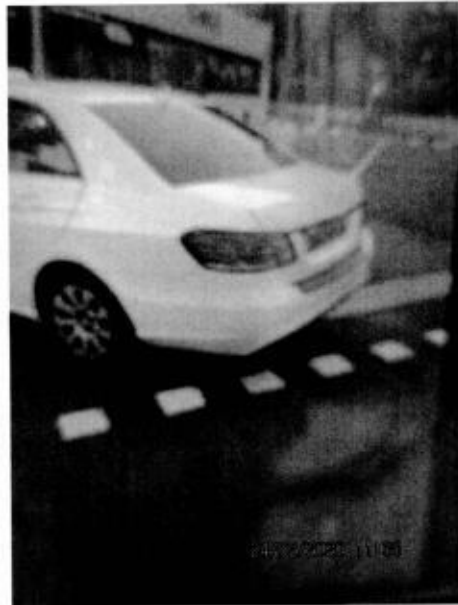
THE VEHICLE SUSTAINED DAMAGES AT THE REAR PORTION. DAMAGES SEE DETAILS.
--

Qty	Description of Parts	Condition	Estimate By Workshop (\$)	Our Adjusted (\$)
	REPLACEMENT OF PARTS			
1	REAR BUMPER	DEFORMED	1,510.00	1,510.00
1	REAR LOWER COVER	SCRATCHED	325.00	325.00
1	REAR BUMPER MOUNTING	NOT NECESSARY	115.00	-
1	TAIL LAMP RH	CRACKED	536.00	536.00
	LESS 20% DISCOUNT		-497.20	-474.20
			1,988.80	1,896.80
	SPECIAL NETT ITEMS			
1	REAR BUMPER MAT (SN)	NECESSARY	50.00	50.00
			50.00	50.00
	LABOUR			
	PANEL BEATING.		450.00	366.00
	SPRAY PAINTING CHARGE.		280.00	200.00
	CHECK WIRING.		60.00	60.00
			790.00	626.00
	GRAND TOTAL		2,828.80	2,572.80
	RECOMMENDED COST OF LUMP SUM REPAIRS (TO ITS PRE-ACCIDENT CONDITION) (CONFIRMED)			2,050.00
