ACCIDENT INVOLVING SHB2275E AND SLH4790S (MSIG) ON 02/03/2020

Preliminary Advice

Insured Vehicle No	: SLH4790S	Accident Date	: 02/03/2020
TP Vehicle No	: SHB2275E	Assignment Date	: 03/03/2020
Make	: HYUNDAI I40	Est. Duration of Repair	: 4 days
Date of Inspection	: 03/03/2020		
Inspection At	: Ding Automotive Pte Ltd (HQ) 31 CORPORATION ROAD Singapore 649825

VEHICLE DAMAGE INSPECTION REPORT

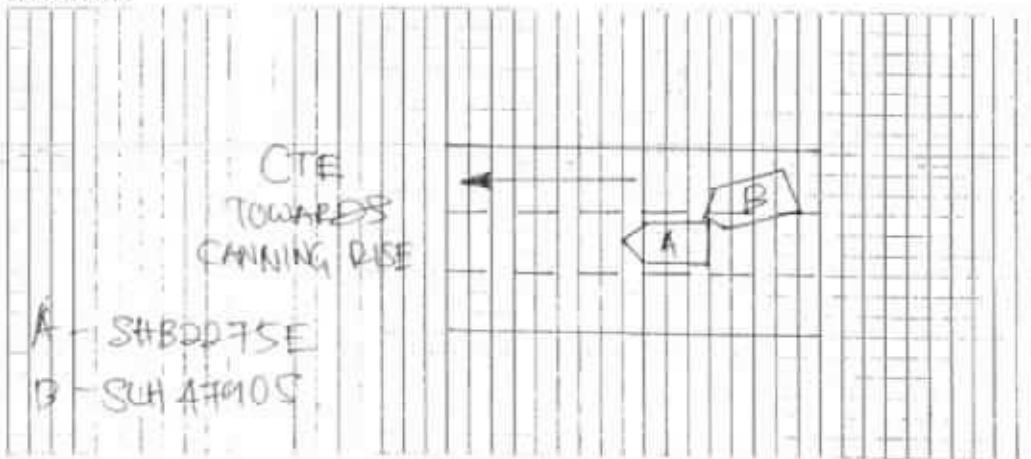
SKETCH PLAN

ON 2/3/2020 ABOUT 08:50 HOURS I WAS DRIVING MY TAXI (SHB2275E) ALONG CTE TOWARDS CANNING RISE. AT TIME 3 PASSENGERS ON BOARD. AT TIME TRAFFIC WAS MODERATE. I WAS DRIVING AT 2ND LANE AT TIME. I WANTED CHANGE TO 3RD BUT DUE TO TRAFFIC I JUST MAINTAIN DRIVING ON 2ND LANE. SUDDENLY I FEEL BIG IMPACT FROM BEHIND. THEREAFTER I WENT DOWN CHECK. I REALIZED 1 VEHICLE HONDA COLLIDED ON MY VEHICLE REAR RHTS. HE CAME FROM 1ST LANE AND COLLIDED INTO MY VEHICLE. THE IMPACT VERY STRONG UNTIL MY PASSENGERS THINGS FLOW OVER. AFTER WHILE WE EXCHANGED PARTICULARS AND TOOK SOME PHOTOS FOR REPORTING PURPOSE. THE OTHER VEHICLE BEARING PLATE NUMBER (SLH4790S).

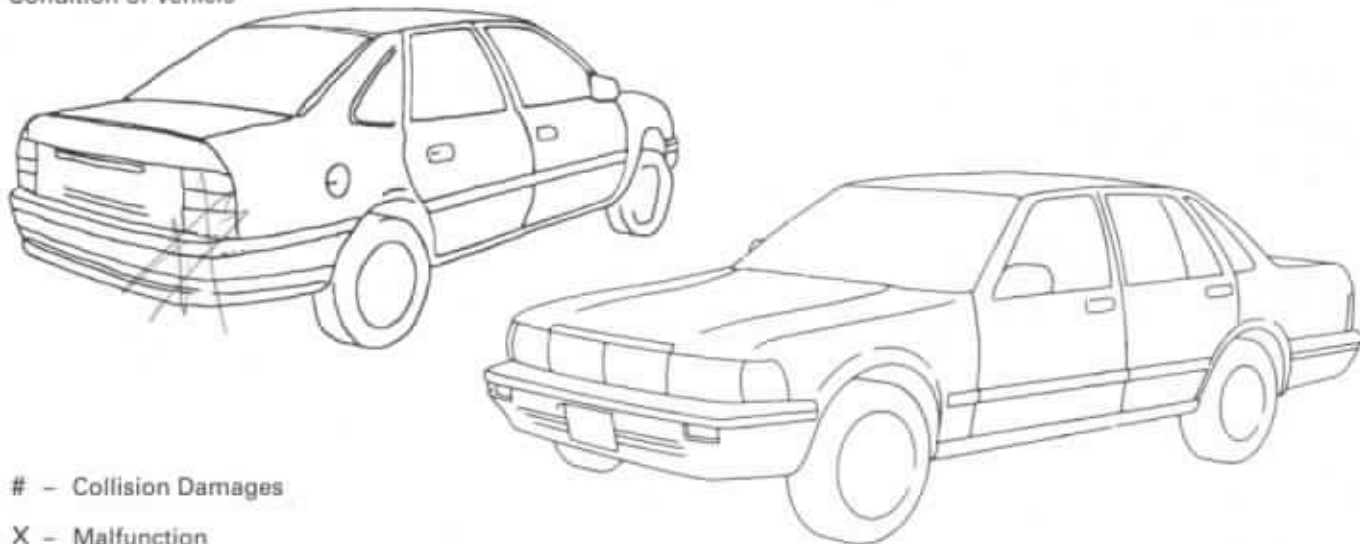
Condition of Vehicle

- Collision Damages

X - Malfunction
