Your Ref: G/IP/05272/2019
Our Ref: CI/SPF20003502/D

03 March 2020

MECHANICAL INSPECTION REPORT OF AN ELECTRIC SCOOTER

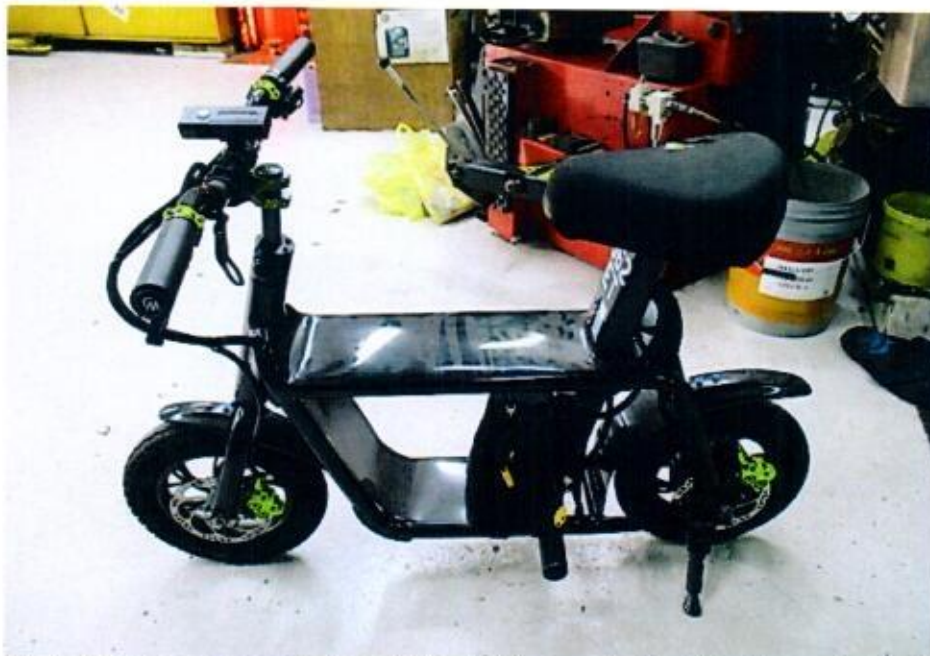
Photo 1 shows a general view of the electric scooter that I had inspected. The electric scooter was observed to be in good general condition however some relatively minor damage was observed along the right side of the electric scooter.

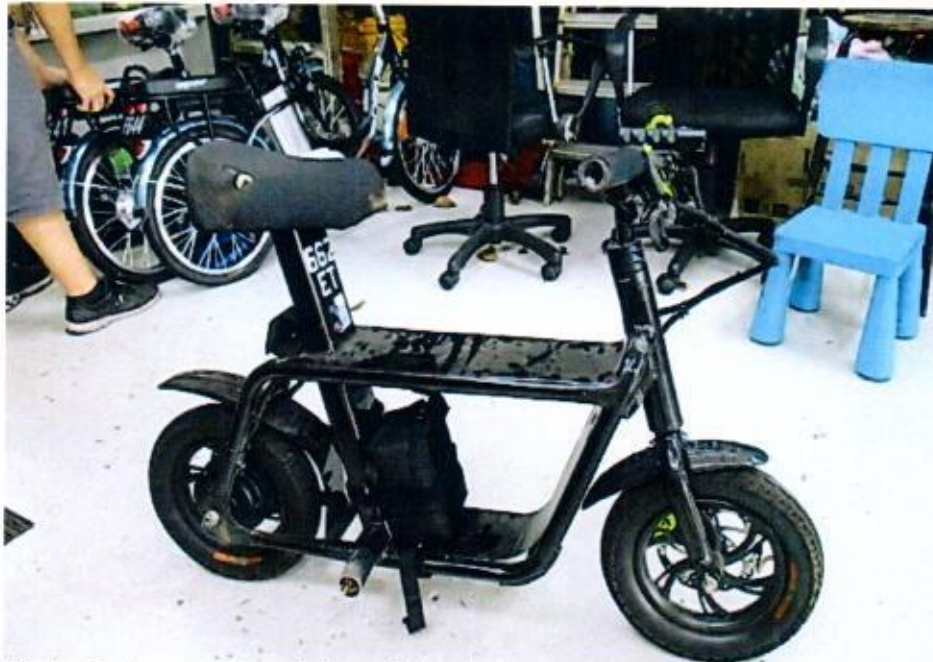
Photo 2 shows a general view of the electric scooter that I had inspected. The electric scooter was observed to have sustained relatively minor damage along its right side. The right side of the handlebar and right side leg rest were observed to be scratched/cut. The seat of the electric scooter was also torn.

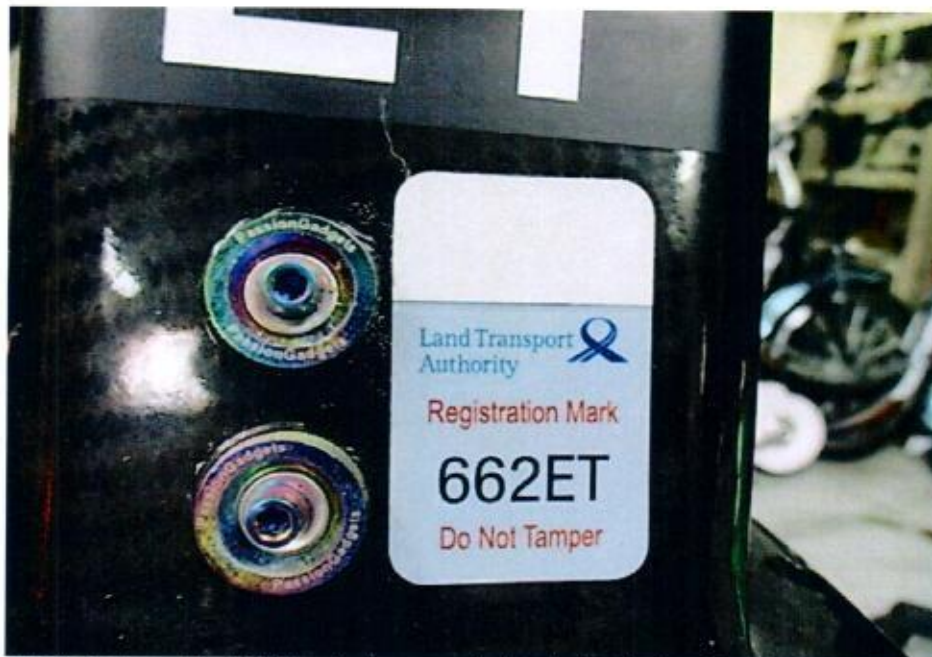
Photo 3 shows the LTA tag that was pasted onto the body of the electric scooter. The electric scooter was noted to be a LTA registered electric scooter with registration number 662ET.

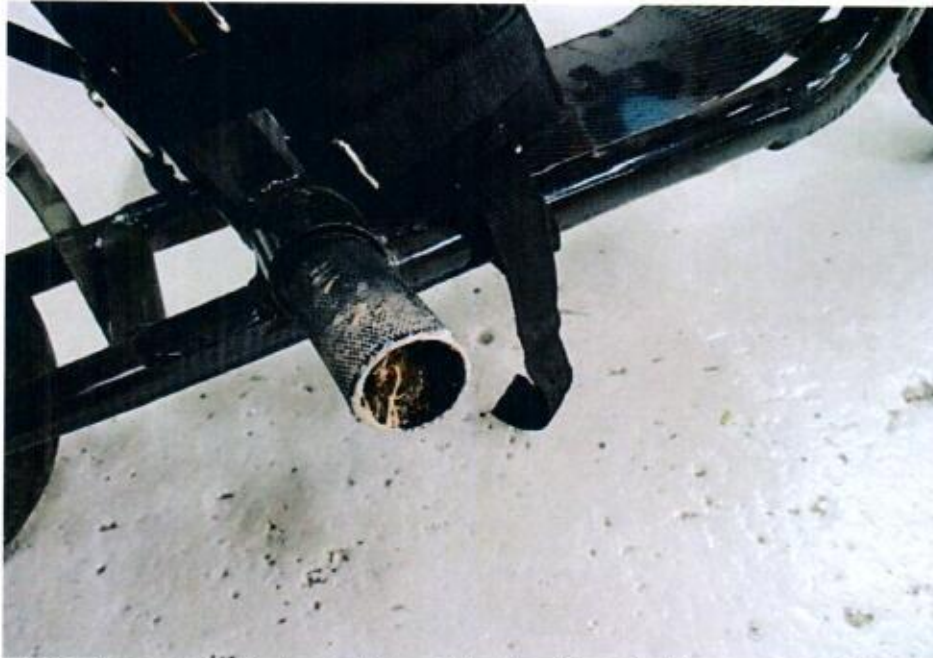
Photo 4 shows the footrest at the right side of the electric scooter, which was observed to be scratched/cut.

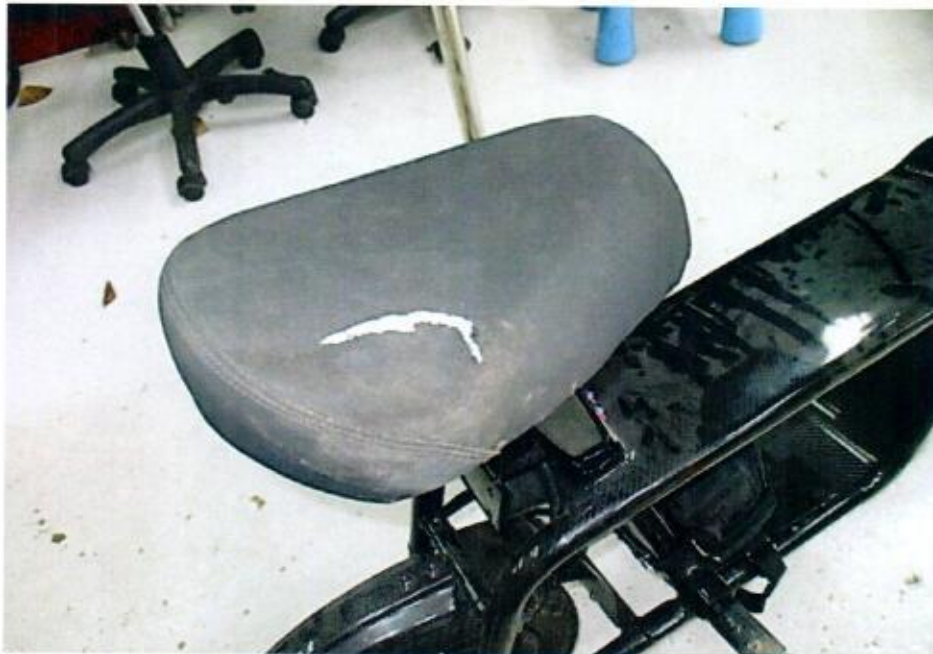
Photo 5 shows the seat cover of the electric scooter, which was observed to be torn.

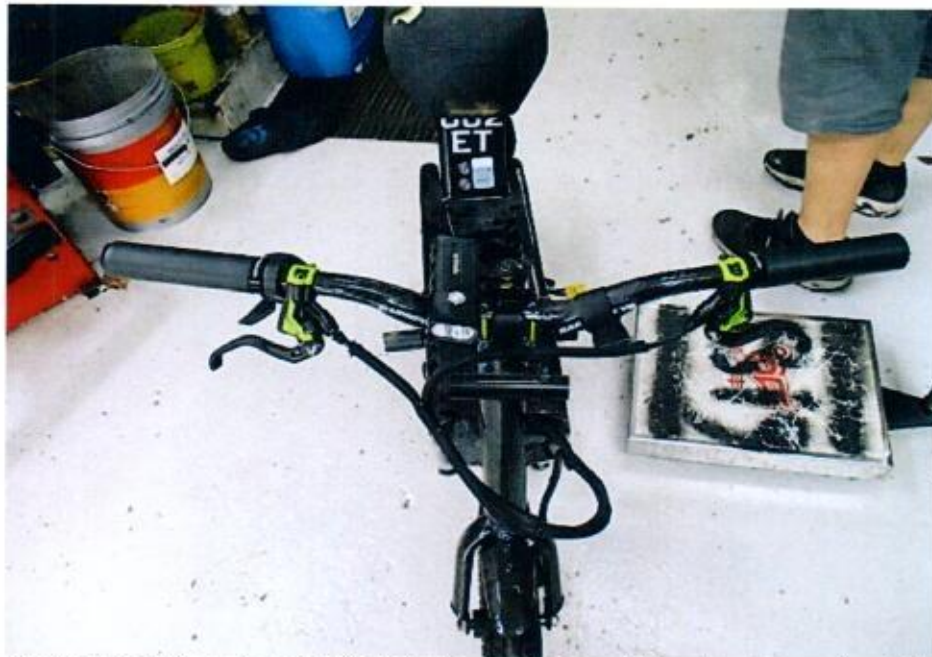
Photo 7 shows a general view of the handlebar of the electric scooter. The handler bar of the electric scooter was able to turn left and right with any abnormality.

14. The steering system of the electric scooter was tested by turning the handlebar to full left and full right. I did not feel any abnormal resistance and/or free play during this action. The front wheel of the electric scooter was able to turn in the same direction to the turned direction of the handlebar. The steering system of the electric scooter was in serviceable condition.

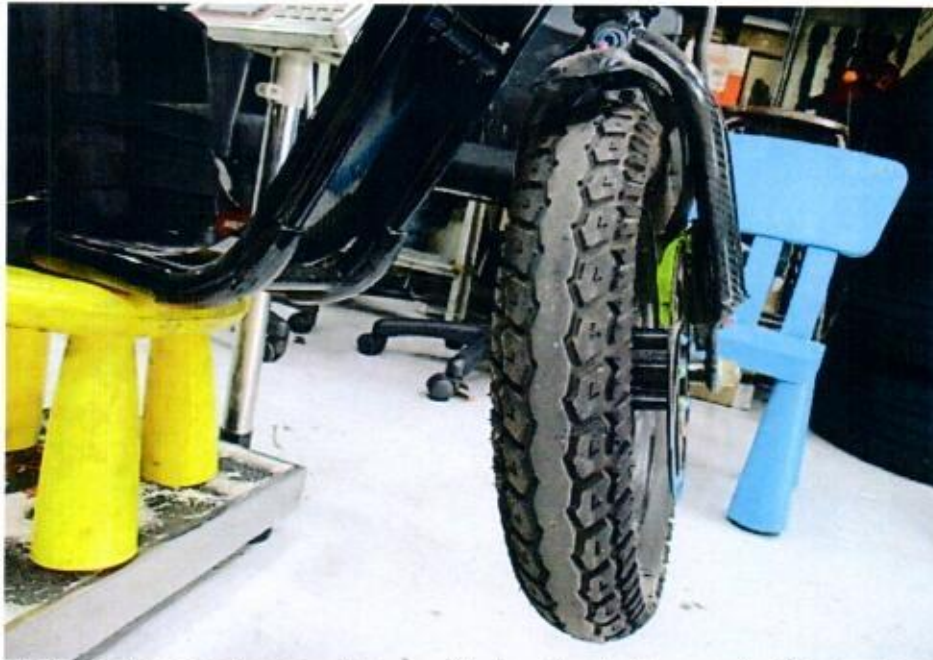
Photo 8 shows the front tyre that was fitted on the electric scooter. The front tyre was observed to be of serviceable condition with the tread pattern clearly visible. It was also sufficiently inflated for operational use.

20. The 2 tyres fitted on the electric scooter were also found to be in serviceable condition and sufficiently inflated for operational use.

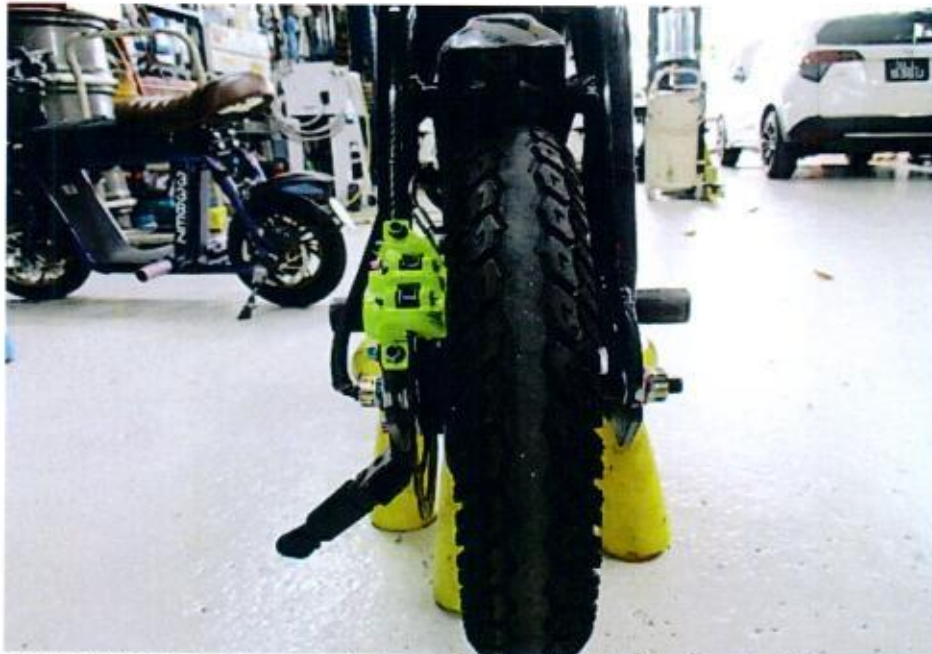
Photo 9 shows the rear tyre that was fitted on the electric scooter. The rear tyre was observed to be of serviceable condition with the tread pattern clearly visible. It was also sufficiently inflated for operational use.

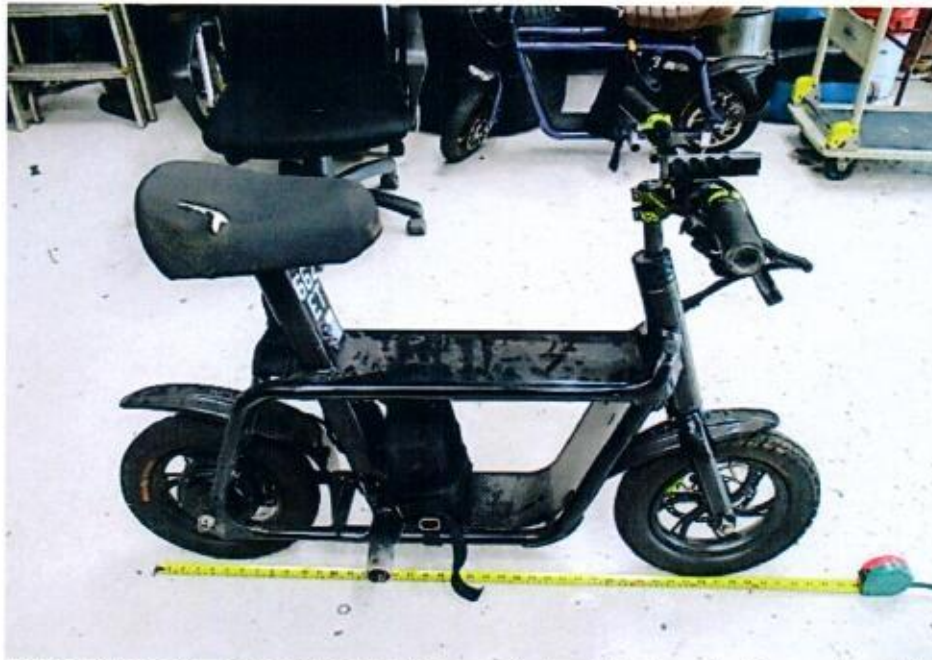
Photo 10 shows measurements being carried out to the electric scooter. The length of the electric scooter was measured to be 107cm while the width of the electric scooter was measured to be 65cm.

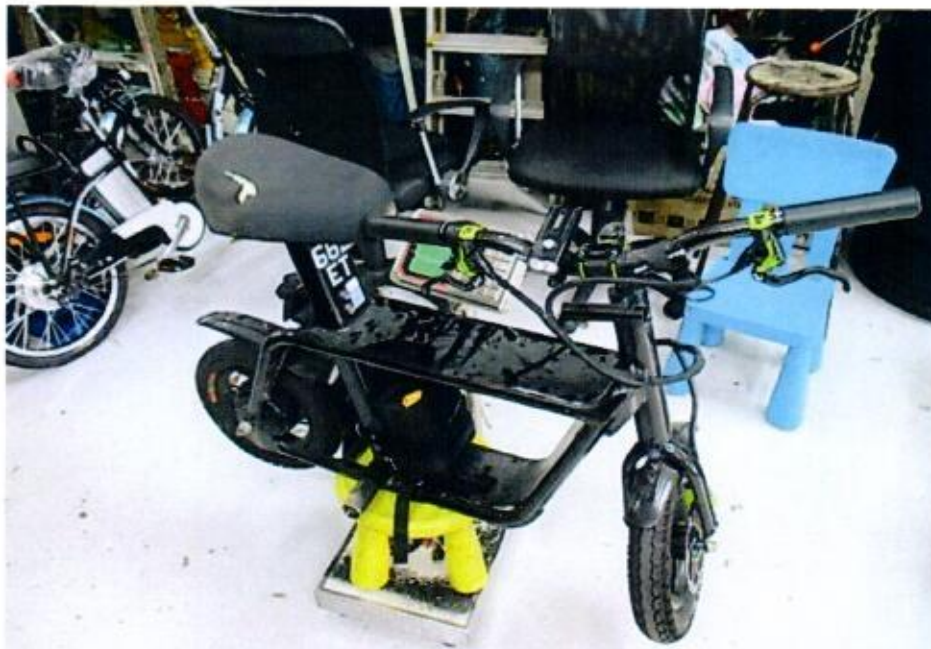
Photo 11 shows the electric scooter being weighed on a digital weighing scale. The yellow plastic chair supporting the electric scooter on the weighing scale was to prevent the tyres of the electric scooter from touching the ground during the weighing. The digital weighing scale was first calibrated to zero when the yellow plastic chair was placed on the scale.

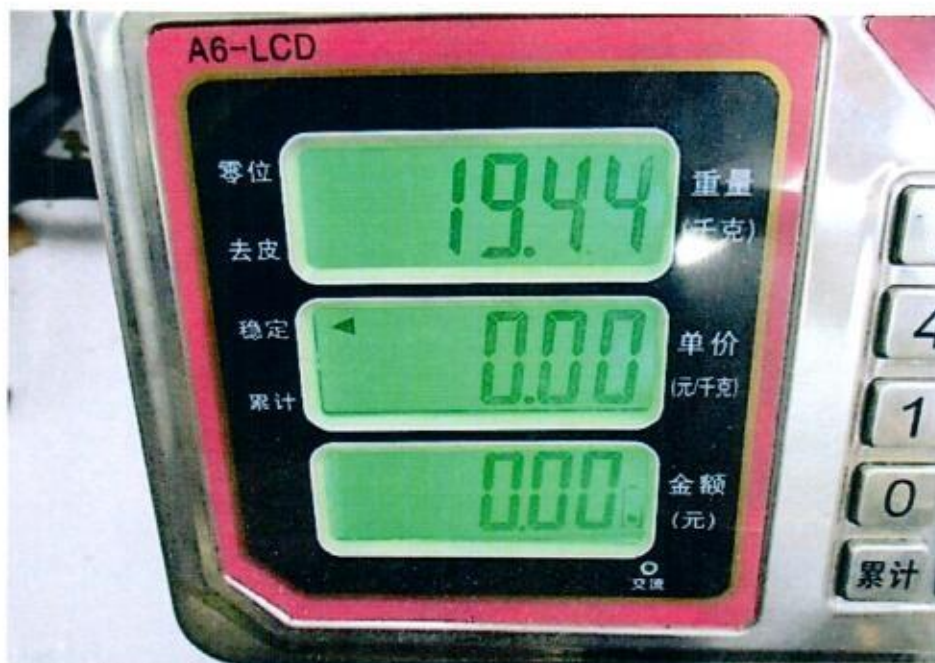
Photo 12 shows the weight of the electric scooter that was recorded by the digital weighing scale. The weight recorded was 19.44kg.

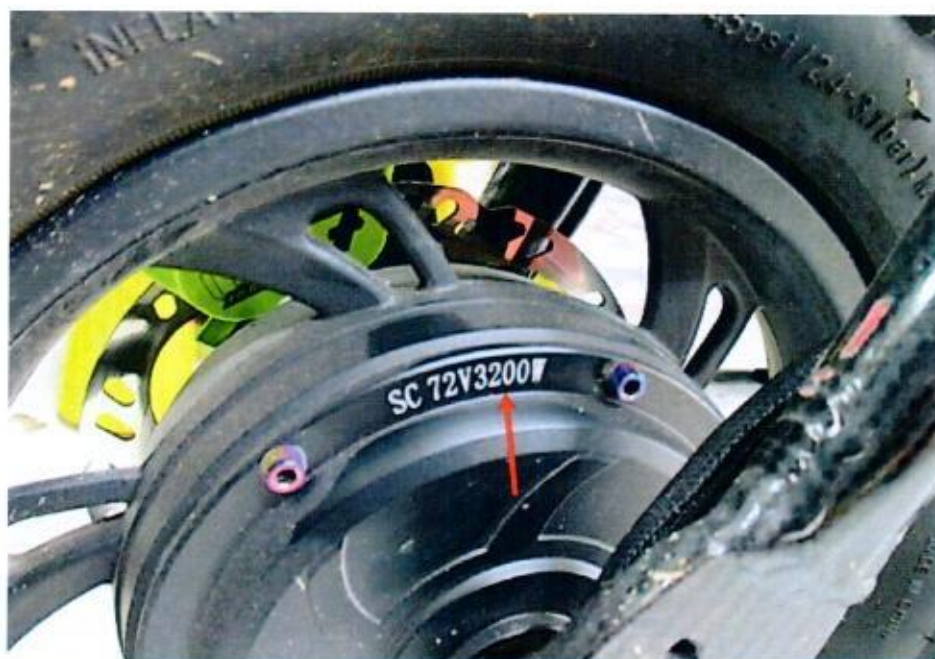
Photo 13 shows the electric motor that was fitted on the rear wheel of the electric scooter. The power rating of the electric motor was observed to be 3200 Watt (arrowed). The motor in this electric motor turns/rotates when electric power is supplied from the battery of the electric scooter.

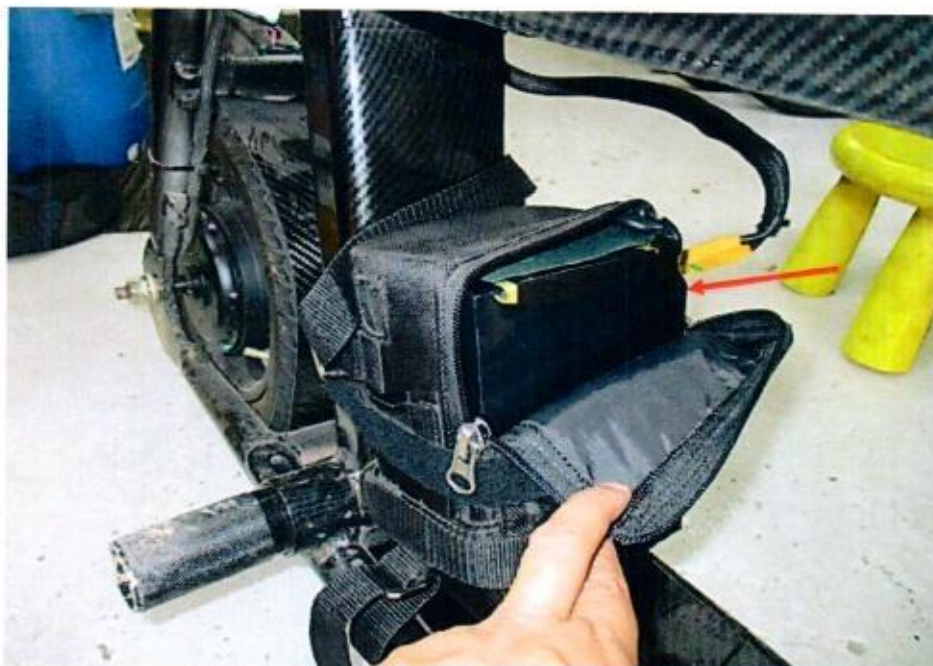
Photo 14 shows the battery (arrowed) pack that was fitted on the electric scooter. The battery pack was removed for checks on its power ratings.

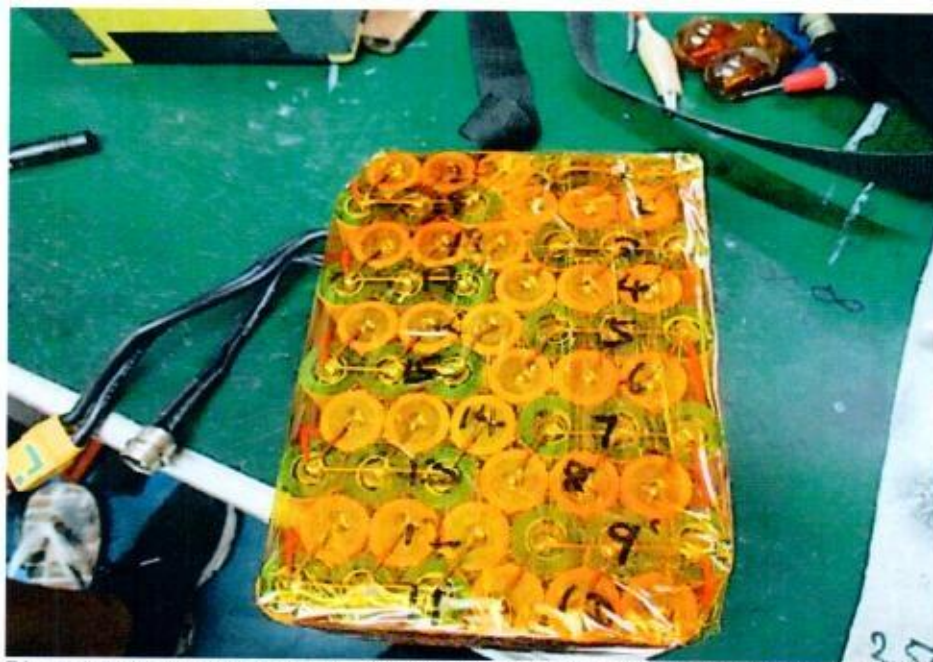
Photo 15 shows the battery pack that was fitted on the electric scooter. The battery pack was made up of 60 battery cells. This battery pack supplies the electric power to the electric motor in order for the electric scooter to accelerate/move.

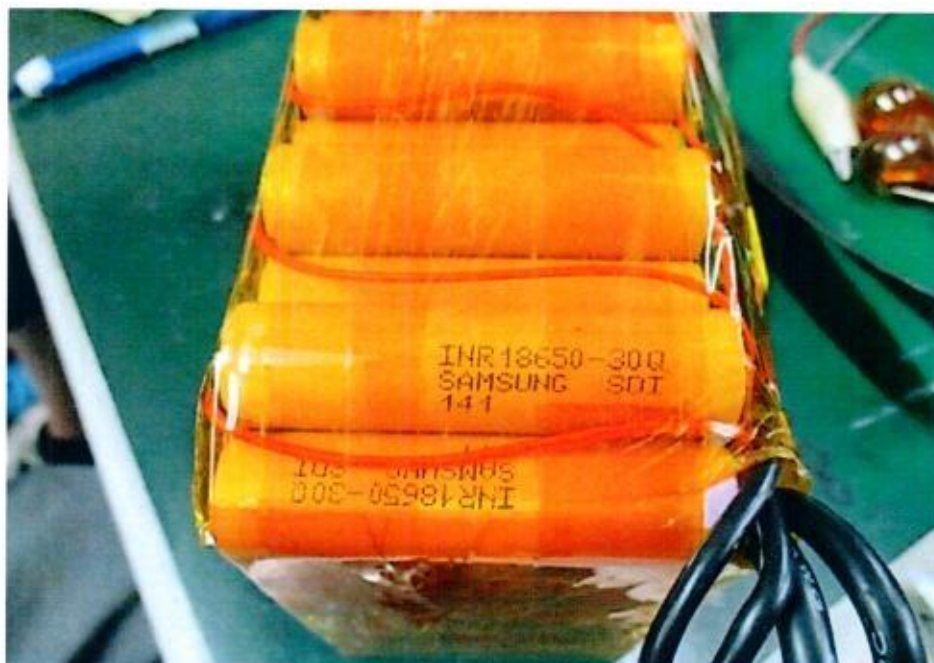
Photo 16 shows the brand and model of the battery cells. In total the battery pack fitted on the electric scooter has 72 Volt.

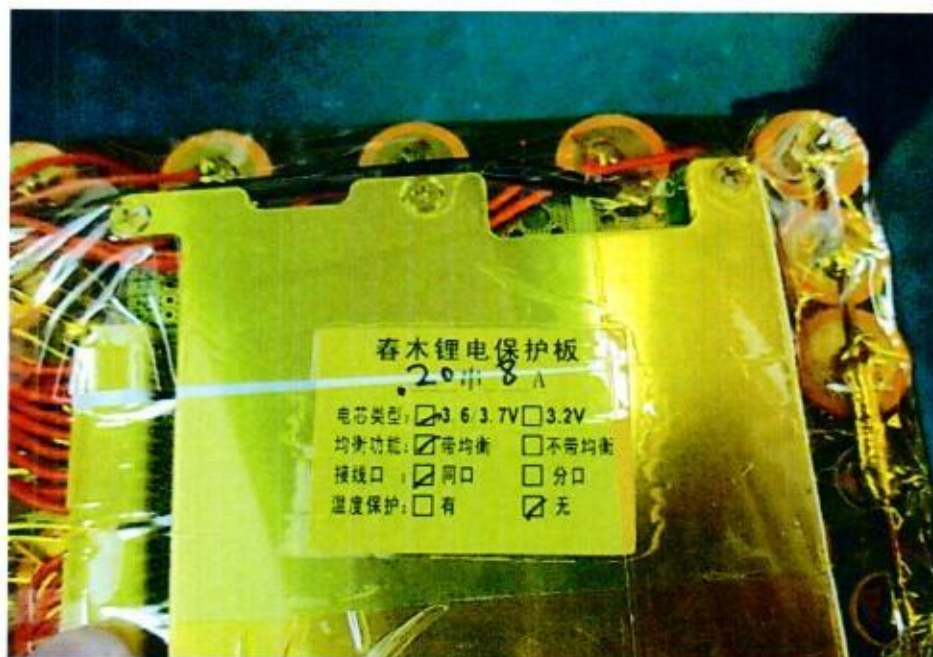
Photo 17 shows the information pasted on the battery pack of the electric scooter. The battery pack fitted on the electric scooter has 72 Volt.

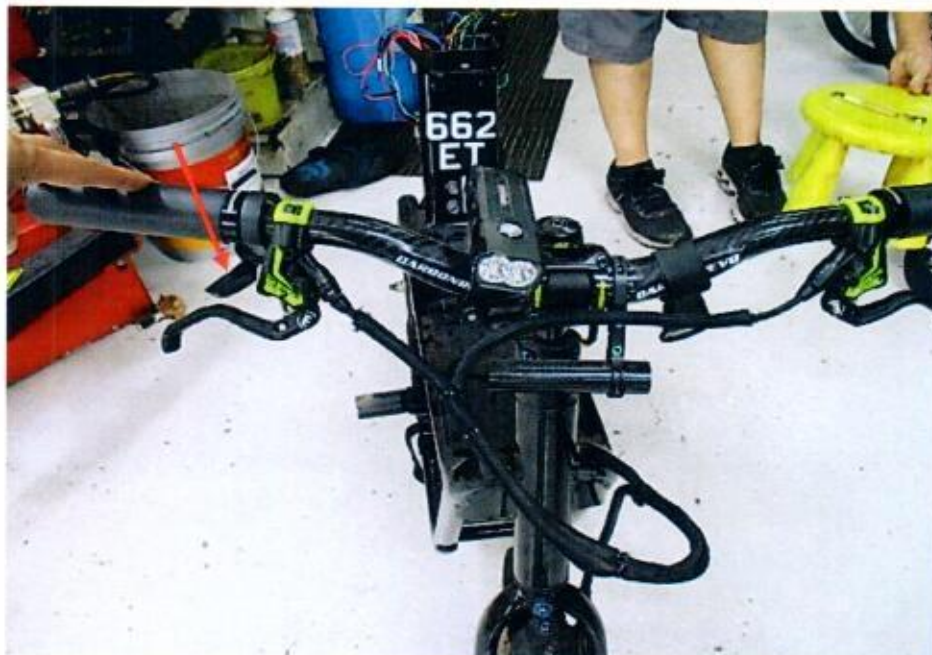
10. The acceleration/movement function of the electric scooter is via a lever which acts as a throttle. This lever is located towards the right side of the handlebar. When manually depressed, the electric scooter will accelerate/move. To maintain acceleration/movement, the lever will have to be continuously depressed.
11. When this lever is depressed, electric power from the battery pack of the electric scooter is supplied to the electric motor that is fitted at the rear wheel. The motor in the electric motor then turns/rotates resulting in the rear wheel of the electric scooter to also turn/rotate. This allows the electric scooter to accelerate/move. See photo 18 & 19 below.

Photo 18 shows the lever (arrowed) for the acceleration/movement function of the electric scooter. When this lever is depressed, electric power from the battery pack of the electric scooter is supplied to the electric motor that is fitted at the rear wheel. The motor in the electric motor then turns/rotates resulting in the rear wheel of the electric scooter to also turn/rotate. This allows the electric scooter to accelerate/move.

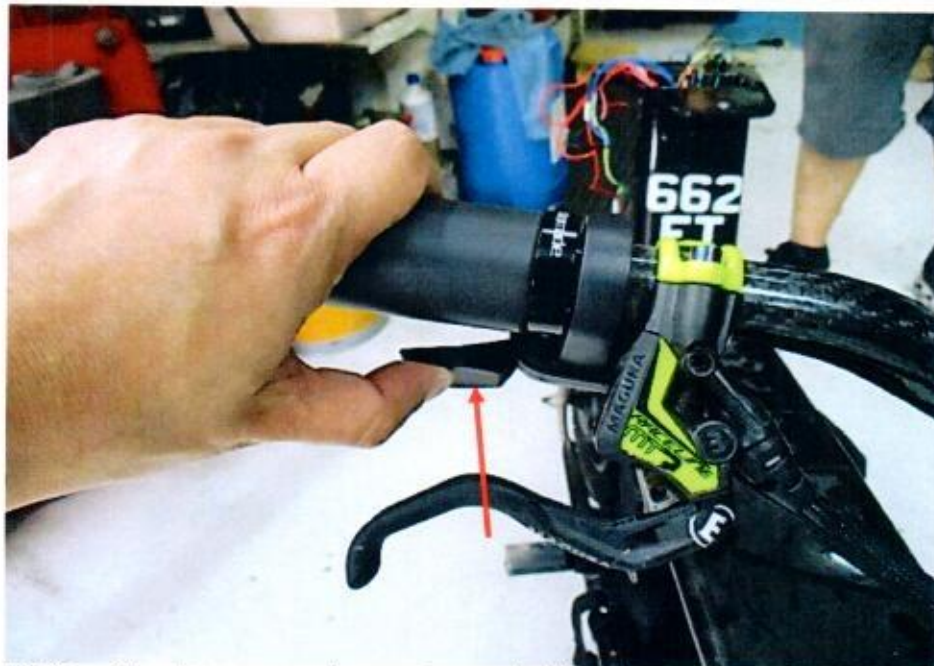
Photo 19 shows a closer view of the lever (arrowed) for the acceleration/movement function of the electric scooter being depressed. To maintain acceleration/movement, the lever will have to be continuously depressed. Once the lever is no longer depressed, electric power to the electric motor is cut off and the electric scooter will gradually come to a stop.

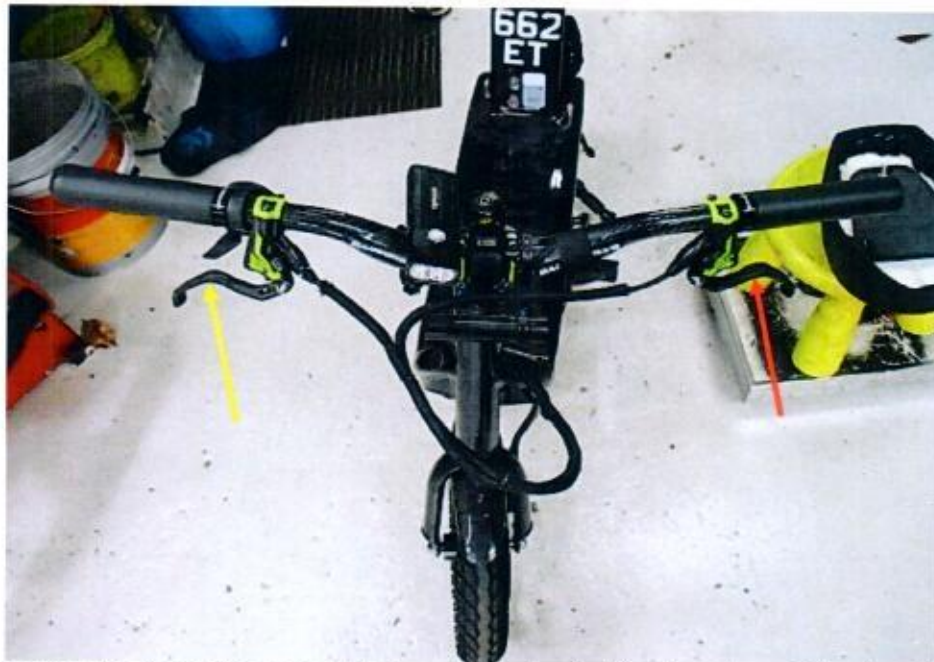
12. The stopping function of the electric scooter is via 2 levers that are located, one at the right side of the handlebar and the other at the left side of the handlebar. The lever at the right side operates the brake for the front wheel while the lever at the left side operates the brake for the rear wheel. The 2 levers can be depressed simultaneously to operate the brake for the front wheel and rear wheel; or individually depressed to operate the respective brake for the front wheel or the rear wheel. Both the 2 levers are operated manually.
13. When the lever(s) is depressed, the brake is activated by cable and spring pushing the brake pads to clamp onto the brake disc at the wheels of the electric scooter. Frictional resistance from this clamping action reduces the rotation of the wheels, hence creating the braking effect for the electric scooter. See photo 20 – 22 below.

Photo 20 shows the levers that operates the braking function of the electric scooter. The lever (yellow arrow) at the right side of the handlebar operates the brake for the front wheel while the lever (red arrow) at the left side of the handlebar operates the brake for the rear wheel. The levers can be simultaneously depressed or individual depressed.

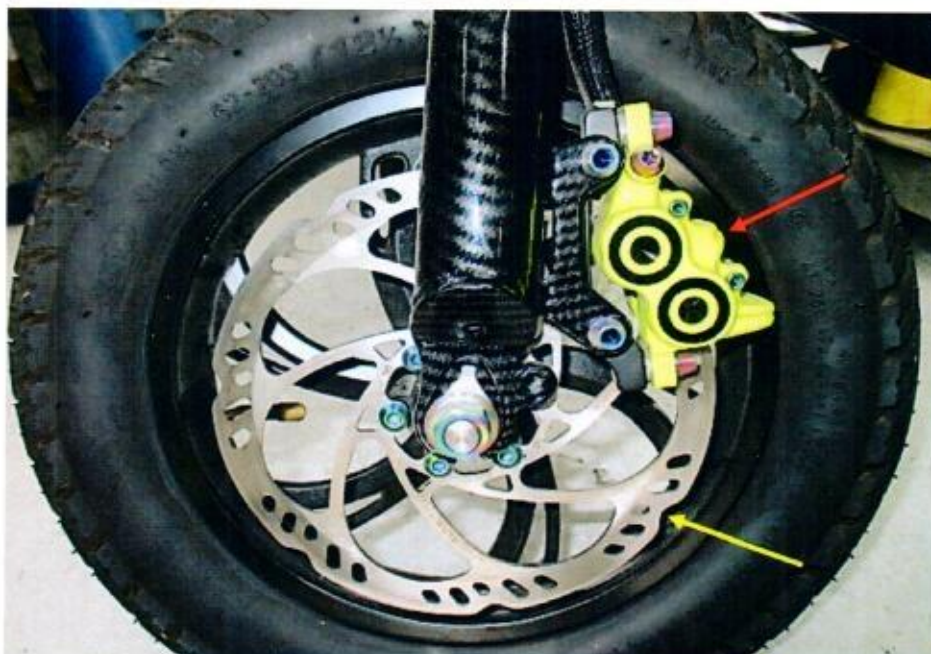
Photo 21 shows the braking components at the front wheel of the electric scooter. When the front brake lever of the electric scooter is depressed, the brake pad (red arrow) is pushed towards the brake disc (yellow arrow) via cable and spring. The brake pad clamps against the brake disc providing the frictional resistance to reduce the rotation of the front wheel, hence creating the braking effect for the electric scooter.

17. With regard to the front brake, I had manually rotated the front wheel, simulating movement of the electric scooter's front wheel. The front brake lever located at the right side of the handlebar was then depressed. It was observed that the front wheel stopped rotating almost instantaneously. This would indicate that the front brake of the electric scooter was in serviceable/working condition.
