Preliminary Advice

Insured Vehicle No	: SJA1651R	Accident Date	: 15/03/2020
TP Vehicle No	: SGL8229J	Assignment Date	: 17/03/2020
Make	: TOYOTA CAMRY	Est. Duration of Repair	: 5
Date of Inspection	: 17/03/2020		
Inspection At	: XIN YIN AUTO (HQ) BLK 8 PREMIER @ KAKI BUKIT AVE 4 #05-23 SINGAPORE 415875

VEHICLE DAMAGE INSPECTION REPORT

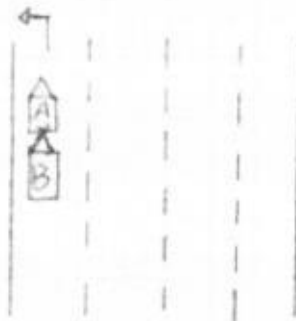
SKETCH PLAN

A: S6L 8229J

B: SJA1651R

I was waiting to turn left at the traffic junction at Ang Mo Kio Avenue 3, when vehicle B: SJA1651R hit the rear of my car.
