## SINGAPORE ACCIDENT STATEMENT

Report No: 0793-18-TCA

## ACCIDENT VEHICLE SURVEY REPORT

Vehicle Reg No.:	SLL9689Z	Odometer:	048350km
Make & Model:	Subaru XV 1.6I-S	Colour:	White
Chassis number:	JF1GP3KC5HG201079	Date of accident:	15/05/2018
Year of Regn.:	17/03/2017	Date inspected:	04/09/2018
Repairer at:	Twincar Automotive Pte Ltd 2 Kaki Bukit Ave 2 #01-17 Kaki Bukit Auto Hub Singapore 417921	Date inspected (After Repair):	07/09/2018

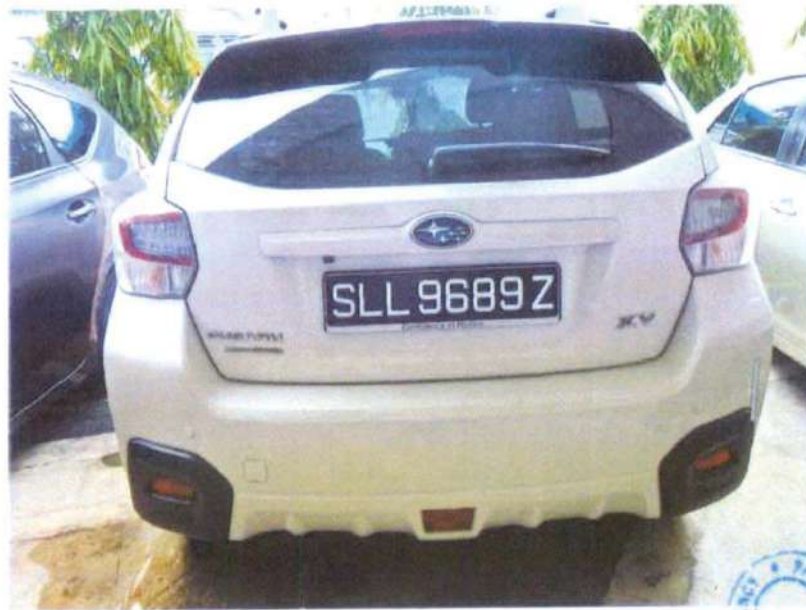
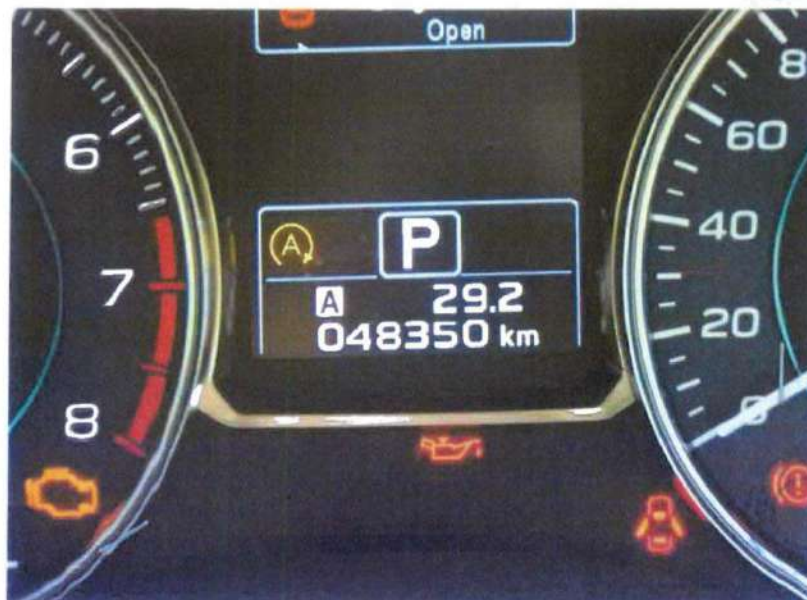
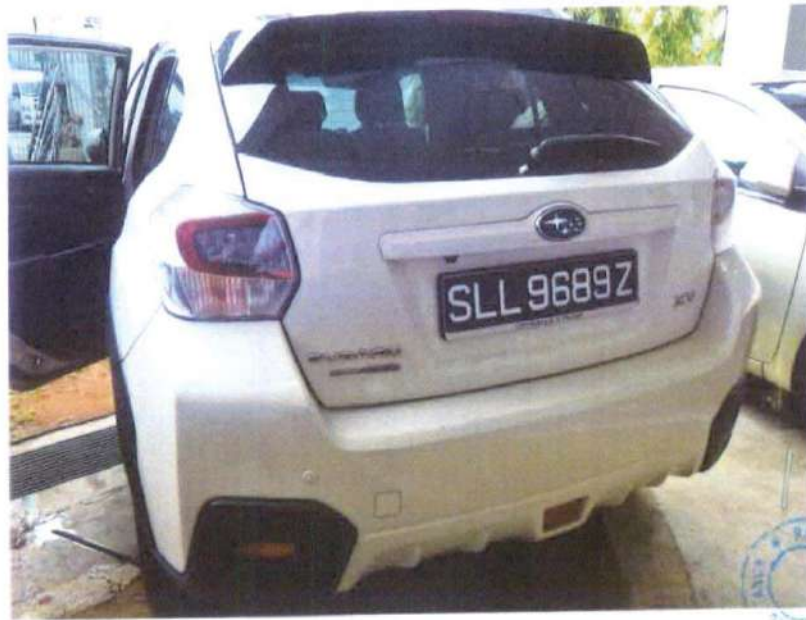
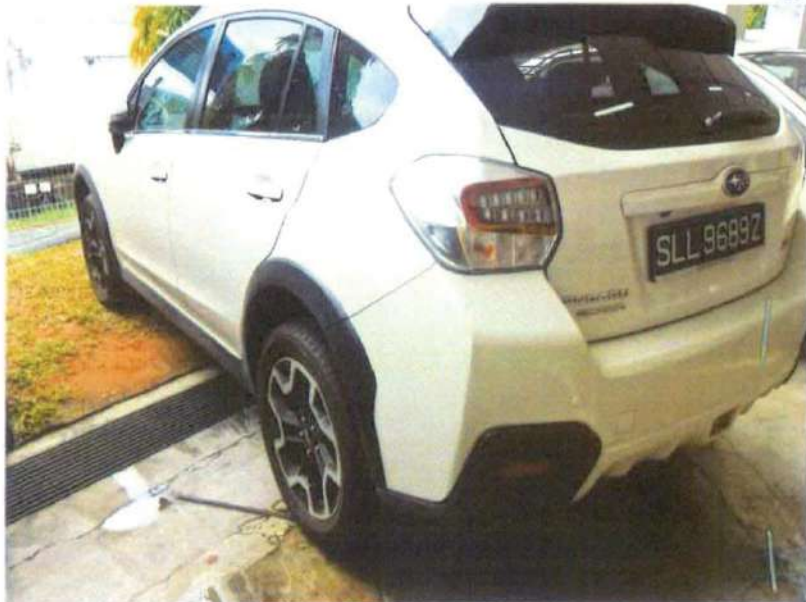
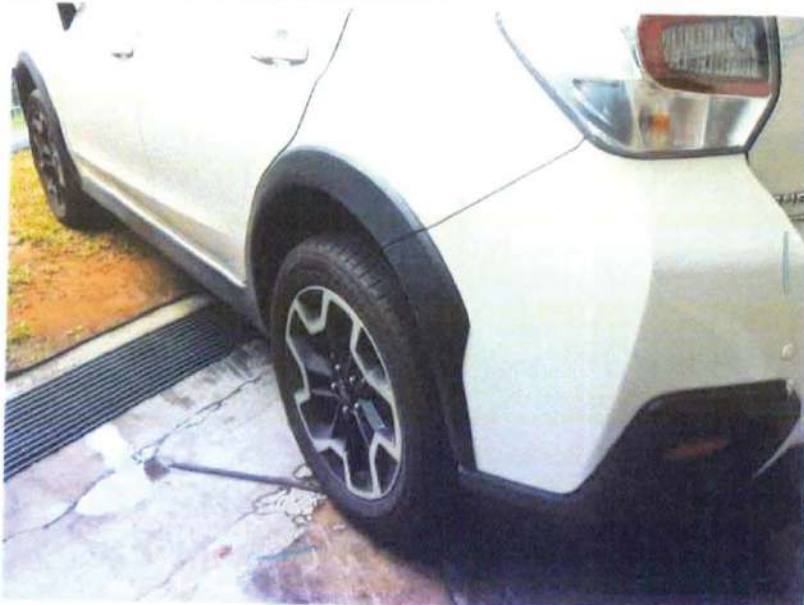
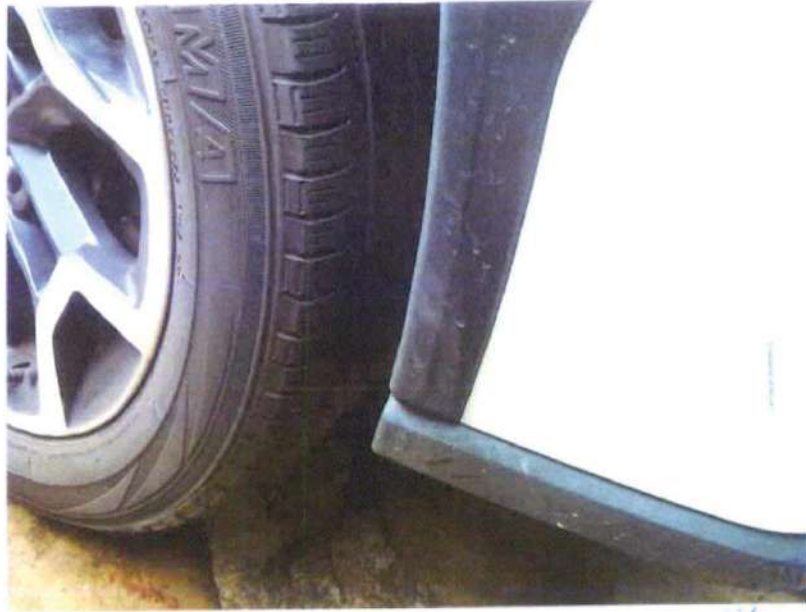
Impact on the rear LH portion.  
Please see details as described in the Annex for parts and labour.

Hence, the recommended cost of repairs based on Lump Sum repairs is ; SS 4,900.00  
and the recommended number of working days for the repairs is within 6 day(s).

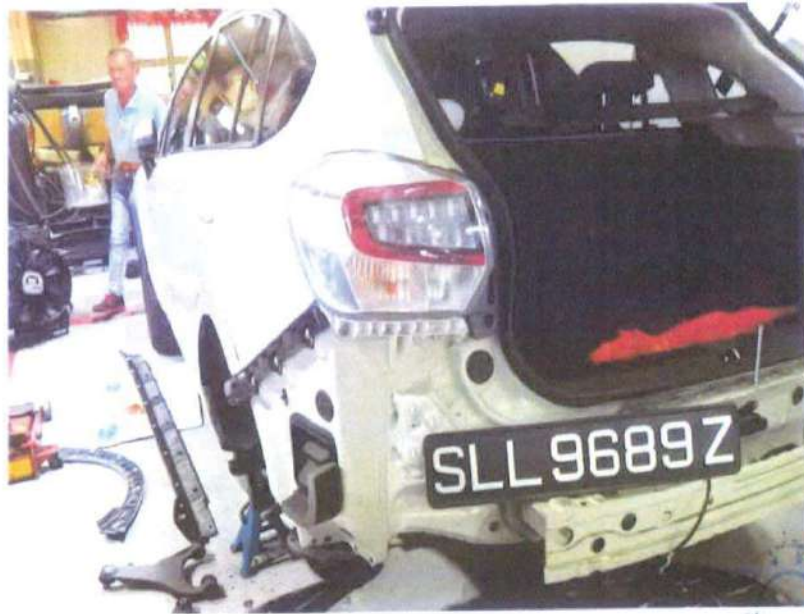
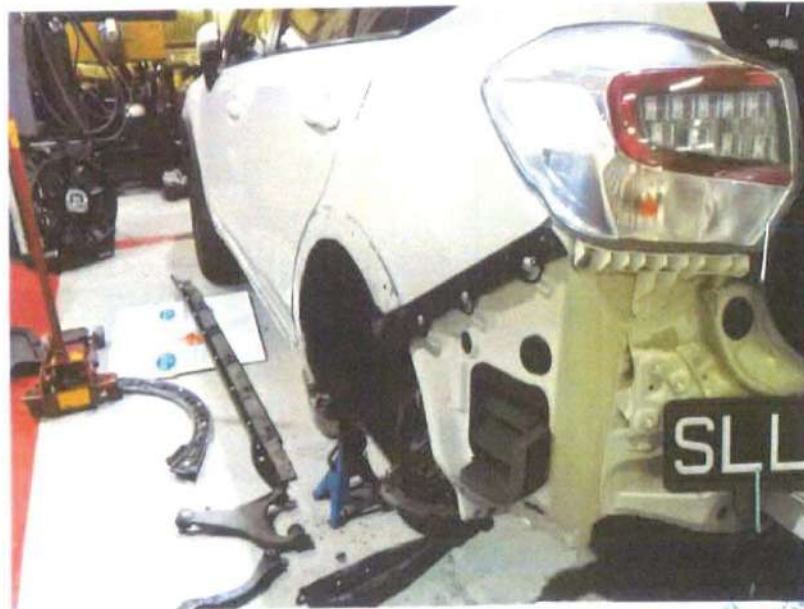
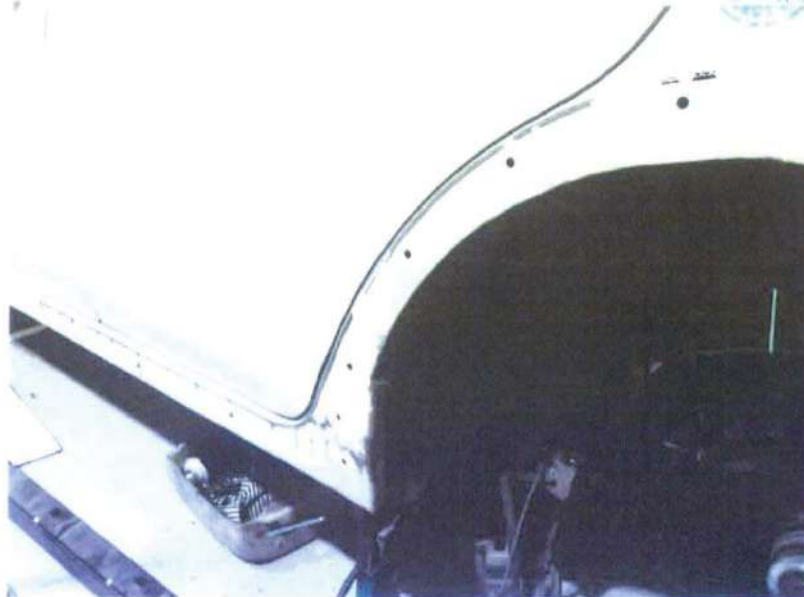
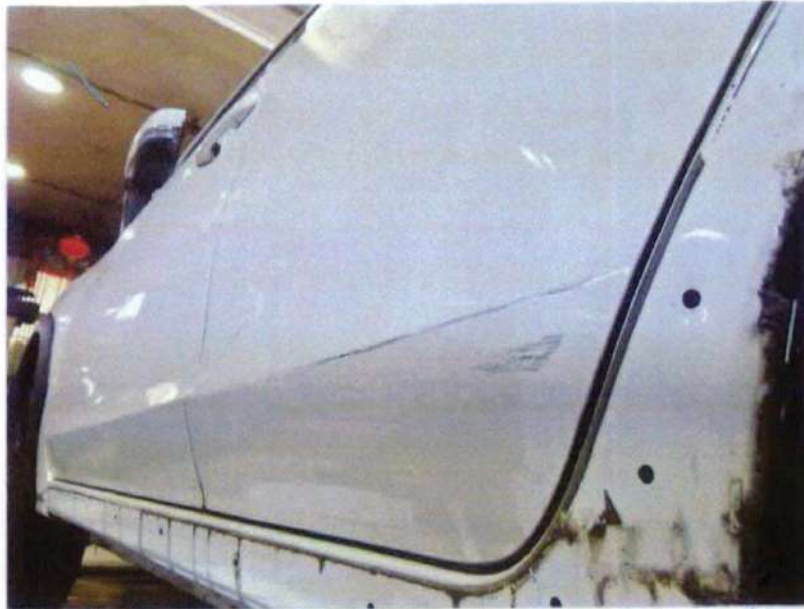
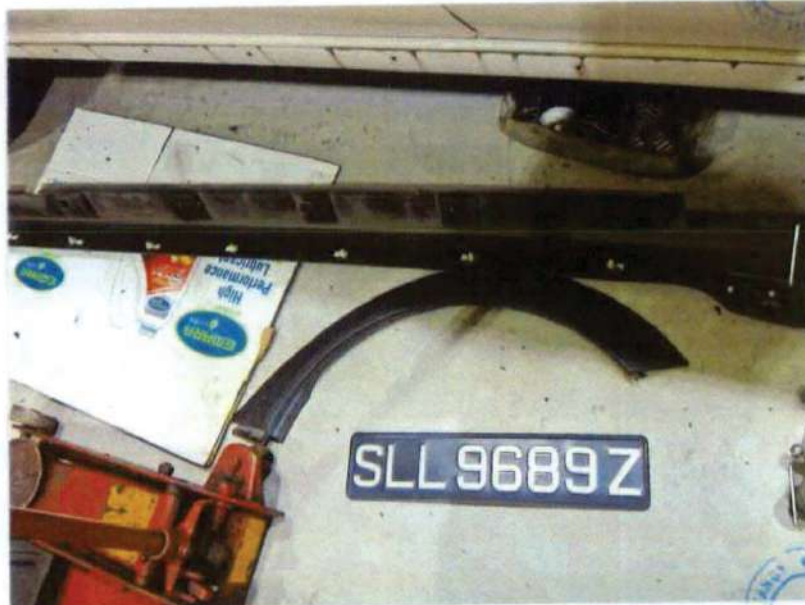
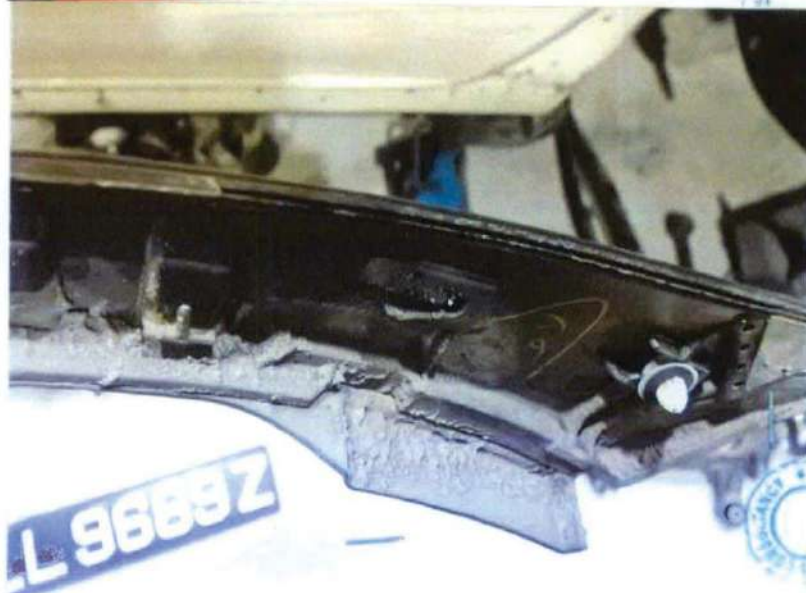
We had carried out re-inspection during works in progress and post repair inspection on the above vehicle. Attached in Annex B are the re-inspection photos, showing the work in progress and our re-inspection to the hidden part that were damaged.
