## National Assessment Centre Services

**ADJUSTMENT ON REPAIR COST FOR VEHICLE NO. SHA 4072R**

PHOTOGRAPHS FOR VEHICLE NO. SHA 4072R

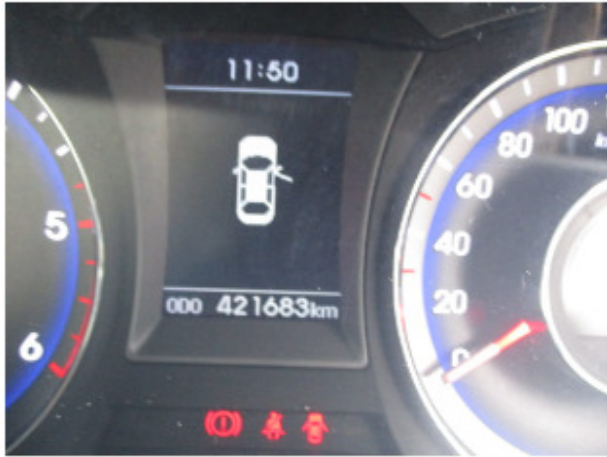
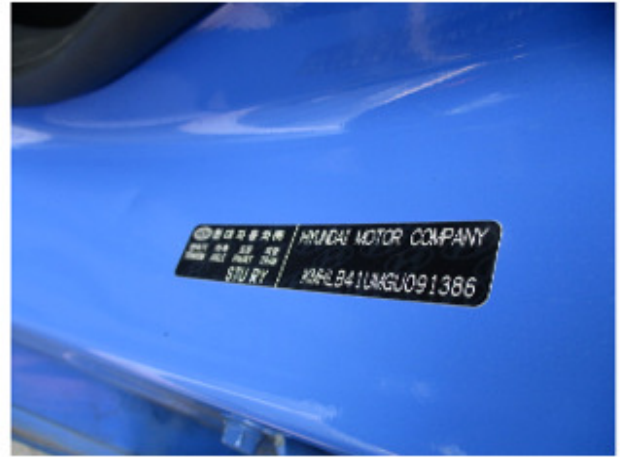
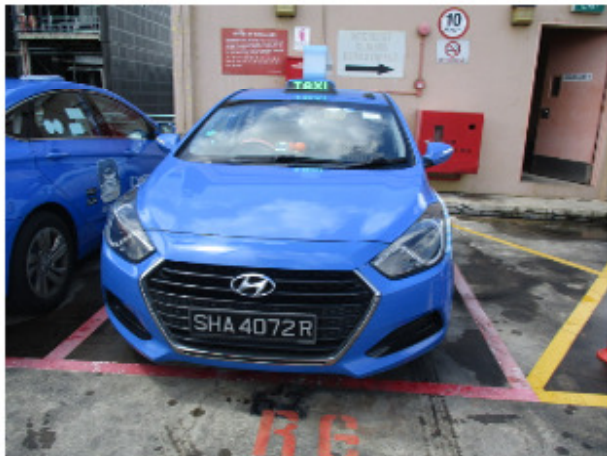
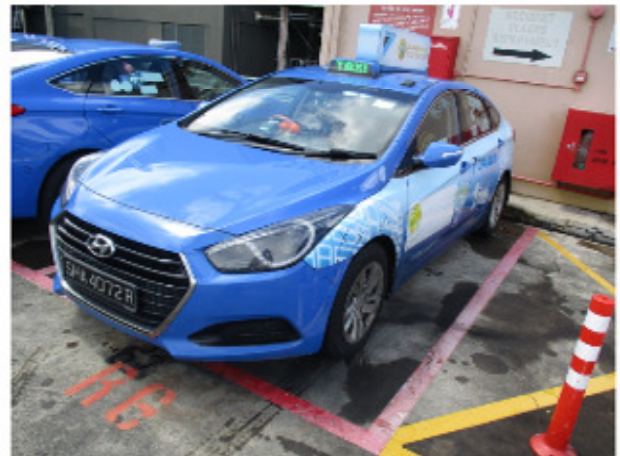
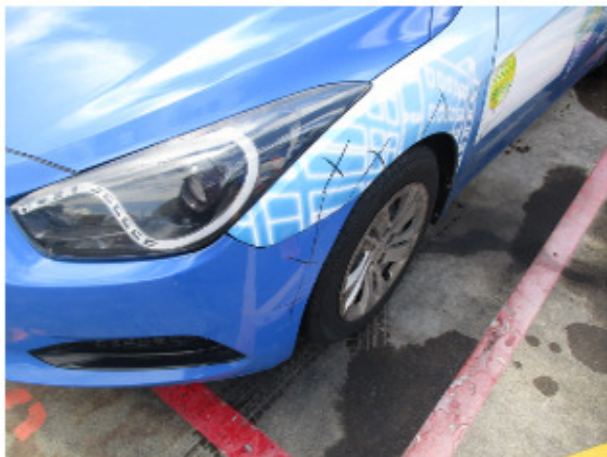
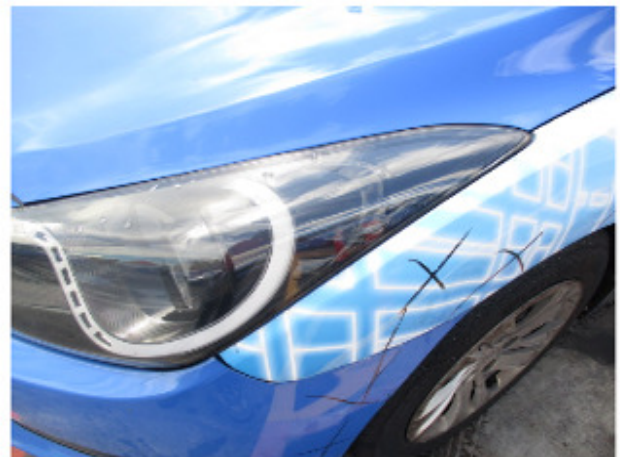
THE VEHICLE SUSTAINED DAMAGES AT THE N/S FRONT PORTION. DAMAGES SEE DETAILS.			
<b>5. General Information</b>				
Accident Date	02/06/2020	Inspection Date	03/06/2020	
Survey held at	COMFORTDELGRO ENGINEERING PTE LTD 59 LOYANG DRIVE SINGAPORE 508969			
<b>5a. Remarks</b>				
	A)THE INSPECTION WAS CONDUCTED ON A"WITHOUT PREJUDICE" BASIS. B)IN ACCORDANCE TO YOUR INSTRUCTIONS, WE HAVE NOT AUTHORISED REPAIRS.			
<b>5b. Estimate Days of Repair</b>				
	ESTIMATED NORMAL PERIOD FOR REPAIR:		3 Working Days

275.00	275.00
	<b><u>LABOUR</u></b>			
	PANEL BEATING.INCLUSIVE OF THE REPAIR OF FRONT BUMPER COVER AND FRONT LH FENDER.		540.00	420.00
	SPRAY PAINTING CHARGE.		600.00	550.00
	TUFF KOTE.	NOT NECESSARY	80.00	-
	CHECK LIGHTING.		60.00	30.00
			1,280.00	1,000.00
	<b>GRAND TOTAL</b>		<b>4,120.84</b>	<b>1,360.68</b>
	<b>RECOMMENDED COST OF LUMP SUM REPAIRS (TO ITS PRE-ACCIDENT CONDITION) (CONFIRMED)</b>			<b>1,050.00</b>
