ACCIDENT INVOLVING PA8930T & GP558R ALONG JURONG WEST AVENUE 4 ON 03/04/2020 @ 14:30 HRS

Final repair bill for PA8930T Toyota Hiace 3.0 D DX (A)

VEHICLE DAMAGE ASSESSMENT REPORT

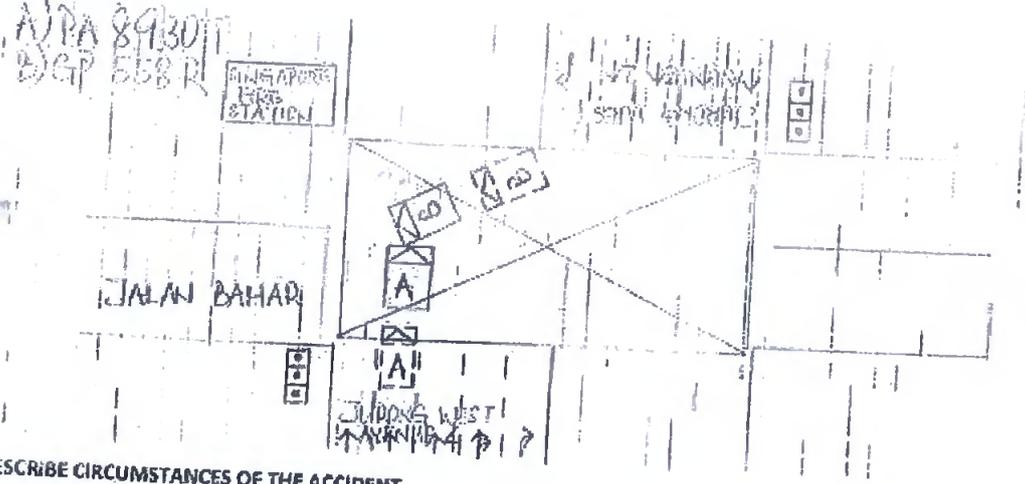
SKETCH PLAN

I wish to state that the front airbag was activated and the left sliding door was affected due to the impact.

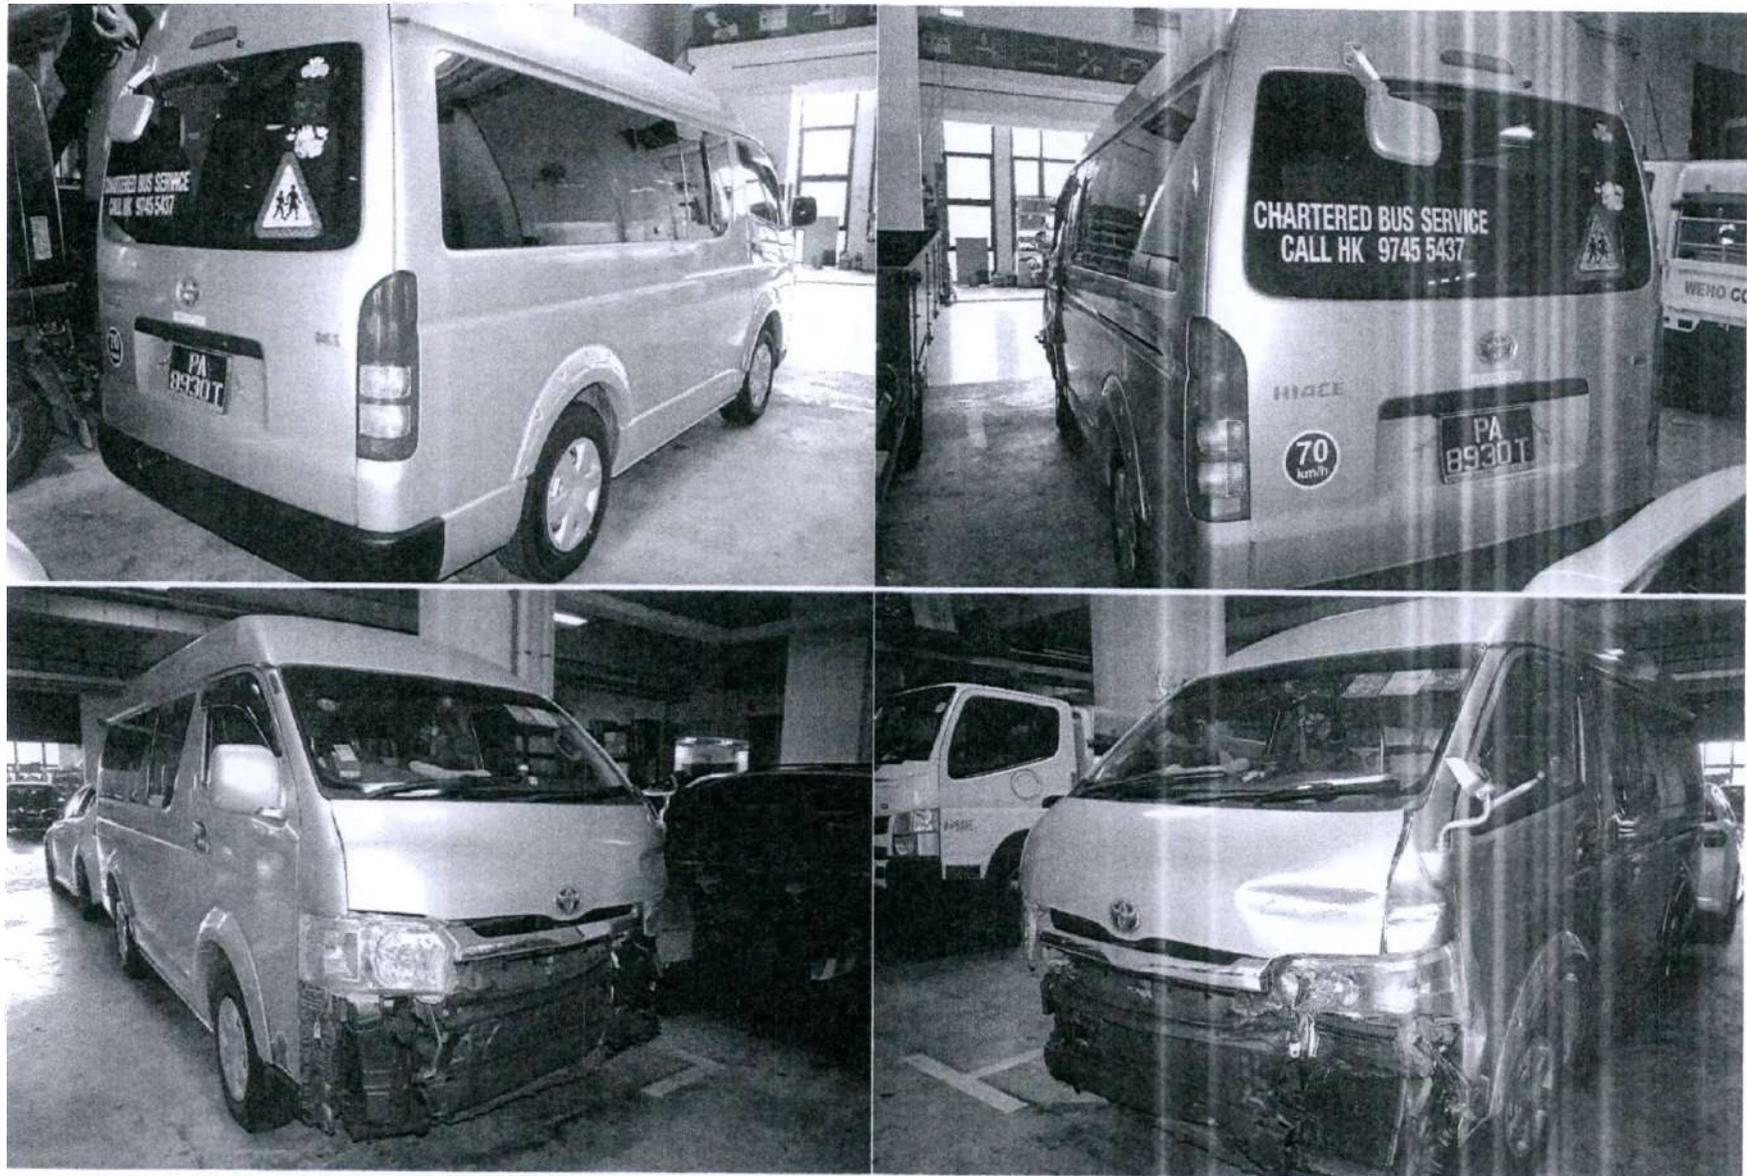
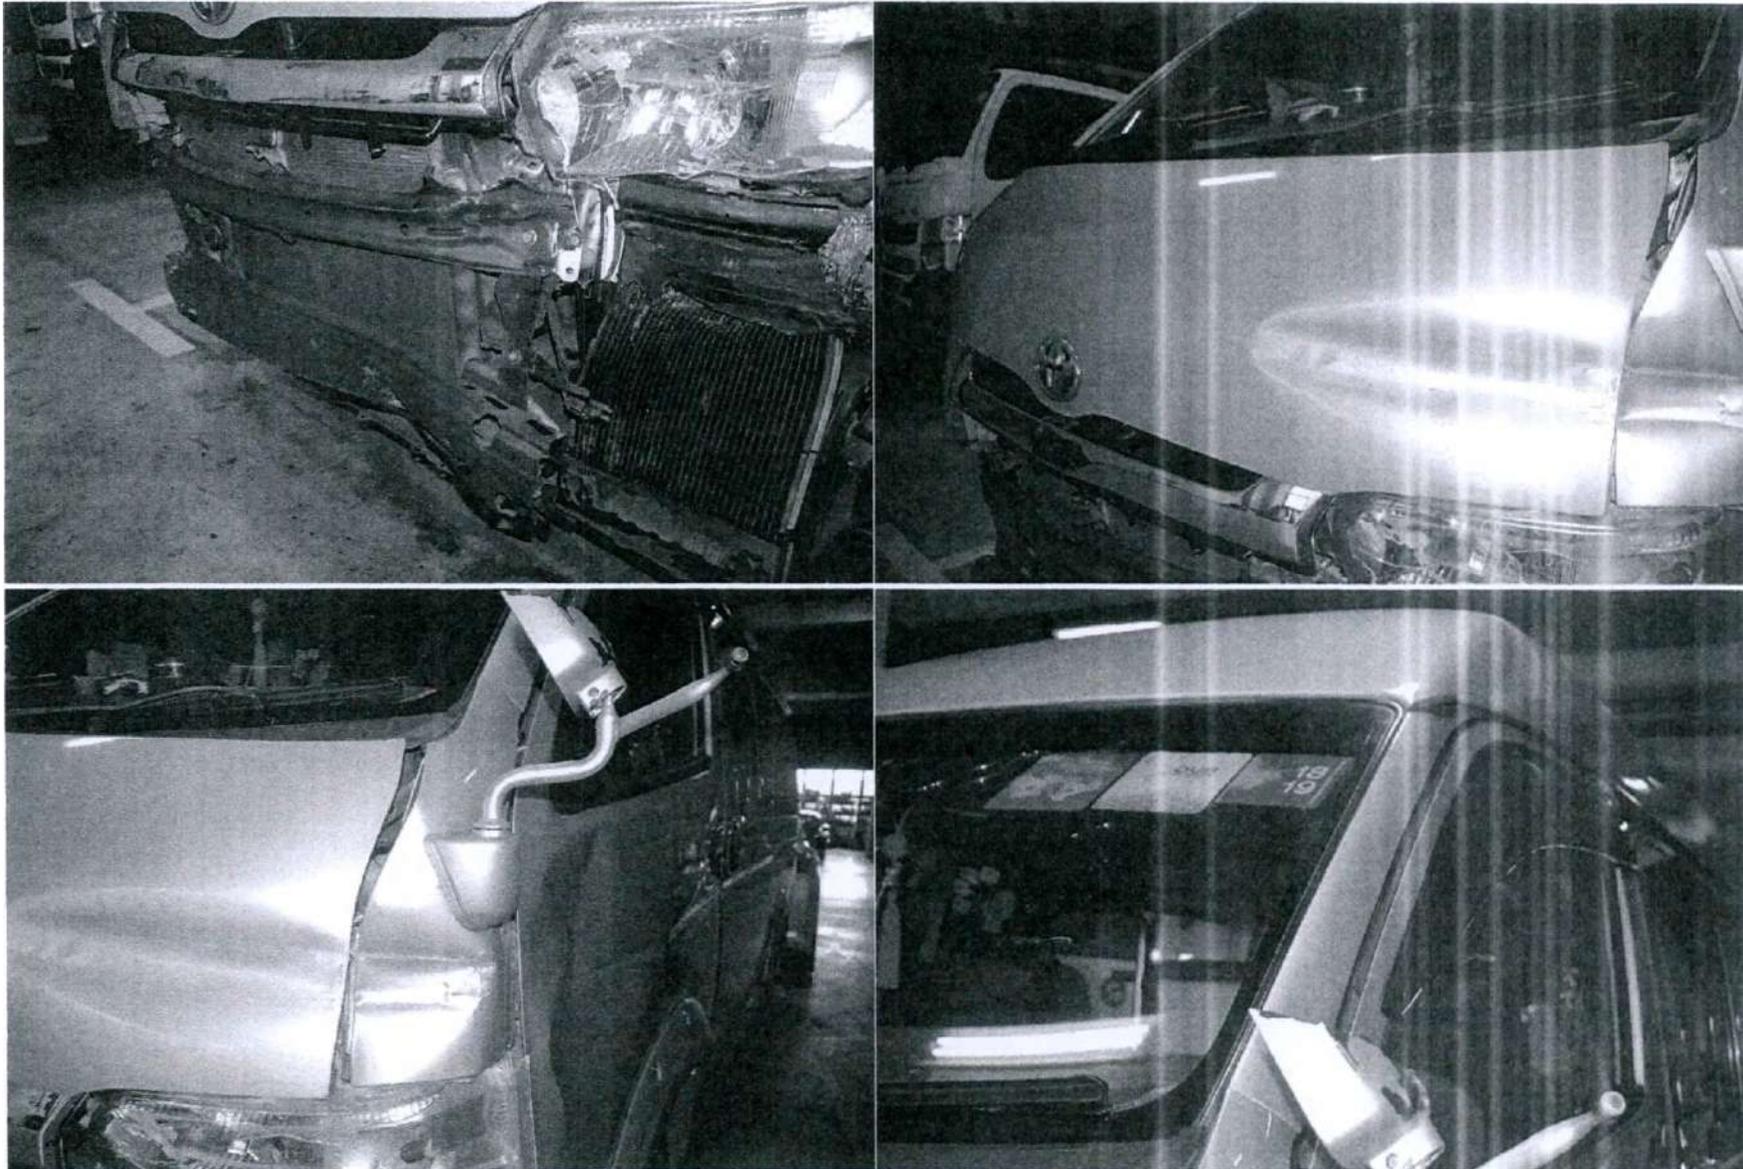
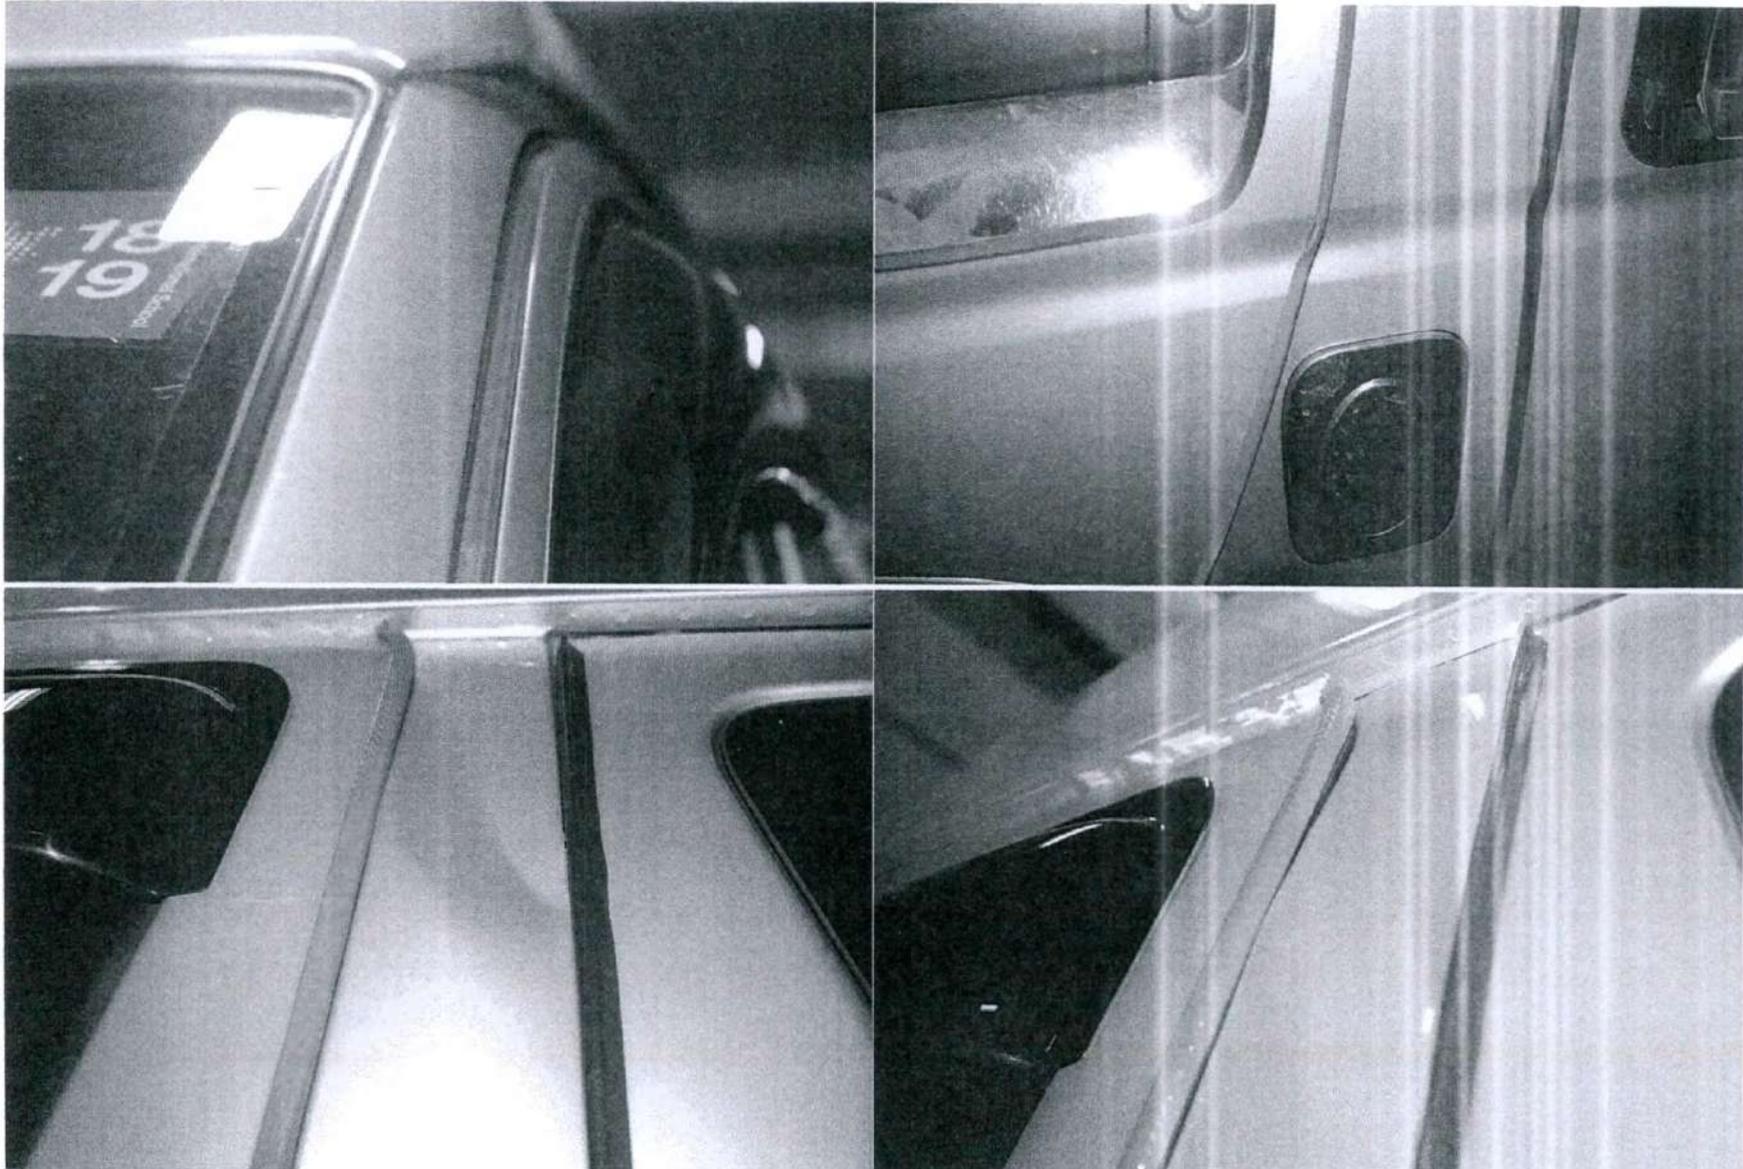
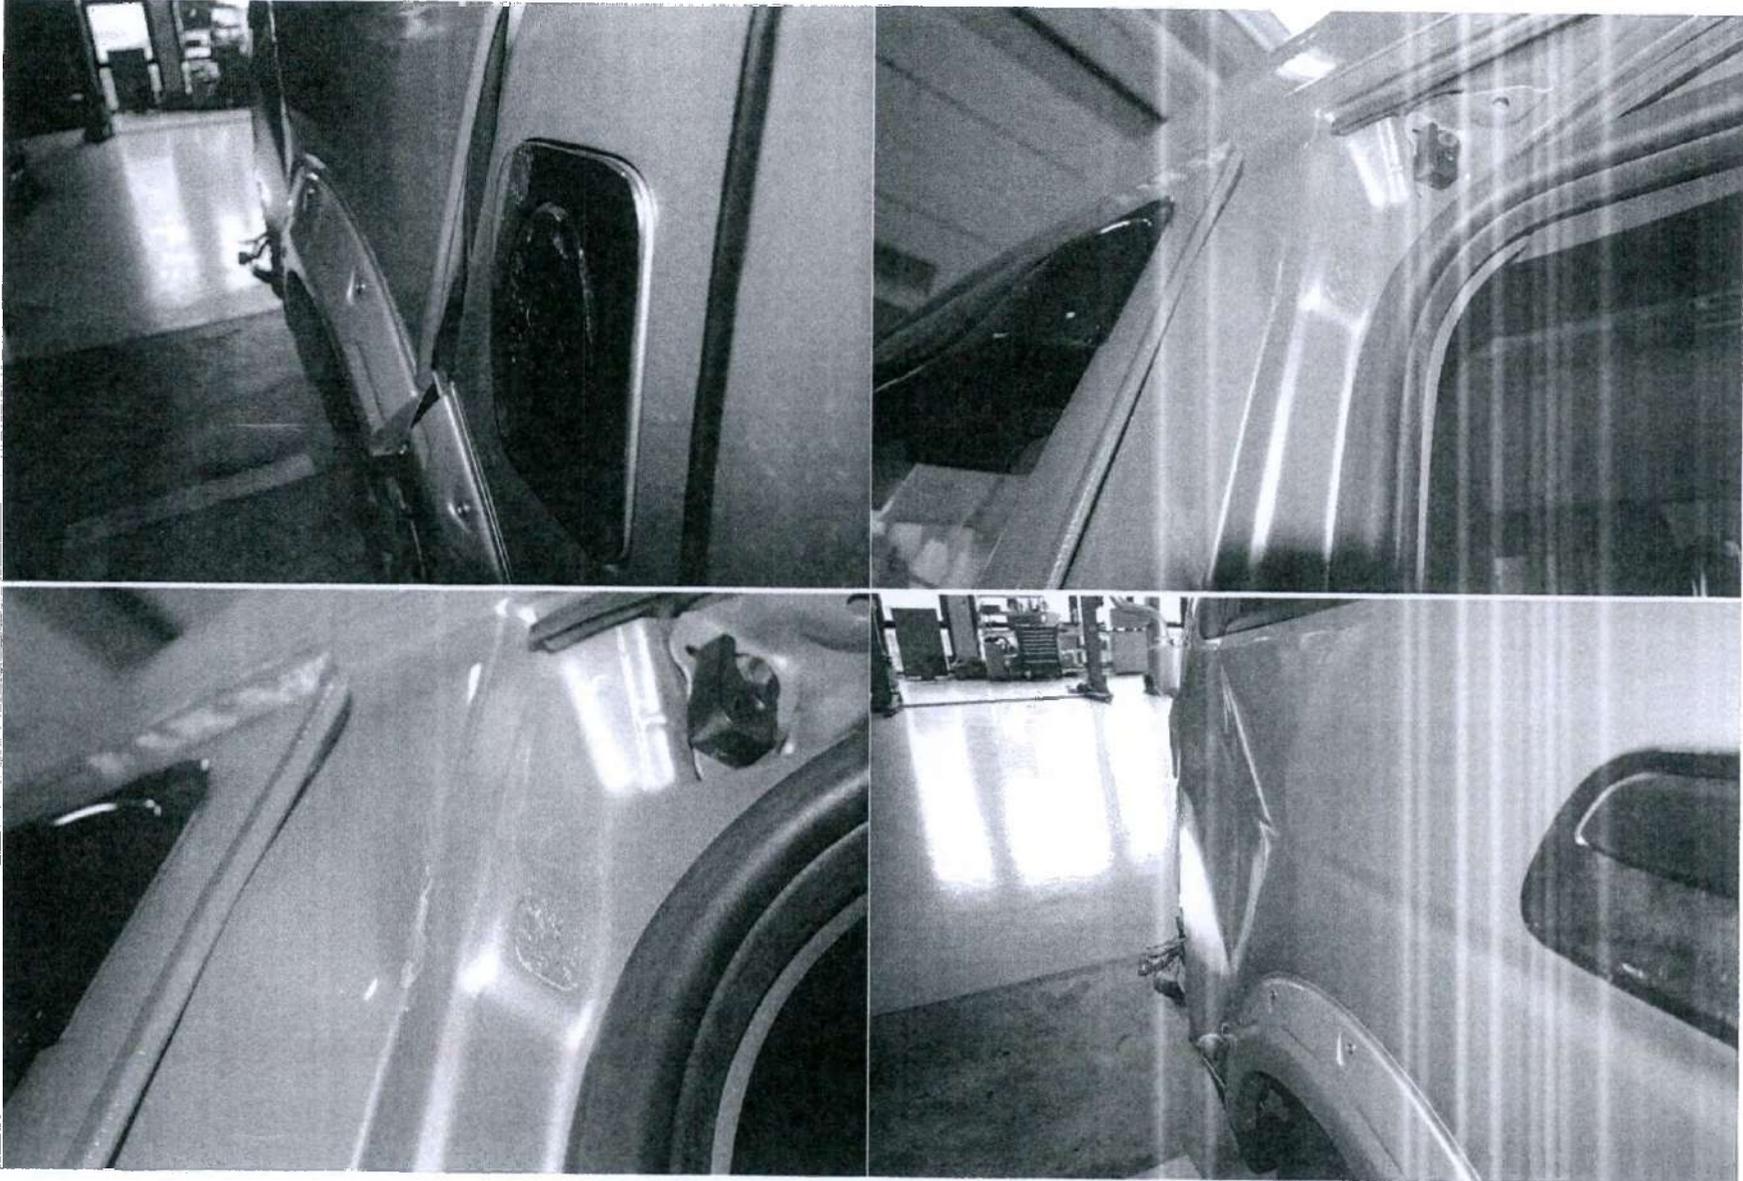
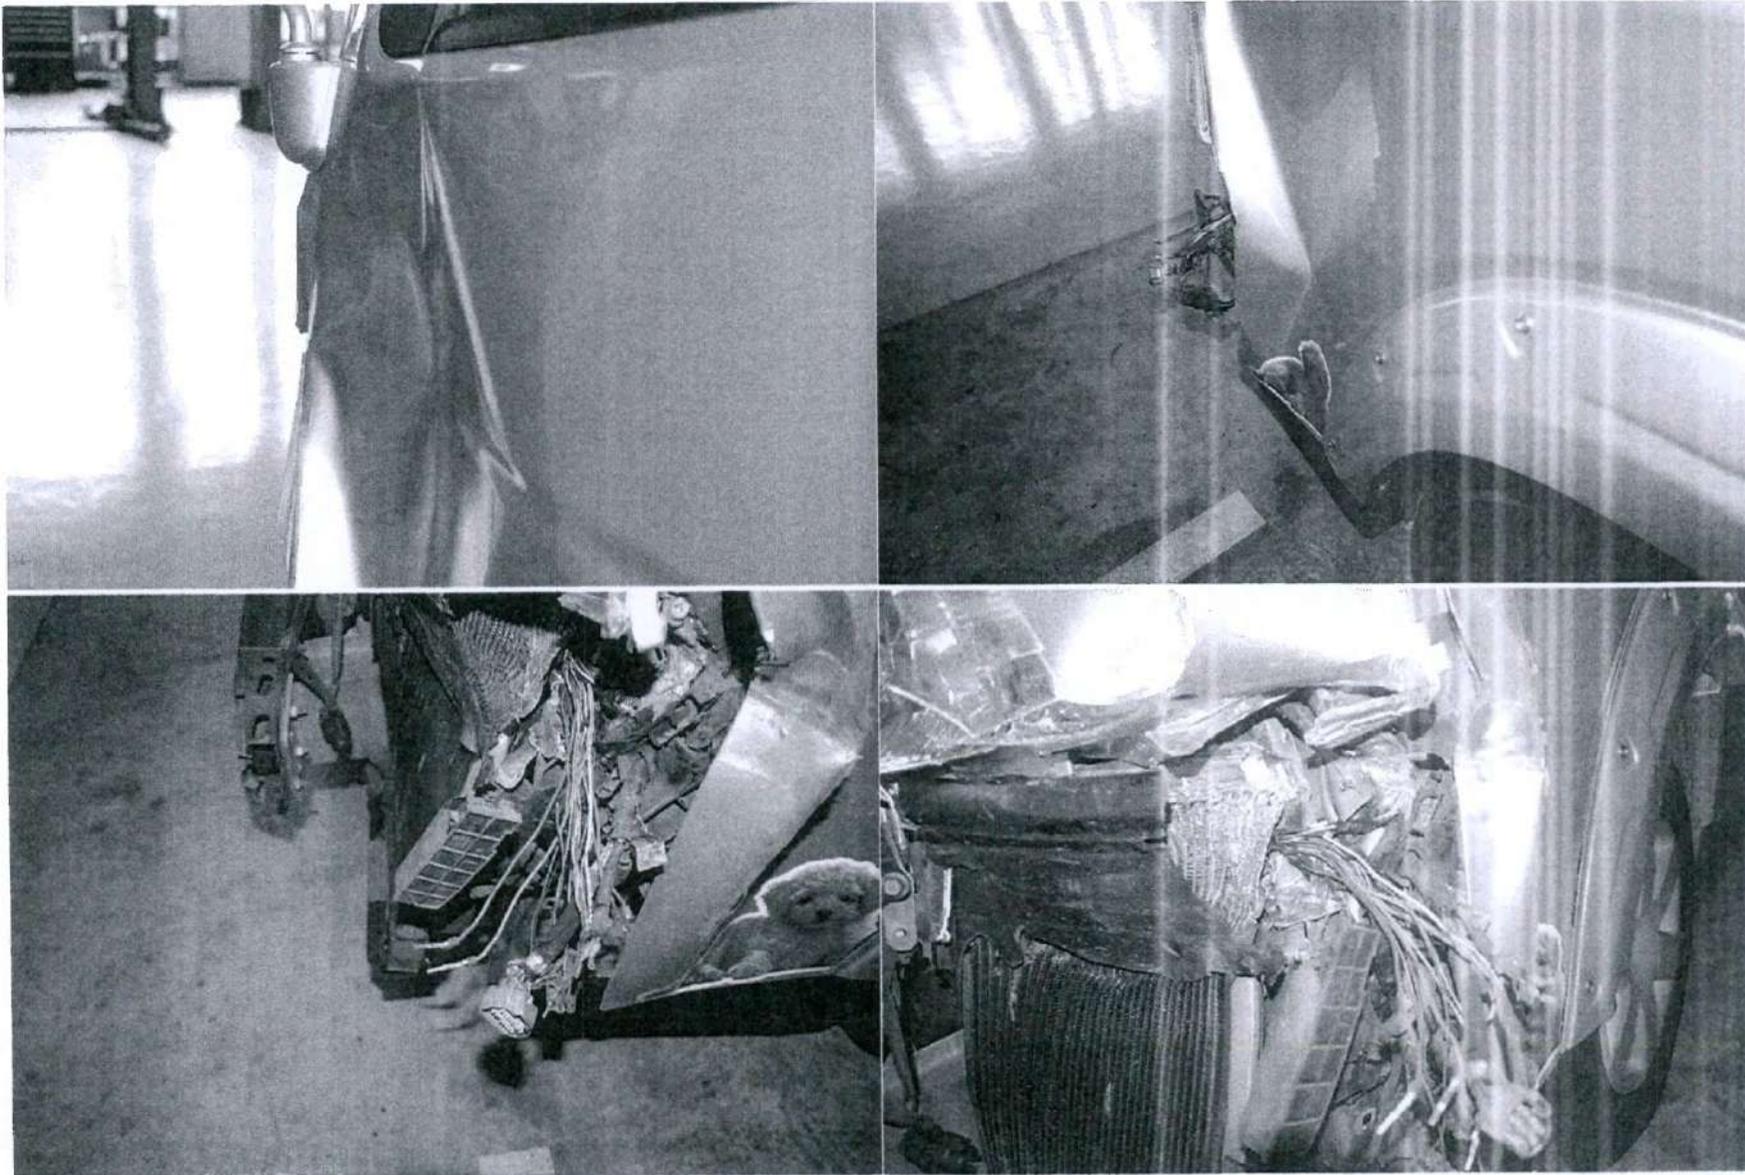
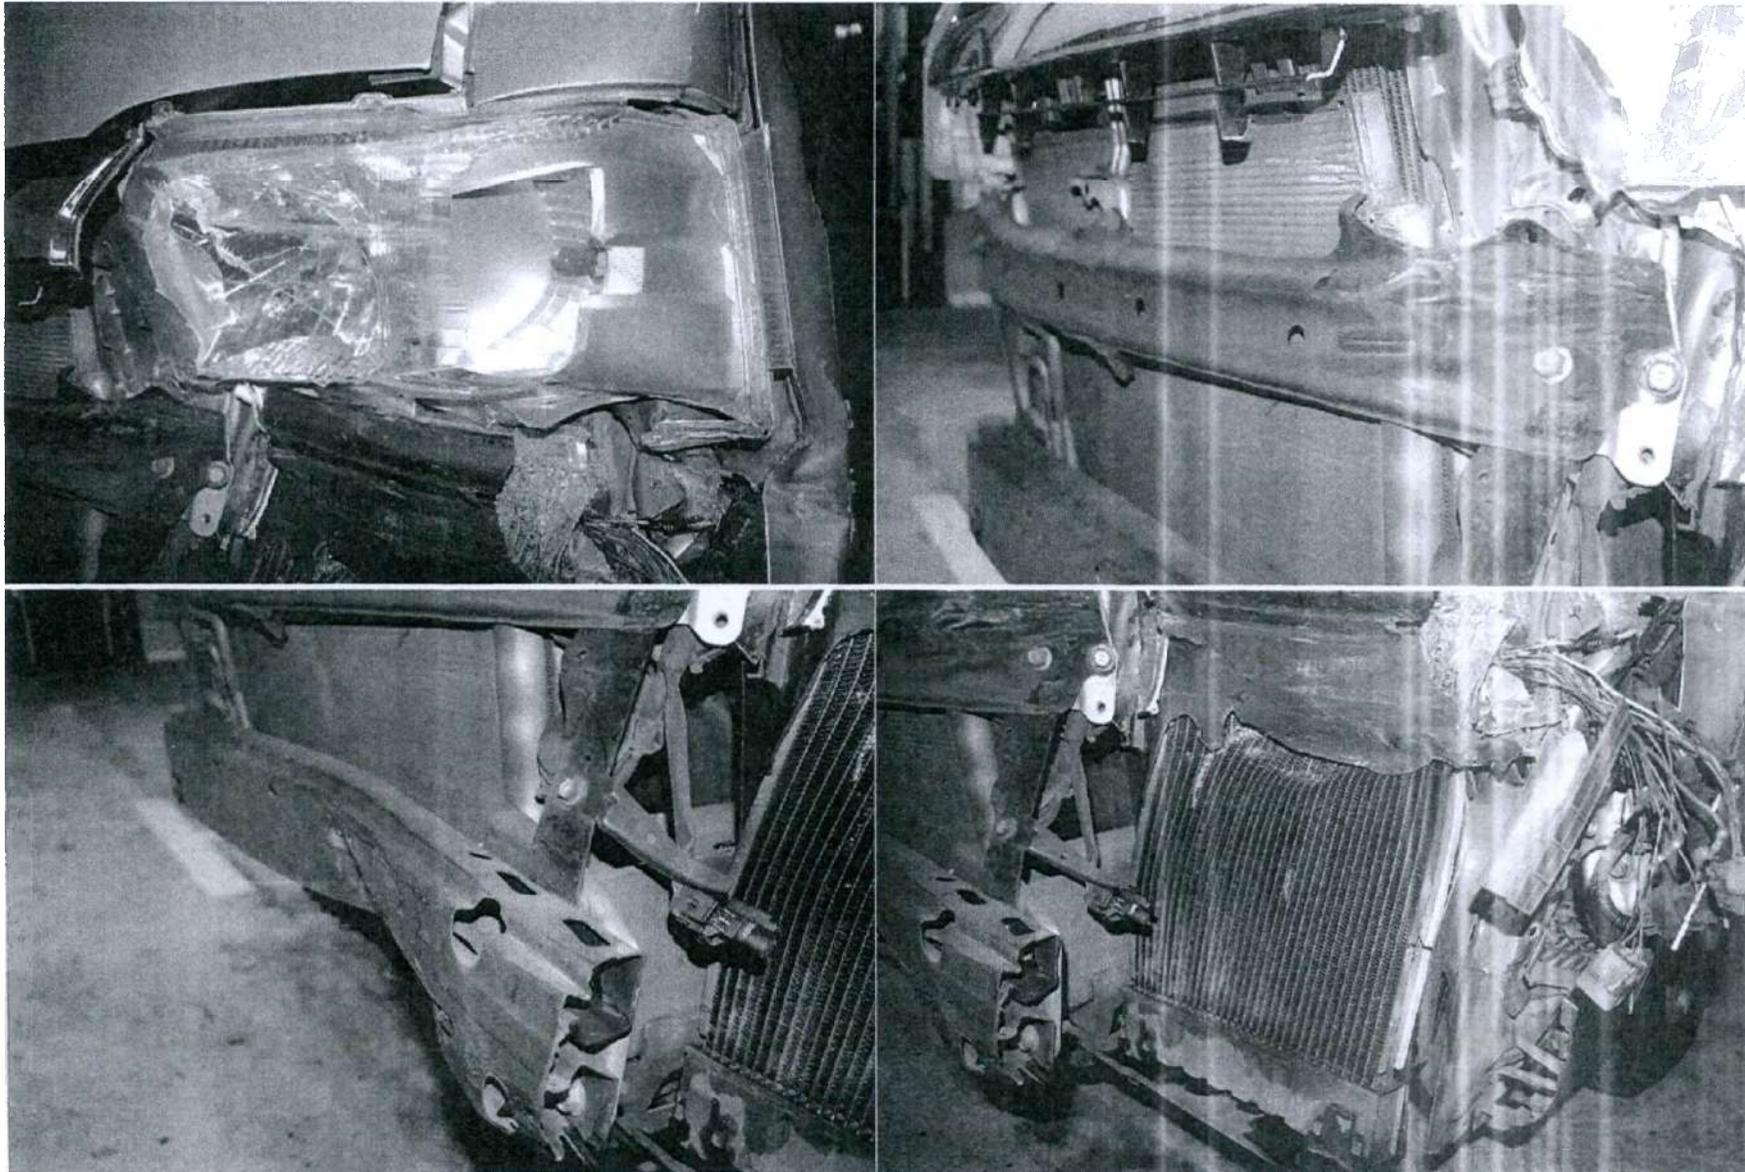
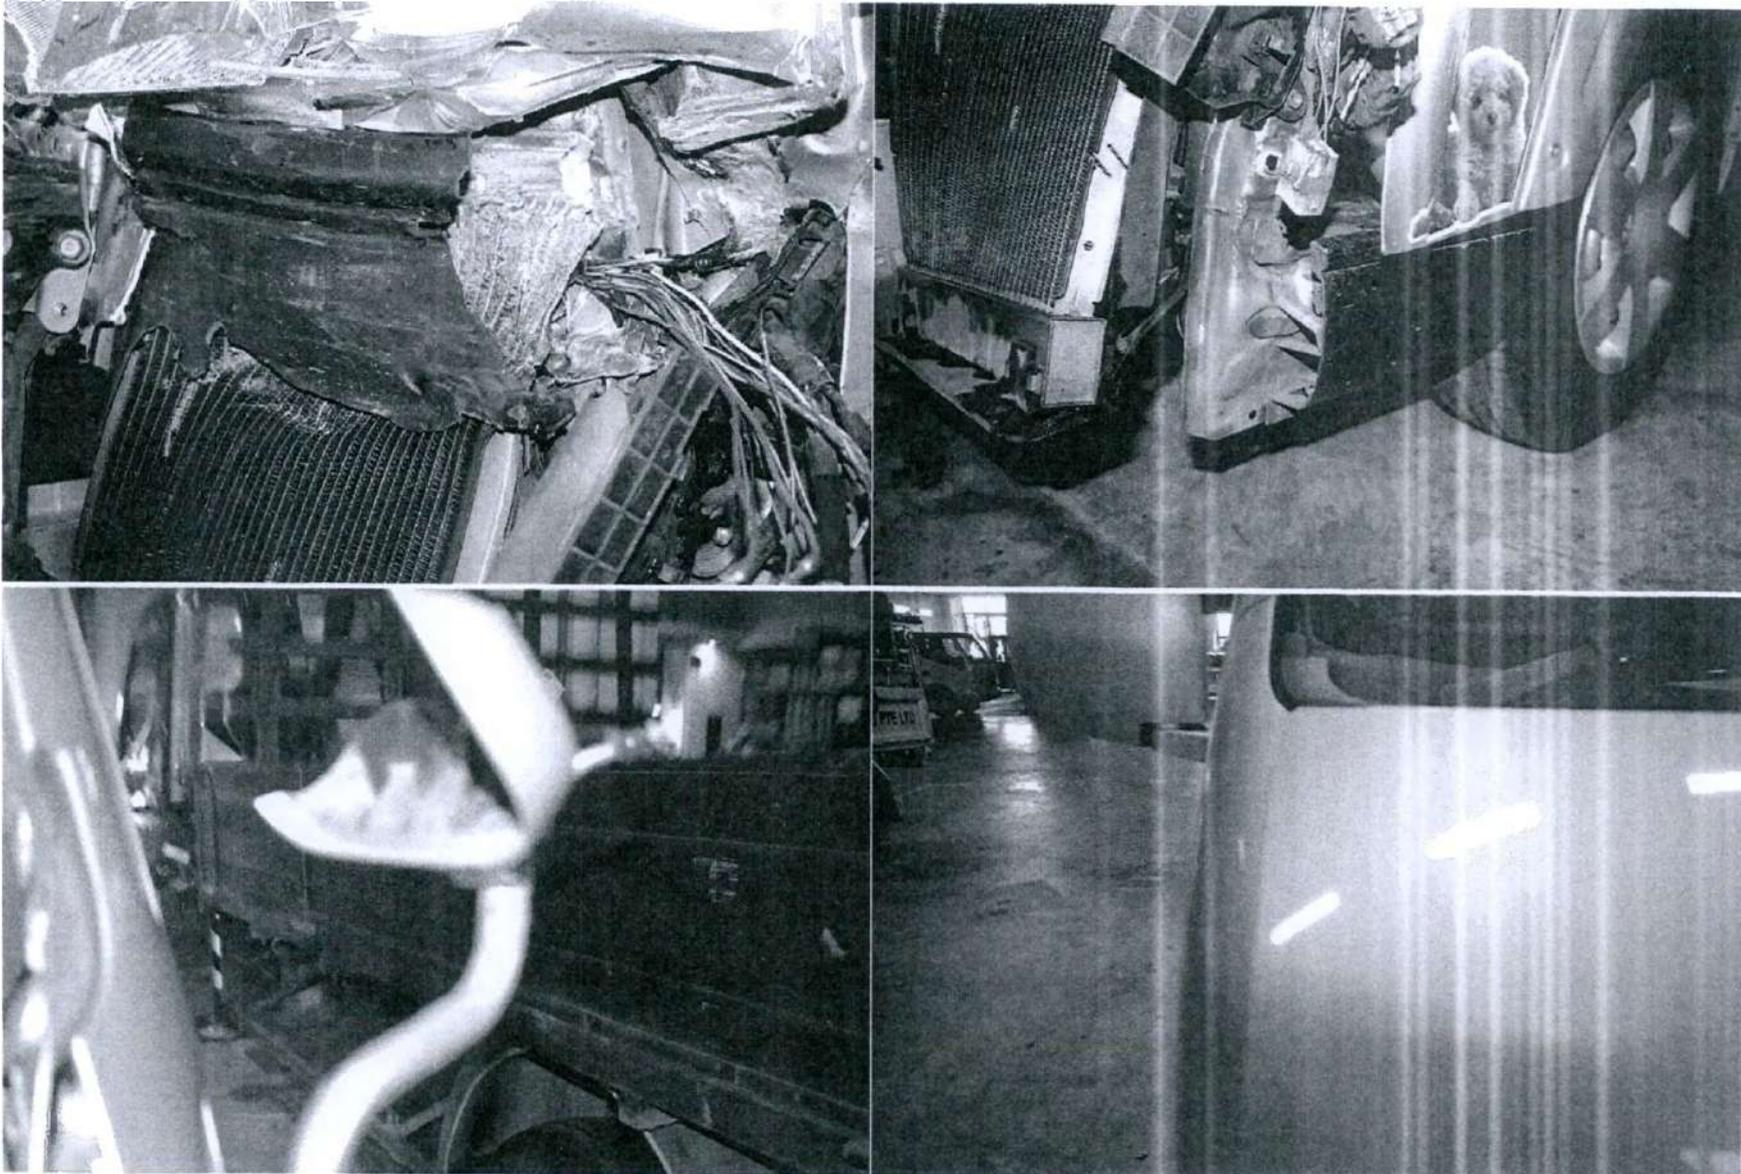
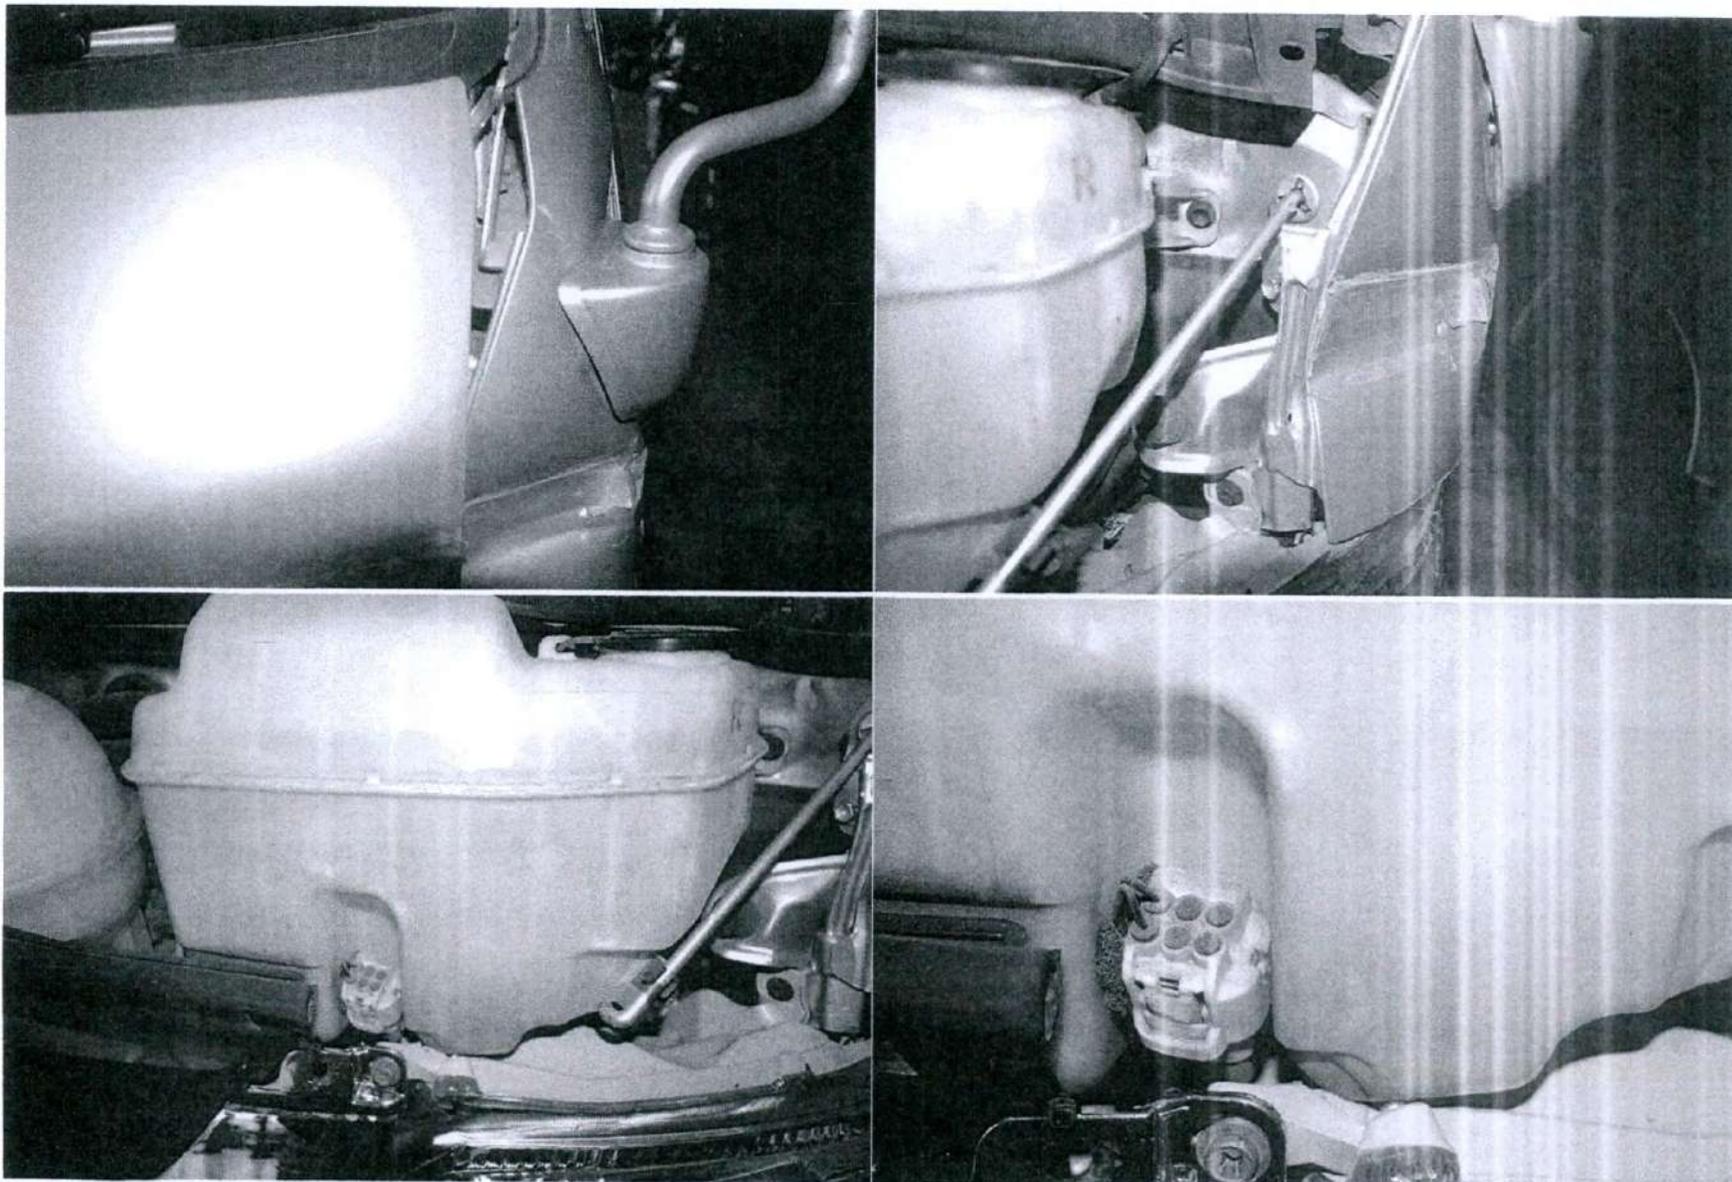
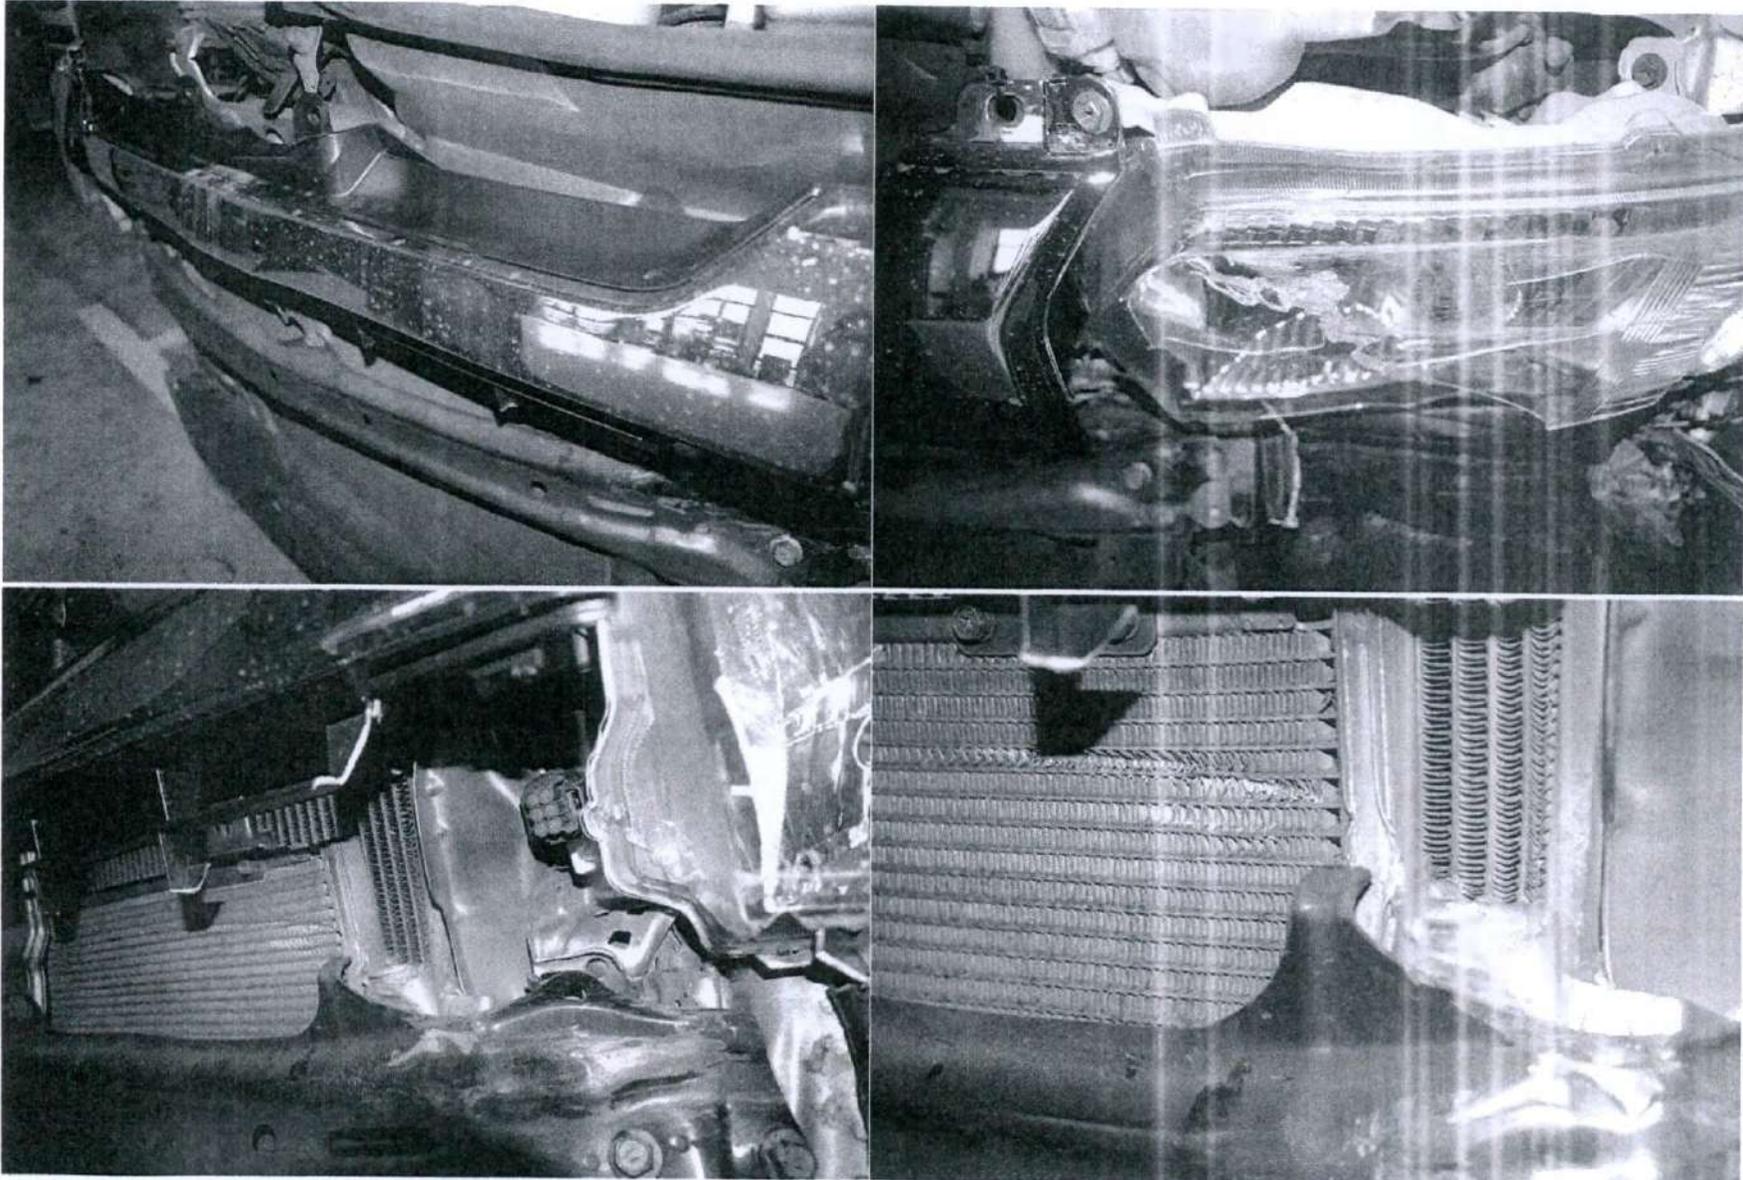
INSPECTION PHOTOS

At the time of inspection, this vehicle sustained damages to the **Front Lh portion**.

Front bumper, bonnet, lh corner panel, fire wall, front lh windscreen pilar, front lh wheel arc panel, floor board dented. Front windscreen crack, headlamp dislodge/ holder torn, condenser, radiator, intercooler dented. Air con blower , cooling coil broken etc.

Recommended Lump Sum Repair Cost (S\$)	: <u>25,350.00</u>
Estimate Repair Duration	: 14
Survey Inspection At	: Sincerelead Garage Pte Ltd
Survey Inspection Address	: 2 Buroh Crescent #02-09 ACE@Buroh Singapore 627546

We have not authorised repair. Under normal circumstances, estimated **14** working days are required to repair the vehicle.
