## ASSIGNMENT

Veh No: SH 9667A Yr Regn: 2018 / Sept

Des. of Damages: Frt / Rear / O/S / N/S / U/C / Rooftop or

# BIFROST AUTO PTE LTD

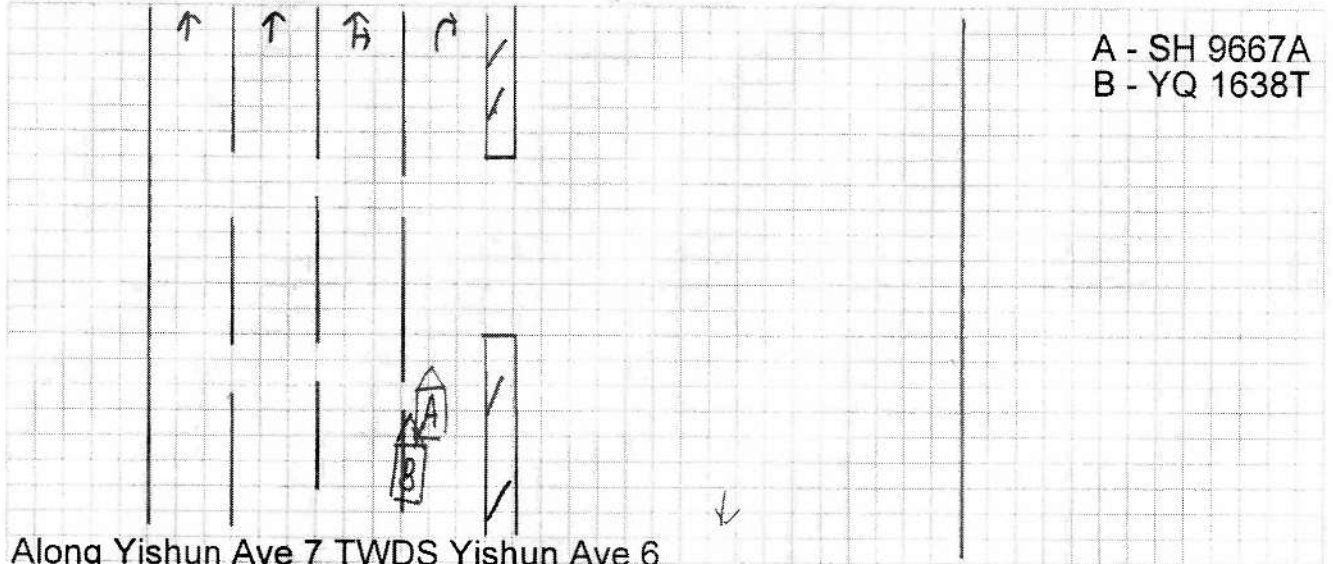
# SKETCH PLAN

Along Yishun Ave 7 TWDS Yishun Ave 6

On 18.09.2020 at about 08:50 hours I was travelling along Yishun Ave 7 TWDS
Yishun Ave 6 with One Female Passenger onboard .
While I saw the taxi in front of me slowed down and stop and I performed a pressure
break and suddenly veh B ( YQ 1638T ) lost control and collided into my taxi A -
Left Rear Portion .
As it take place too fast I could not take evasive action to prevent .
I have company video and photo to support my claims .
After the accident my female passenger and I felt unwell , will consult doctor later
on .
Veh B ( YQ 1638T ) - Mr Kee Bo Xun H/P : 8113 4154
