From: Shiau Chan (LKKAuto)
Sent: Thursday, 29 October 2020 3:39 PM
To: Monica Chung
Cc: SUR
Subject: RE: Claim REF: 629284 - Please update reserve for vehicle no. SGH1826C re-send

According to our surveyor, the damage for bootlid weatherstrip as below:

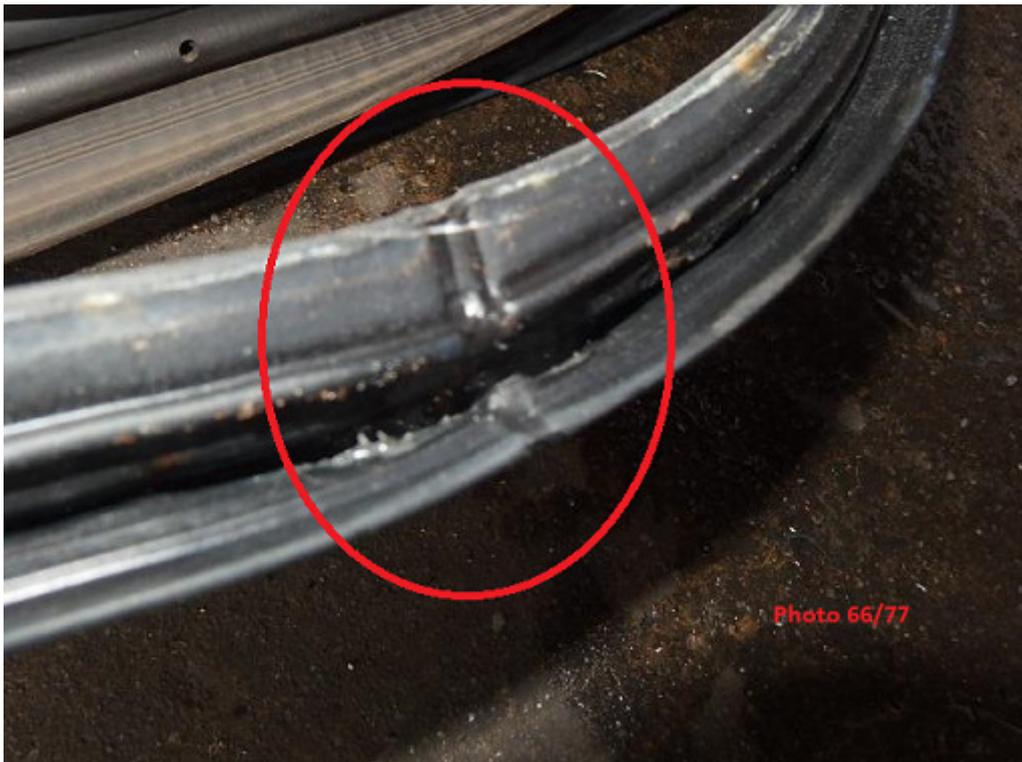
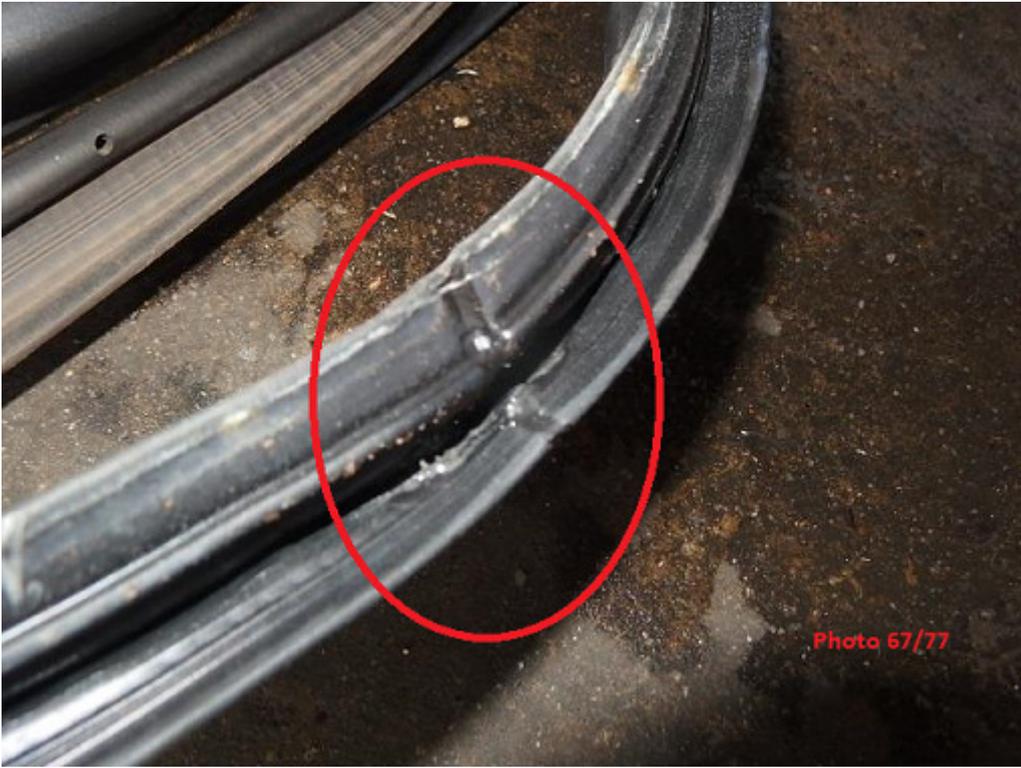
The above photos are showed weatherstrip twisted because it fitted at rear end panel on top and when rear end panel is dented (photo 39/77) will cause bootlid weatherstrip twisted or damaged. If use back it will cause water seepage or hard to close bootlid.

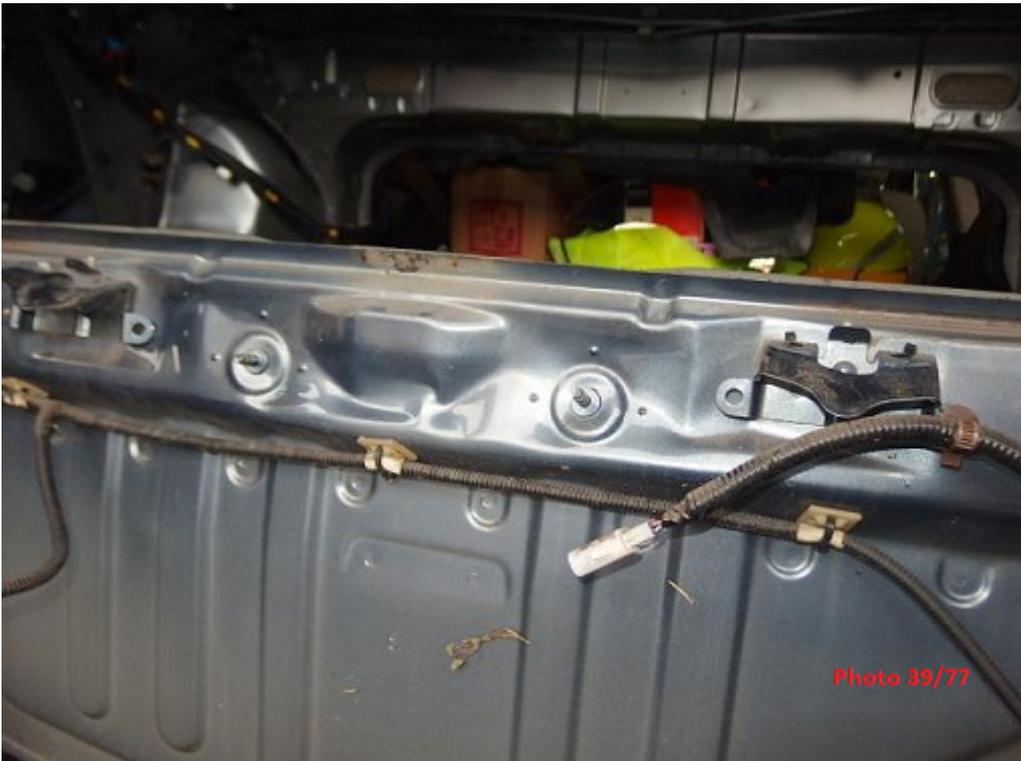
Rear floor panel top board is fitted on top floor panel and rear end panel inside

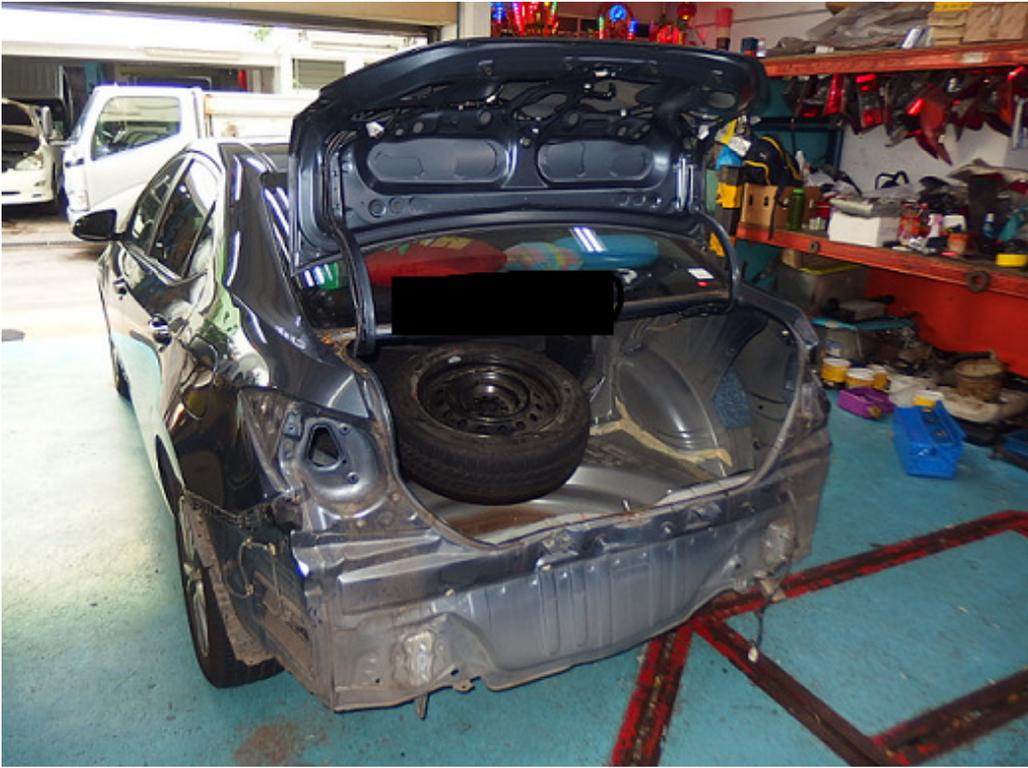
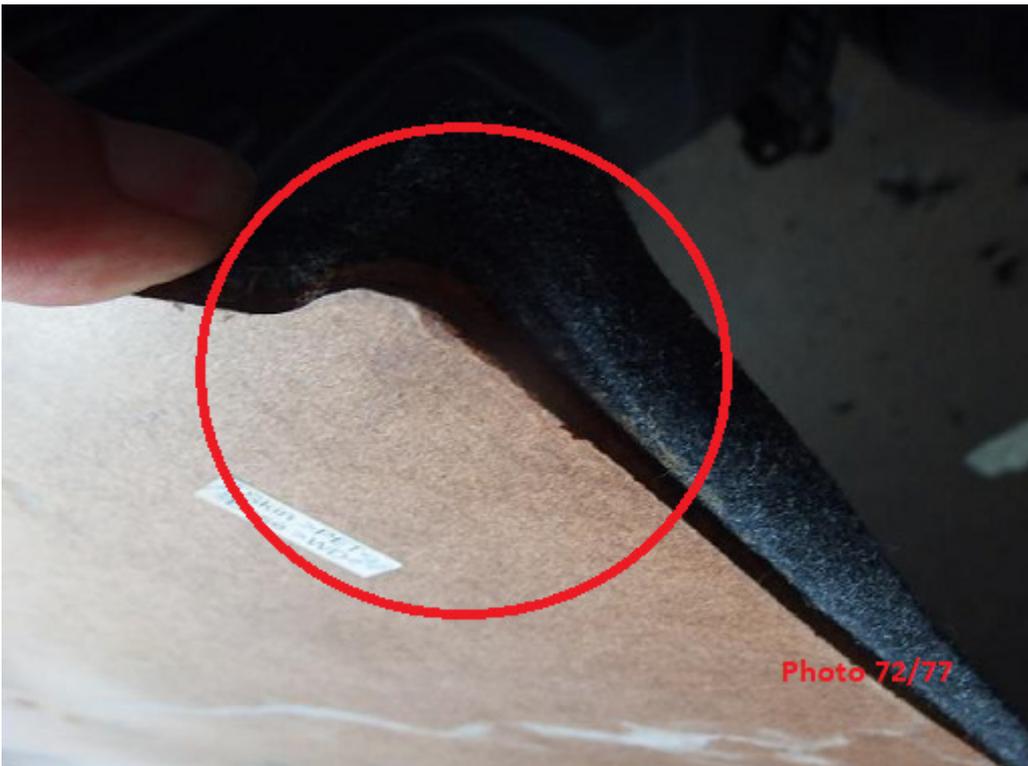
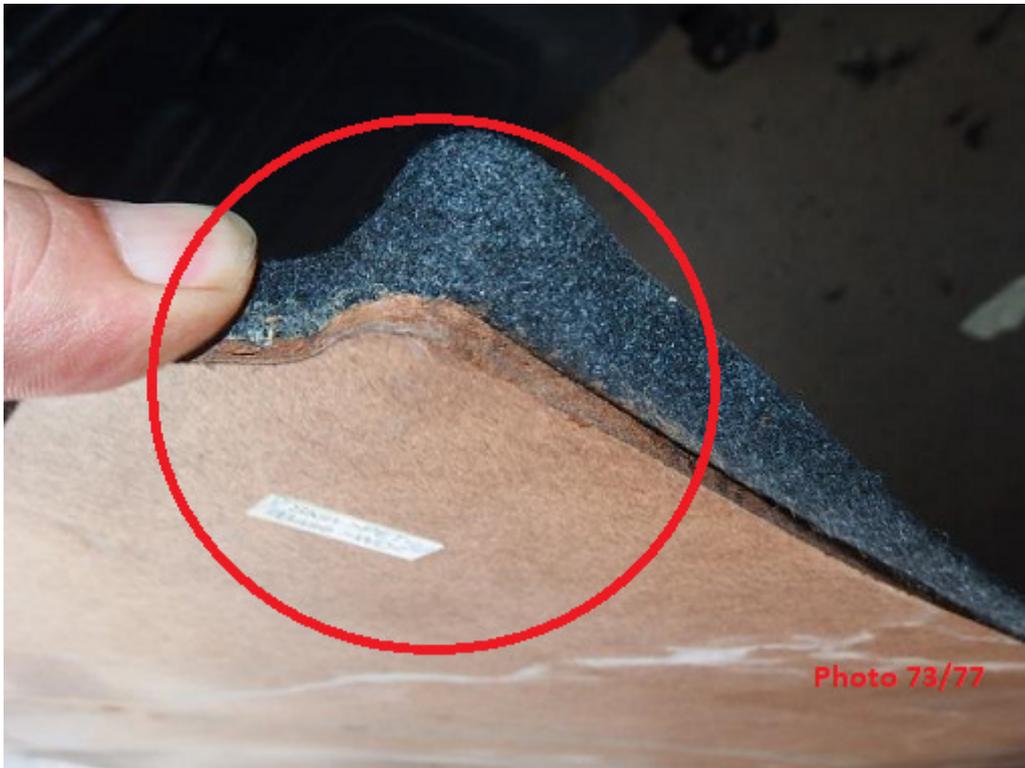
When rear end panel is dented it will push inward and cause rear floor panel top board damage or torn.

So, damage consistent due to impact.
