4.		Description	on of Da	ımages	
	THE VEHICLE SU	STAINED DAMAGES AT THE FRO	ONT POP	RTION.	
	DAMAGES SEE D	ETAILS.			
5.					
	Accident Date	11/10/2020	Inspec	tion Date	14/10/2020
	Survey held at	LOH HENG			
		BLK 176 #03-08 SIN MING DRIVE SINGAPORE 575721			
5a.		Re	emarks		
	A)THE INSPECTION WAS CONDUCTED ON A"WITHOUT PREJUDICE" BASIS. B)IN ACCORDANCE TO YOUR INSTRUCTIONS, WE HAVE NOT AUTHORISED REPAIRS.				
5b.	Estimate Days of Repair				
	ESTIMATED NORI	MAL PERIOD FOR REPAIR:	ESTIMATED NORMAL PERIOD FOR REPAIR: 6 Working Days

ADJUSTMENT ON REPAIR COST FOR VEHICLE NO. SJN 8576K

PHOTOGRAPHS FOR VEHICLE NO. SJN 8576K

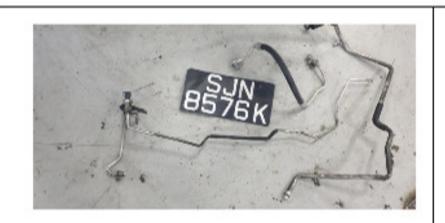
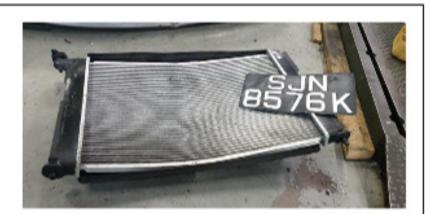
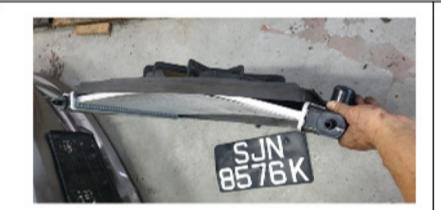
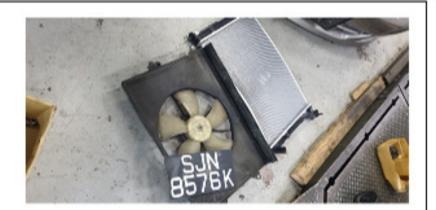
PHOTOGRAPHS FOR VEHICLE NO. SJN 8576K

Qty	Description of Parts	Condition	Estimate By Workshop (\$))	Our Adjusted (\$)
	REPLACEMENT OF PARTS			
1	FRONT BONNET	BENT	887.50	849.30
1	BONNET CHROME MOULDING	CRACKED	228.90	228.90
1	FRONT BONNET LOCK	BENT	104.60	104.60
1	FRONT BONNET HINGE RIGHT	DISTORTED	74.60	74.60
1	FRONT BONNET HINGE LEFT	DISTORTED	74.60	74.60
1	BONNET CABLE	SERVICEABLE	58.70	-
1	FRONT BUMPER	BENT	601.90	527.00
2	FRONT BUMPER RETAINER (RIGHT AND LEFT) @\$87.00	DISTORTED	174.00	174.00
1	FRONT BUMPER GRILL	CRACKED	274.10	167.30
1	FRONT BUMPER REINFORCEMENT	BENT	547.00	319.20
10	PANEL GARNISH CLIPS	NECESSARY	40.00	40.00
1	FRONT BUMPER SPONE	CRACKED	128.40	128.40
1	FRONT BUMPER GARNISH	CRACKED	93.00	93.00
1	BRACE PANEL FRONT	BENT	189.50	189.50
1	HEADLAMP RIGHT	MTG CRACKED	1,214.60	861.90
1	HEADLAMP LEFT	MTG CRACKED	1,214.60	861.90
1	FRONT SUPPORT PANEL	BENT	1,325.30	1,018.60
1	RADIATOR	BENT	1,685.00	1,543.00
1	AIR CON FAN MOTOR	SERVICEABLE	375.00	-

1	RADIATOR FAN MOTOR	JAMMED	375.00	375.00
1	RADIATOR COWLING	CRACKED	241.00	241.00
1	RADIATOR TOP GARNISH	DENTED	123.70	123.70
1	AIR CON CONDENDER	BENT	1,980.60	1,488.00
1	AIR CON DISCHARGE PIPE	BENT	394.10	366.00
1	AIR CON LIQUID PIPE	DENTED	547.00	408.00
1	AIR CON SUCTION PIPE	SERVICEABLE	375.00	-
	LESS 25% DISCOUNT		-3,331.93	-2,564.38
			9,995.77	7,693.12
	SPECIAL NETT ITEMS			
1	NO PLATE WITH CASING (SN)	BENT	60.00	45.00

Qty	Description of Parts	Condition	Estimate By Workshop (\$))	Our Adjusted (\$)
			60.00	45.00
	<u>LABOUR</u>			
	TO REMOVE AND REPLACE NEW PARTS, RESTRENGTHEN INNER CHASIS, FRONT SUPPORT PANEL, LOWER PANEL. REALIGNMENT BODY STRUCTURE.		1,100.00	700.00
	TO REMOVE AND REPLACE AIR-CON CONDENSER, REFILL AIR-CON GAS.		200.00	100.00
	REMOVE AND REPLACE WIRING HARNESS.	NOT NECESSARY	550.00	-
	TO RESPRAY + PUTTY ON DAMAGED PARTS.		1,100.00	900.00
	TOWING TO WORKSHOP.		60.00	50.00
	UNDER COATING AFTER REPAIR.		150.00	60.00
			3,160.00	1,810.00
	GRAND TOTAL		13,215.77	9,548.12
