Your Ref: Toyota Engine
(number 2AZG586937)
Our Ref : CI/TP20011793/D

INSPECTION REPORT OF A TOYOTA ENGINE WITH NUMBER 2AZG586937

Inspection of the Toyota Engine

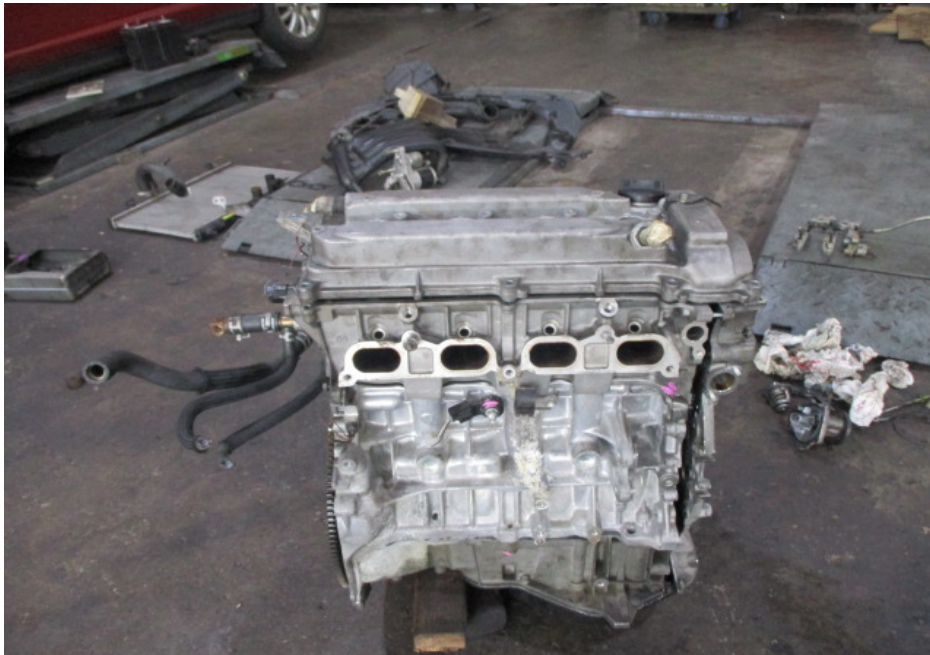
Photo 1 shows a general view of the Toyota engine that I had inspected. The Toyota engine was observed to be a used engine and was not fitted on any motor car. It was also observed to be a complete assembly with all mechanical parts still intact, within the engine housing.

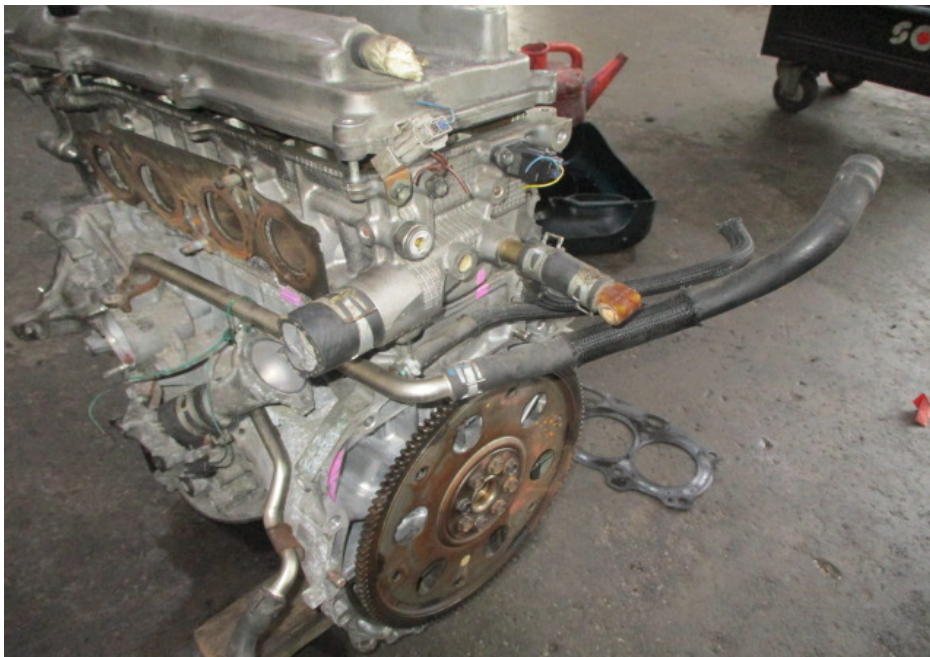
Photo 2 shows a general view of the Toyota engine that I had inspected. My visual examination of the engine housing revealed the housing to be of serviceable/satisfactory condition. There was no crack and/or hole observed on the engine housing.

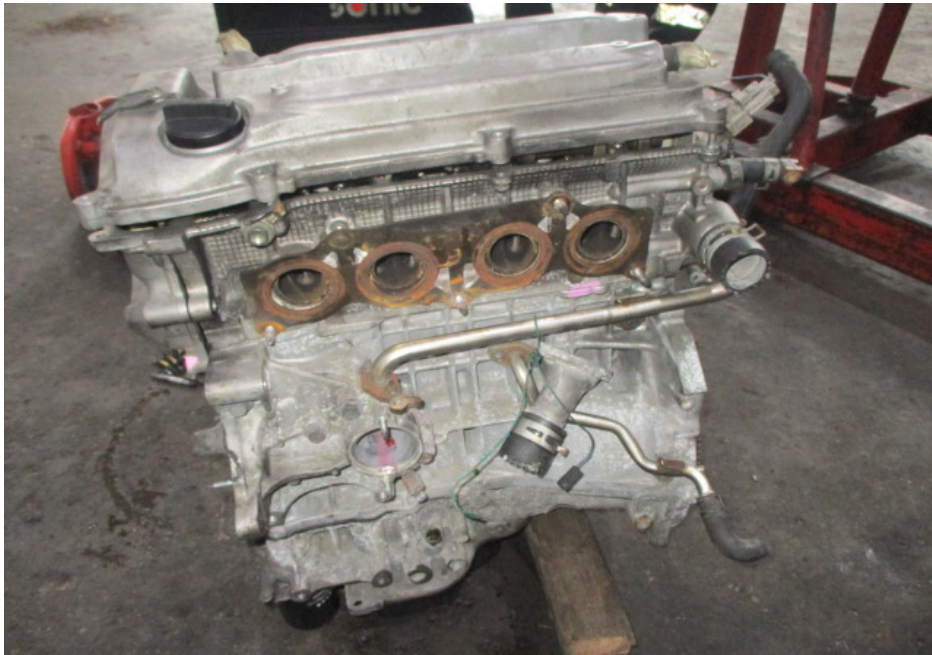
Photo 3 shows a general view of the Toyota engine that I had inspected. My visual examination of the engine housing revealed the housing to be of serviceable/satisfactory condition. There was no crack and/or hole observed on the engine housing.

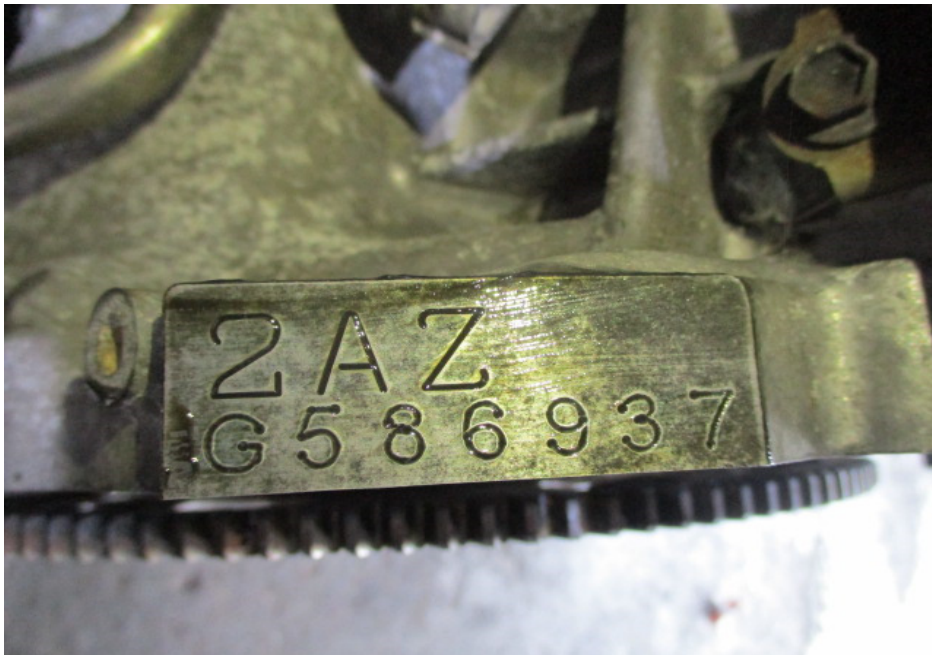
Photo 4 shows the engine number engraved on the housing of the Toyota engine that I had inspected. The engine number was 2AZG586937.

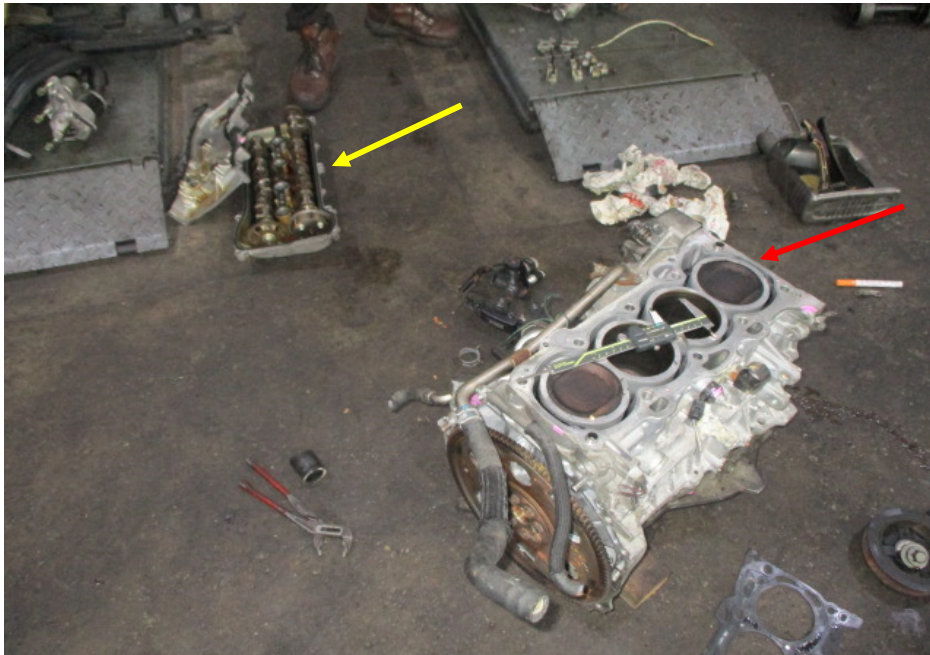
Photo 5 shows the top block (yellow arrow) of the Toyota engine separated from its bottom block (red arrow). This was to enable me to carry out measurements of its cylinders, in particular the bore and stroke measurements of each cylinder, which typically can be used to determine the engine displacement or more commonly referred to as engine cc.

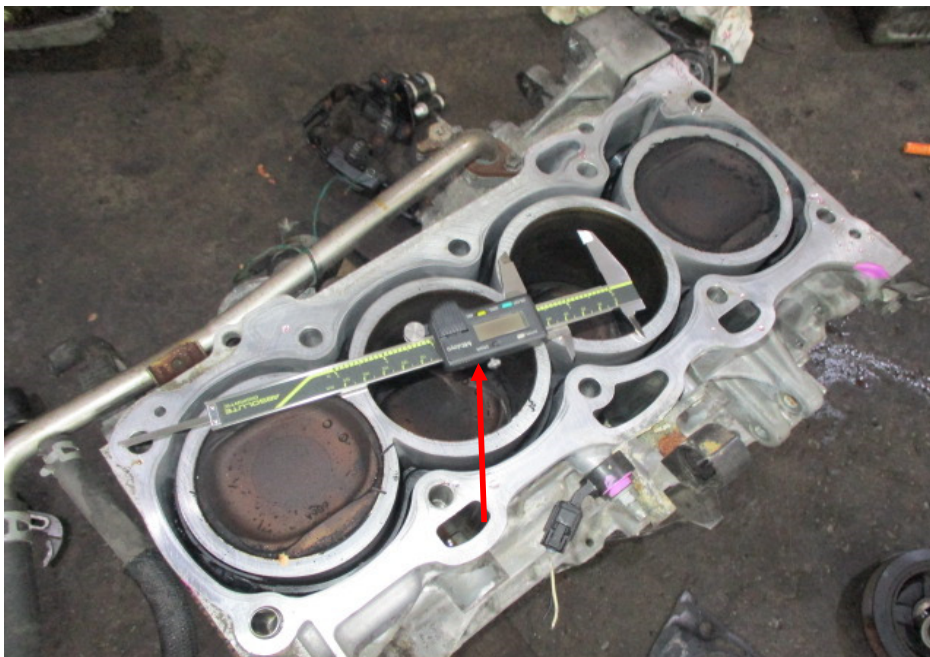
Photo 6 shows the bottom block of the Toyota engine and the digital Vernier Caliper (arrowed) that was used to measure the bore and stroke measurements of each cylinder. The digital Vernier Caliper was calibrated before the start of the measurements.

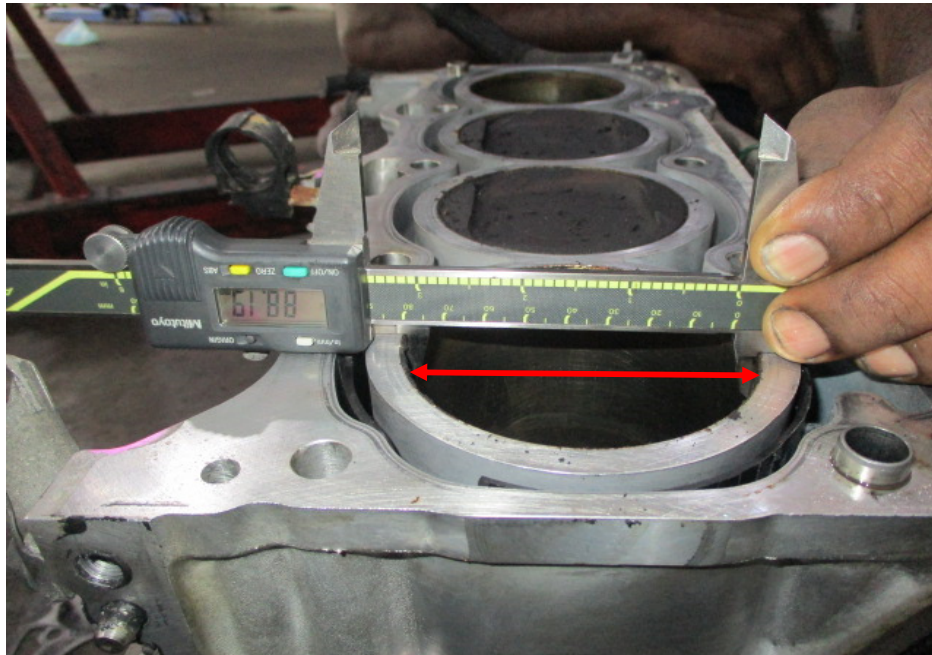
Photo 7 shows measurement being carried out to the bore (arrowed) of cylinder 1 of the Toyota engine. The measurements were carried out using a digital Vernier Caliper that was calibrated before the start of the measurements. The bore measurement of cylinder 1 was recorded to be 88.19mm.

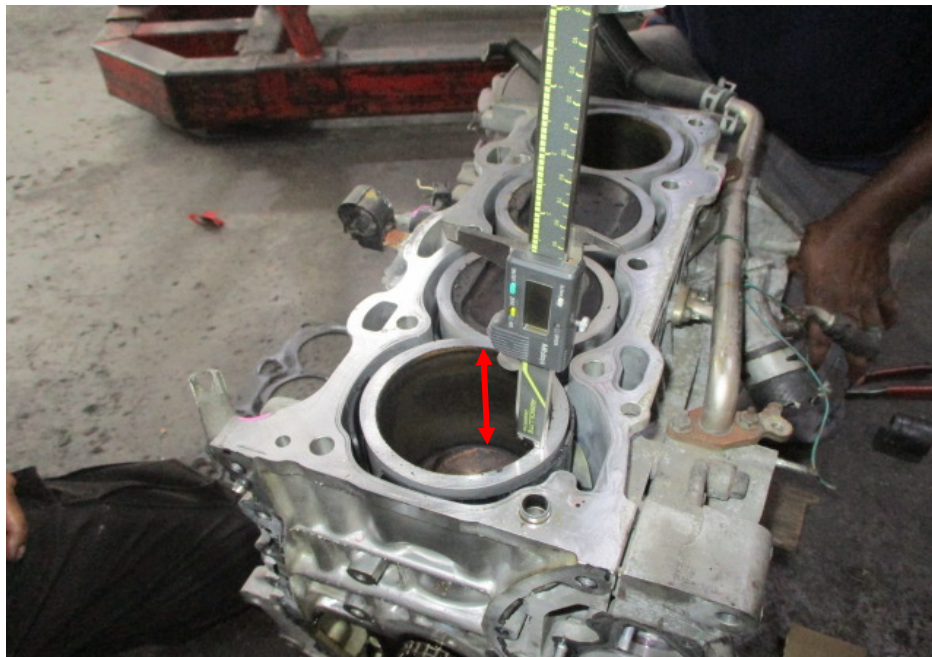
Photo 8 shows measurement being carried out to the stroke (arrowed) of cylinder 1 of the Toyota engine. The bore and stroke measurements of the Toyota engine were carried out using a digital Vernier Caliper that was calibrated before the start of the measurements.

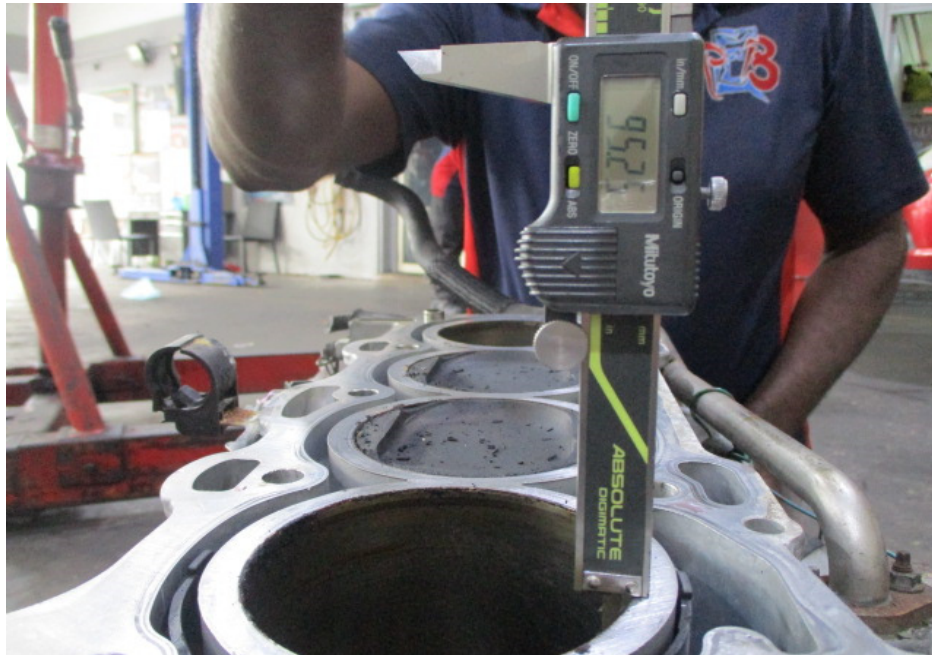
Photo 9 shows the stroke measurement of cylinder 1, which was recorded to be 95.25mm.

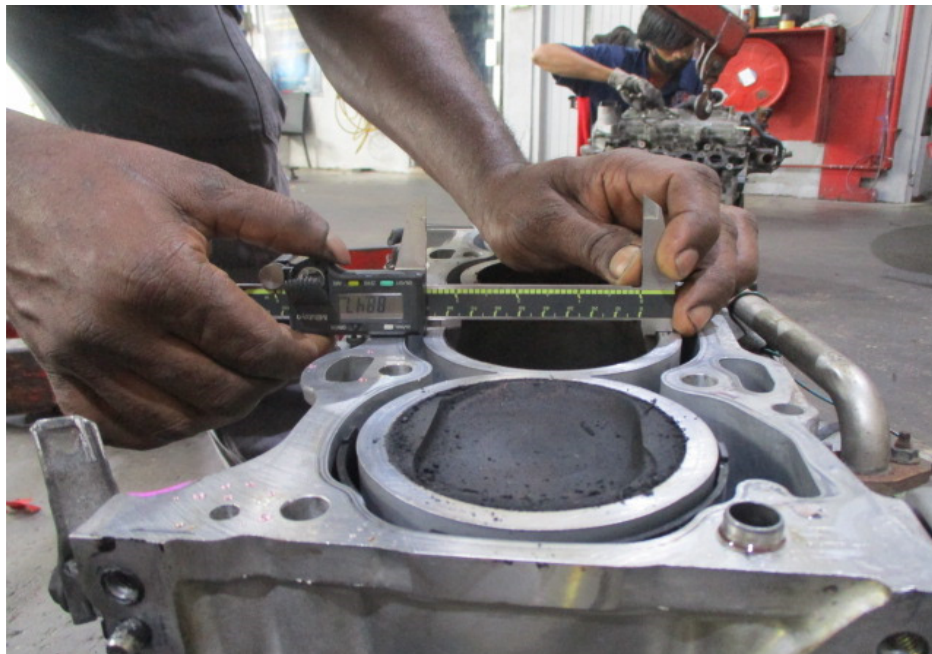
Photo 10 shows measurement of the bore for cylinder 2 of the Toyota engine that I had inspected. The bore and stroke measurements of the Toyota engine were carried out using a digital Vernier Caliper that was calibrated before the start of the measurements.

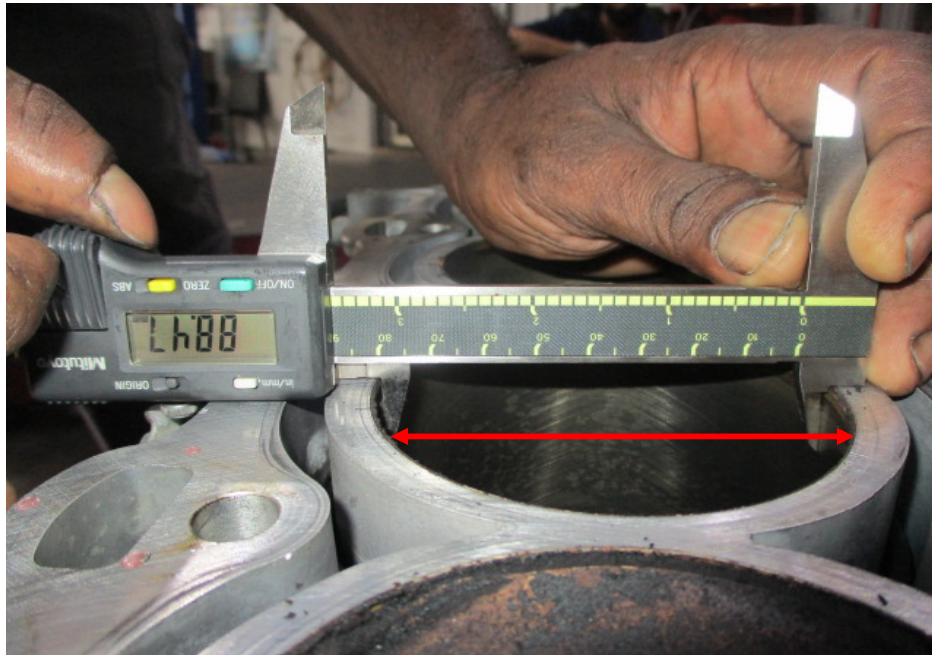
Photo 11 shows measurement being carried out to the bore (arrowed) of cylinder 2 of the Toyota engine. The bore measurement of cylinder 2 was recorded to be 88.47mm.

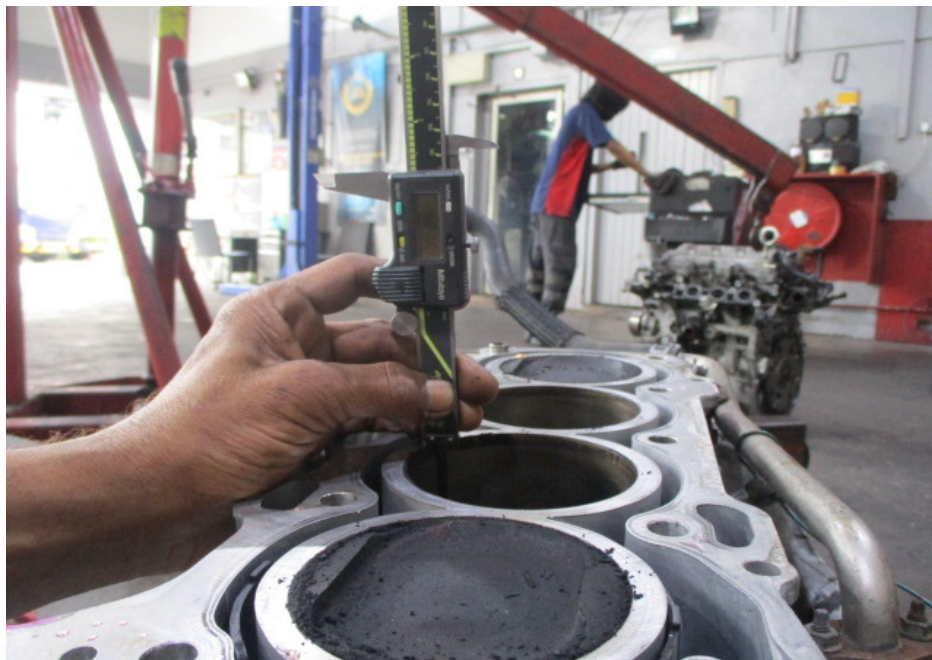
Photo 12 shows measurement of the stroke for cylinder 2 of the Toyota engine that I had inspected. The bore and stroke measurements of the Toyota engine were carried out using a digital Vernier Caliper that was calibrated before the start of the measurements.

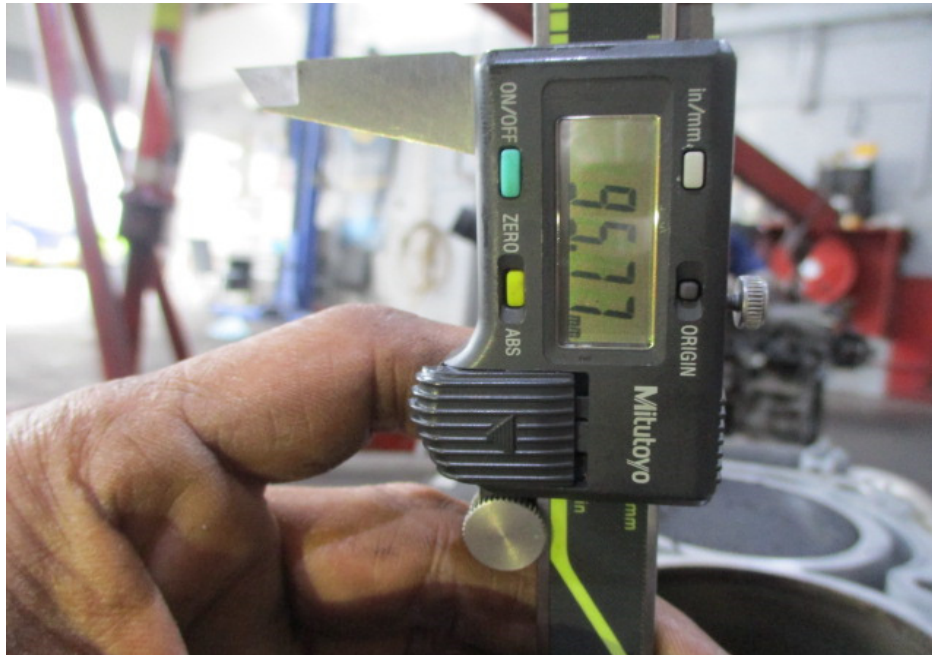
Photo 13 shows the stroke measurement of cylinder 2, which was recorded to be 95.77mm.

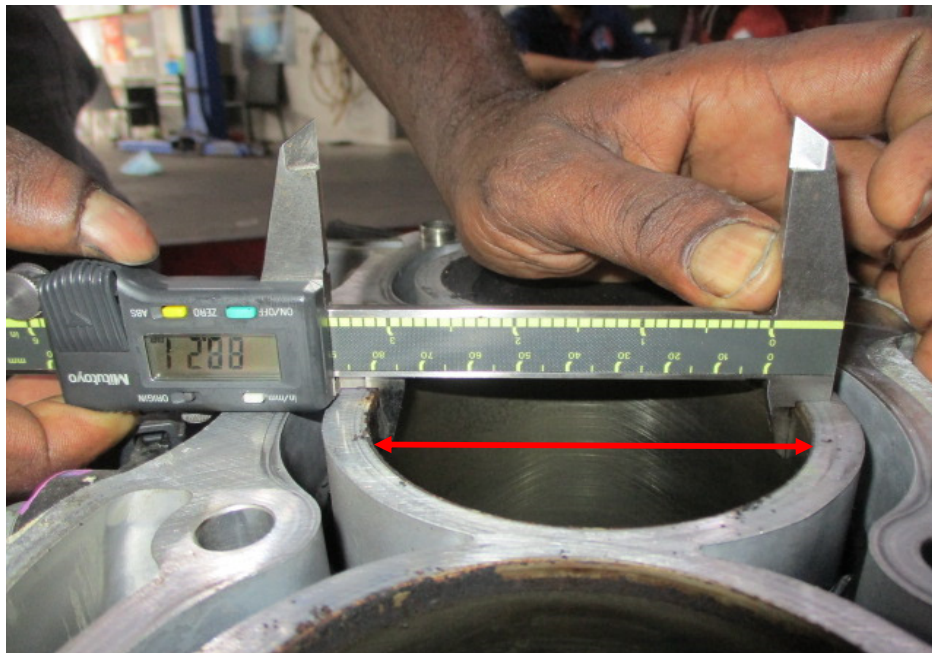
Photo 14 shows measurement being carried out to the bore (arrowed) of cylinder 3 of the Toyota engine. The bore and stroke measurements of the Toyota engine were carried out using a digital Vernier Caliper that was calibrated before the start of measurements. The bore measurement of cylinder 3 was recorded to be 88.21mm.

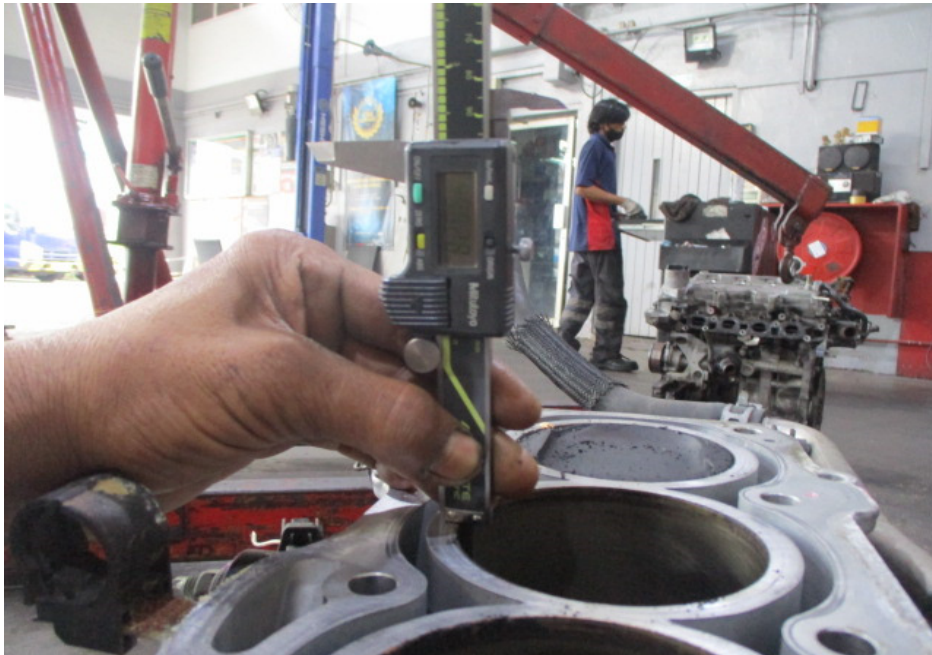
Photo 15 shows measurement of the stroke for cylinder 3 of the Toyota engine that I had inspected. The bore and stroke measurements of the Toyota engine were carried out using a digital Vernier Caliper that was calibrated before the start of measurements.

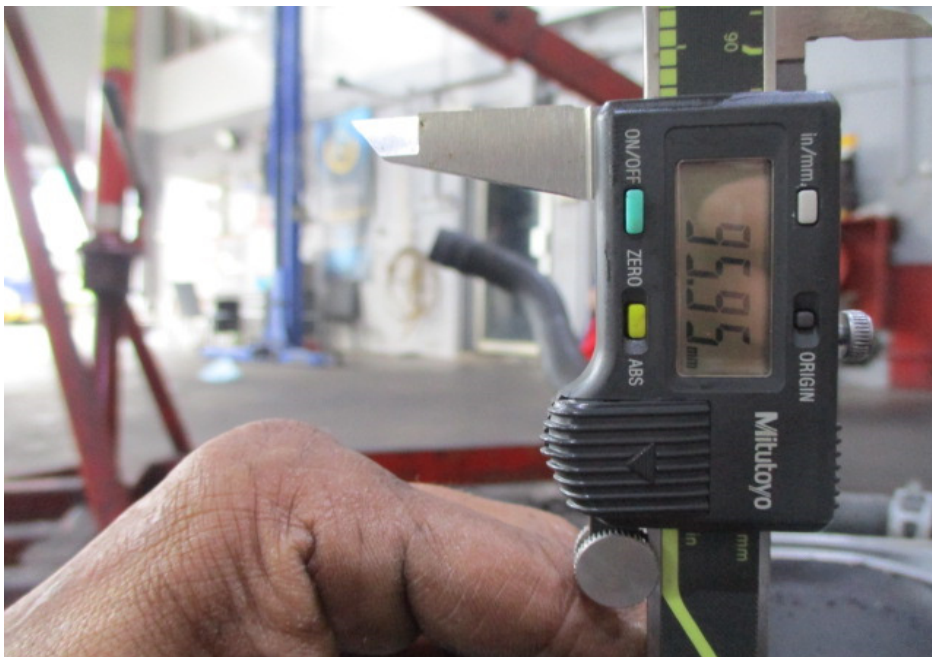
Photo 16 shows the stroke measurement of cylinder 3, which was recorded to be 95.95mm.

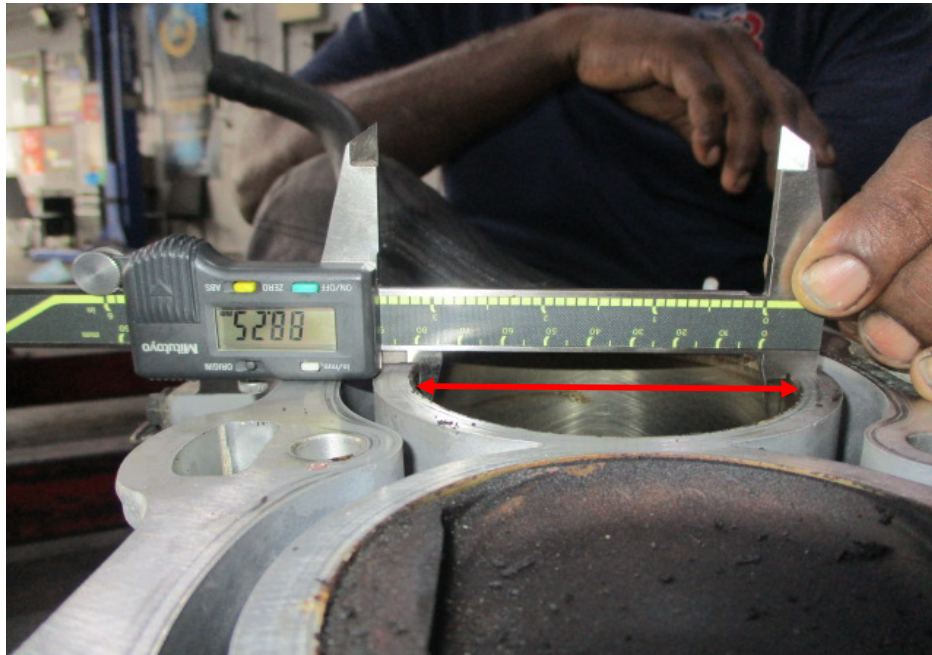
Photo 17 shows measurement being carried out to the bore (arrowed) of cylinder 4 of the Toyota engine. The bore measurement of cylinder 4 was recorded to be 88.25mm.

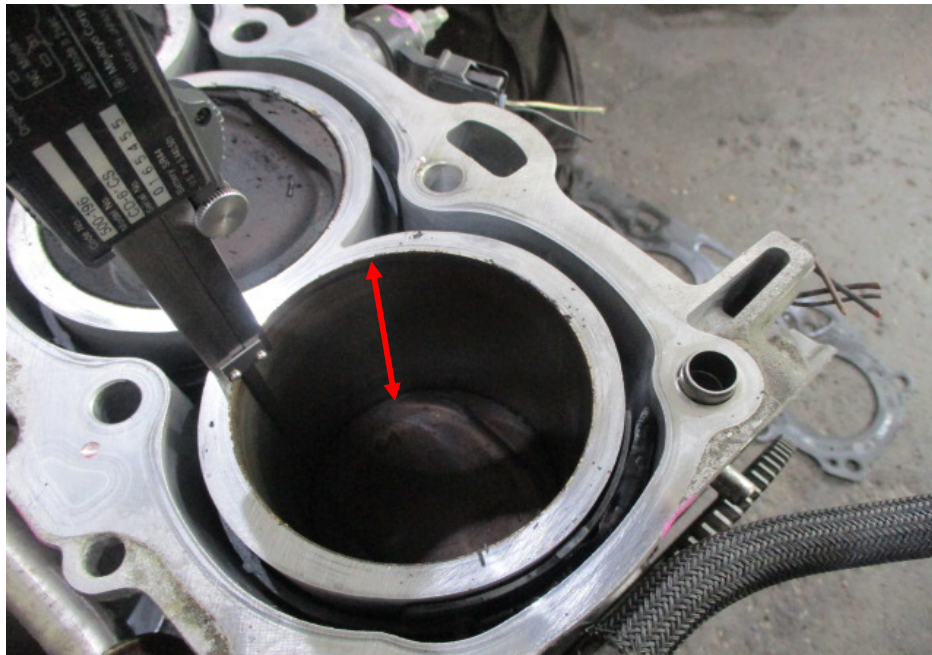
Photo 18 shows measurement being carried out to the stroke (arrowed) of cylinder 4 of the Toyota engine. The bore and stroke measurements of the Toyota engine were carried out using a digital Vernier Caliper that was calibrated prior to the start of measurements.

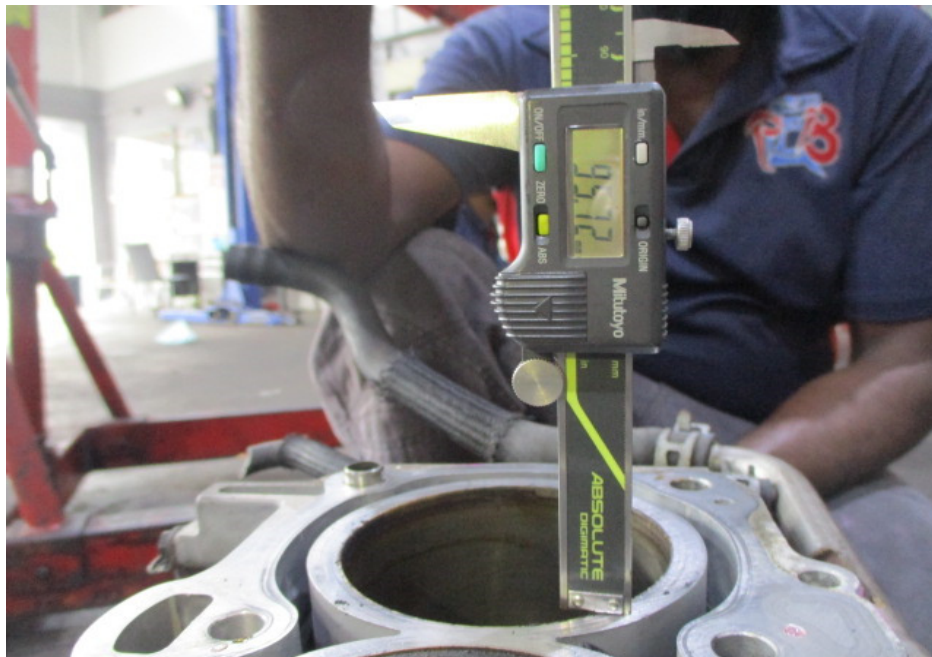
Photo 19 shows the stroke measurement of cylinder 4, which was recorded to be 95.72mm.
