**RE: ACCIDENT INVOLVING SLR 5195 B / SHA 3011 Z ON 17/10/20 ALONG BLK 159 ANG MO KIO AVE 4 OPEN SPACE CARPARK**

## VEHICLE DAMAGE ASSESSMENT REPORT

Reference No : VPA-2020/00423  
Vehicle No : SLR5195B

From documents sighted, the Insured's vehicle and Third Party's vehicle were involved in a change/cross collision.  
On site survey inspection revealed that the damage noted are consistent with the accident as reported.  
Damage at the rear bumper, rear fender rh, rear wheel bearing rh, and etc.

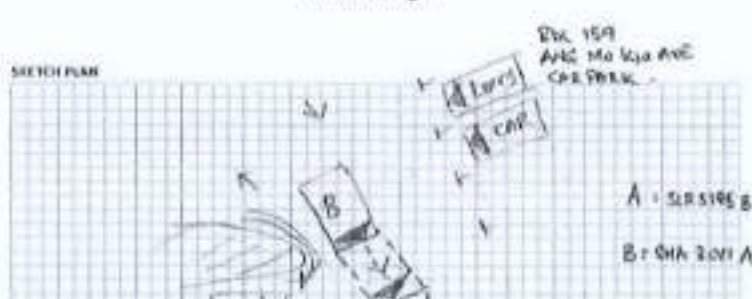
#### Sketch Plan Pg. 1

I was driving Vehicle A heading to exit carpark at BIK 159 ANG MO KIO AVE 4. Suddenly Vehicle B came from the different direction and very near to my lane. So, I stationary to give way, but Vehicle B cut onto my lane and damages my rear. I have video footage to attach to claim him.
