**ACCIDENT INVOLVING SBP 96R AND SLH 5262T ON 09.11.2017 ALONG / AT  
STILL ROAD SOUTH - EAST COAST EXPRESSWAY (JUNCTION BEFORE  
MARINE PARADE)**

1. We refer to your letter dated 23 February 2018 and the instructions therein to comment on the damage consistency of the motor car SLH 5262T involved in the captioned accident, in particular to establish whether there was possibly contact between the right portion of the motor car SLH 5262T and the front left portion of the motor car SBP 96R; and if there was contact, whether the damages on the right portion of the motor car SLH 5262T is consistent to the accident.

### **Damage to the Honda**

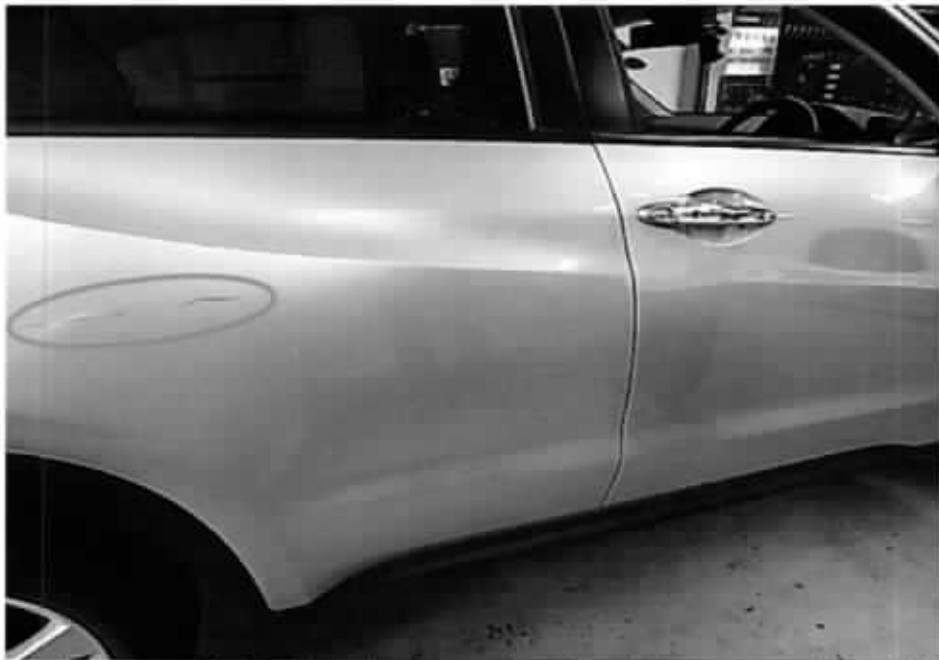
**Photo 4** shows the black marks observed on the right passenger door of the Honda (circled).

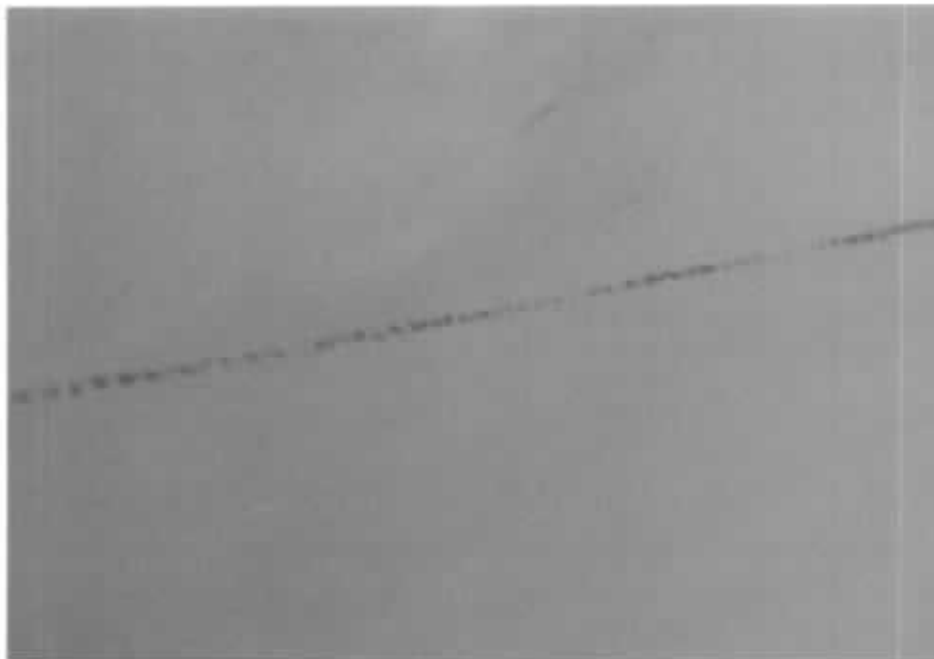
**Photo 6** shows a close up view the black marks observed on the right passenger door of the Honda.

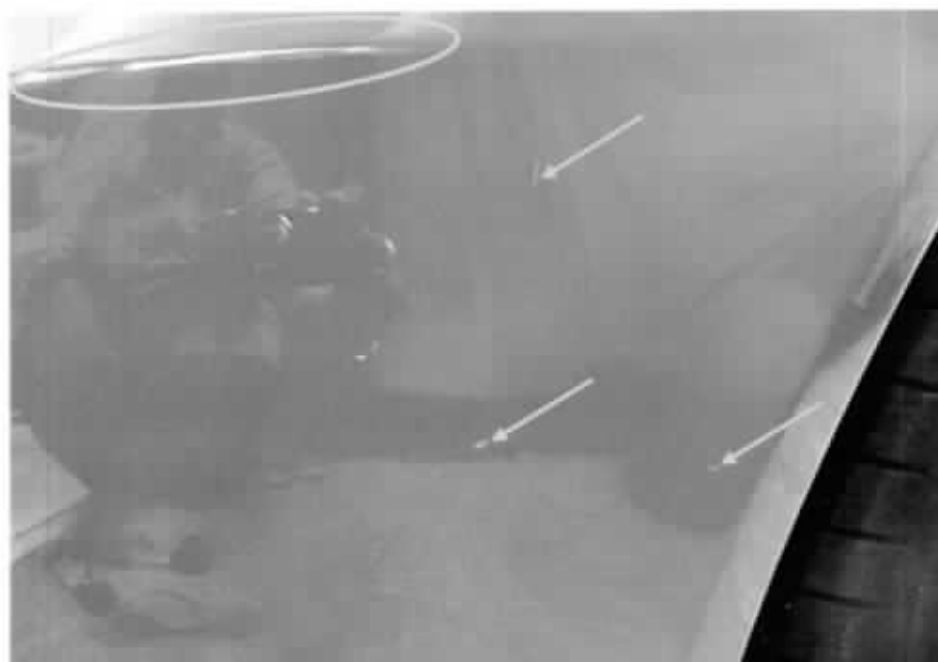
**Photo 9** shows a close up view of paint graze marks (circled) and paint scuff marks (arrowed) found on the front left portion of the Mercedes.

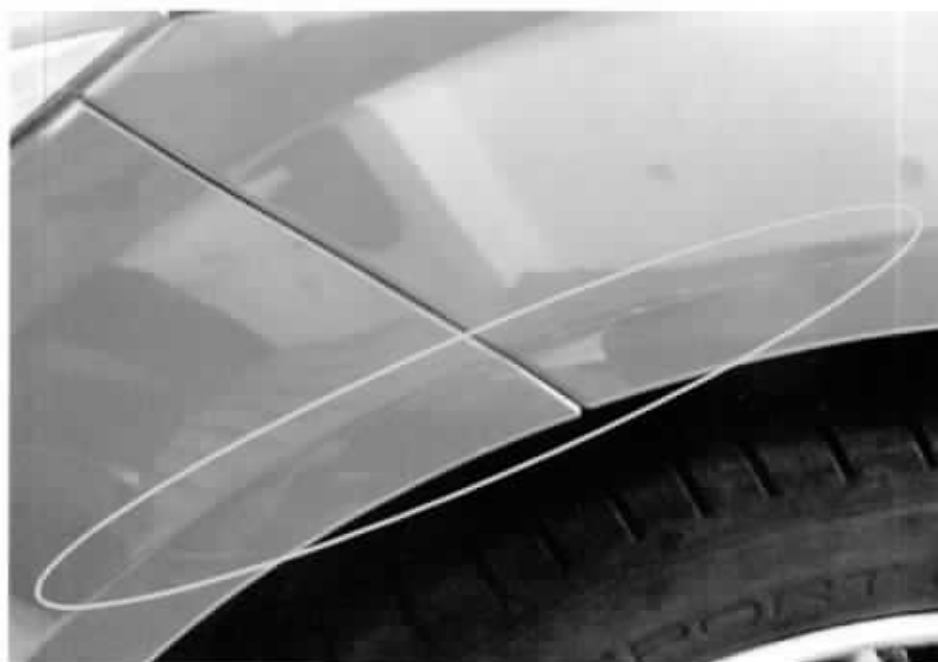
**Photo 10** shows a close up view of the paint graze marks on the top portion of the Mercedes's left front tyre fender (circled).

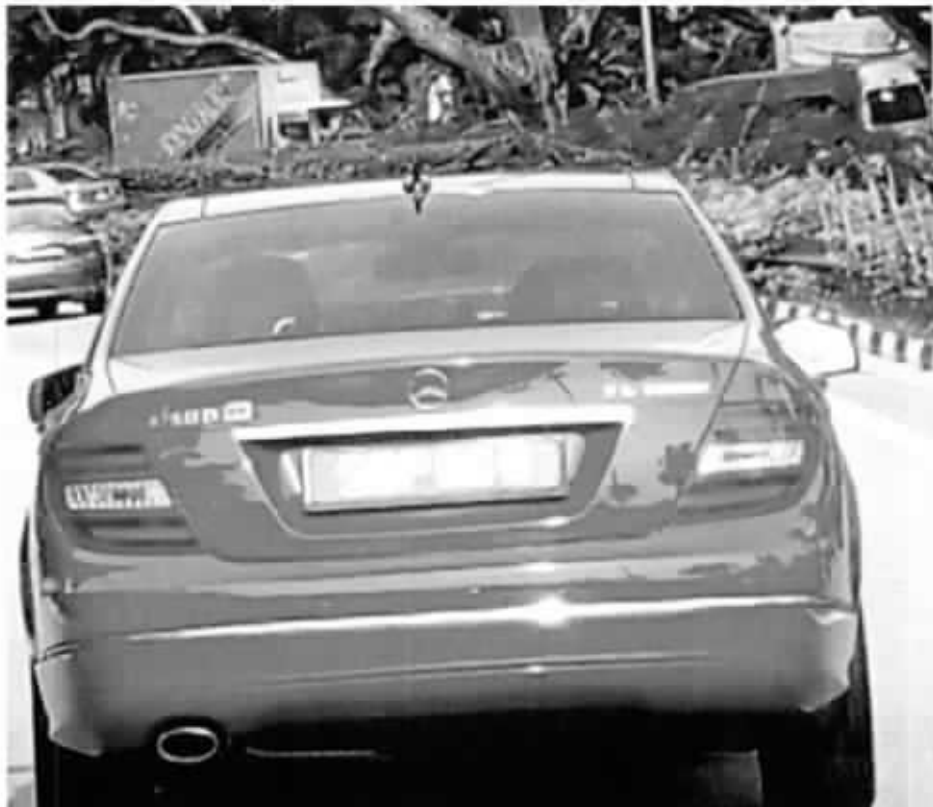
**Photo 15** shows the rear portion of the Mercedes which was taken by Mr Cheaw's passenger as the Mercedes left the accident scene. No other observations could be made from the photograph.

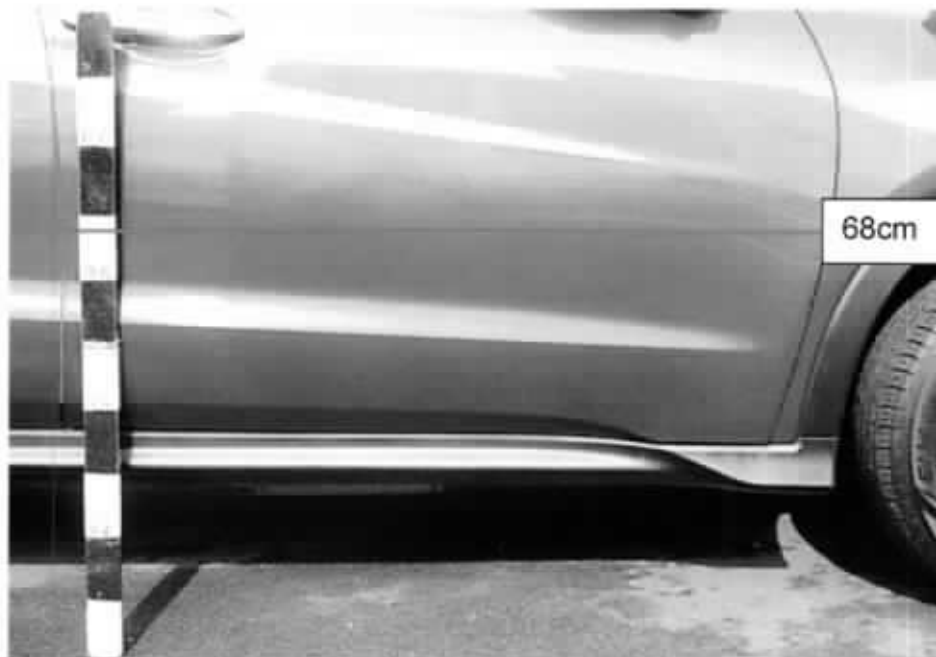
**Photo 19** shows the height measurement being conducted on the right passenger door of the Honda (using a similar make and model). The height above ground level of the area where the reddish paint transfer marks were found was measured to be approximately 68cm.

- a) the height above ground level of the area where the reddish paint transfer marks were found on the driver door of the Honda was measured to be approximately 68cm;

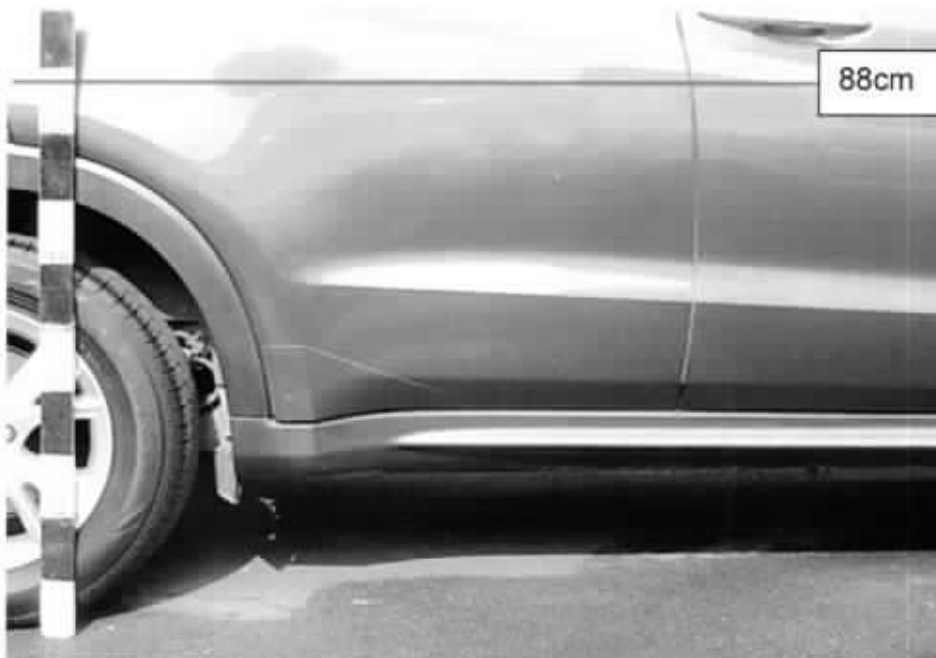
**Photo 20** shows the height measurement being conducted on the right passenger door of the Honda. The height above ground level of the area where the black marks were found was measured to be approximately 88cm.

- b) the height above ground level of the area where the black marks were found on the right passenger door of the Honda was measured to be approximately 88cm;
