### **ACCIDENT AT FLYOVER FROM BKE TO KJE ON 17.11.20 INVOLVING GBH2821T & SHC2503S**

## VEHICLE DAMAGE INSPECTION REPORT

Our Ref: 277/TP/2020

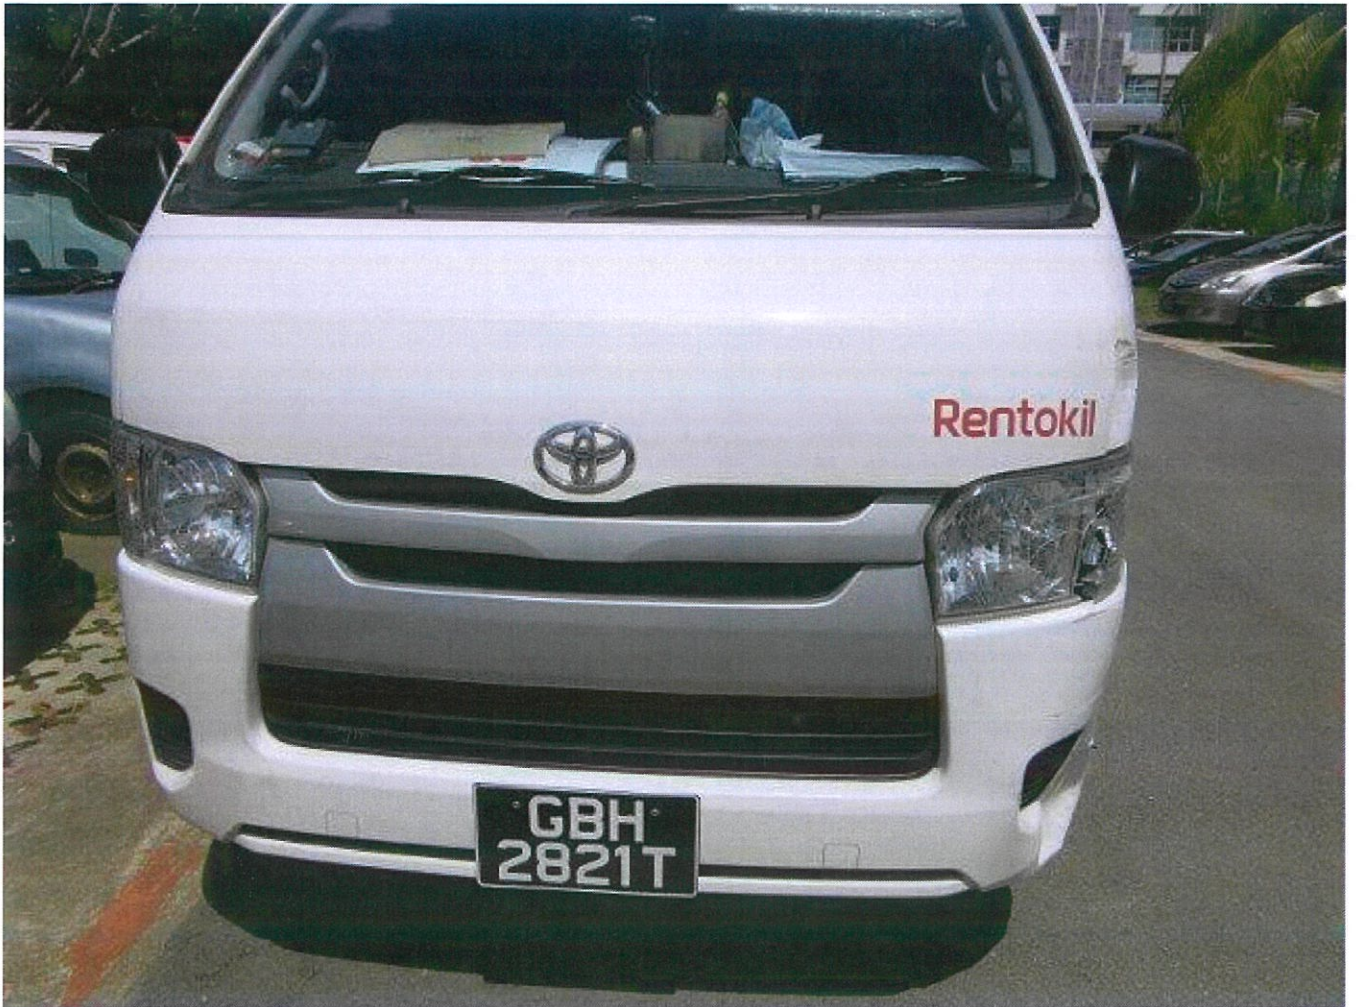
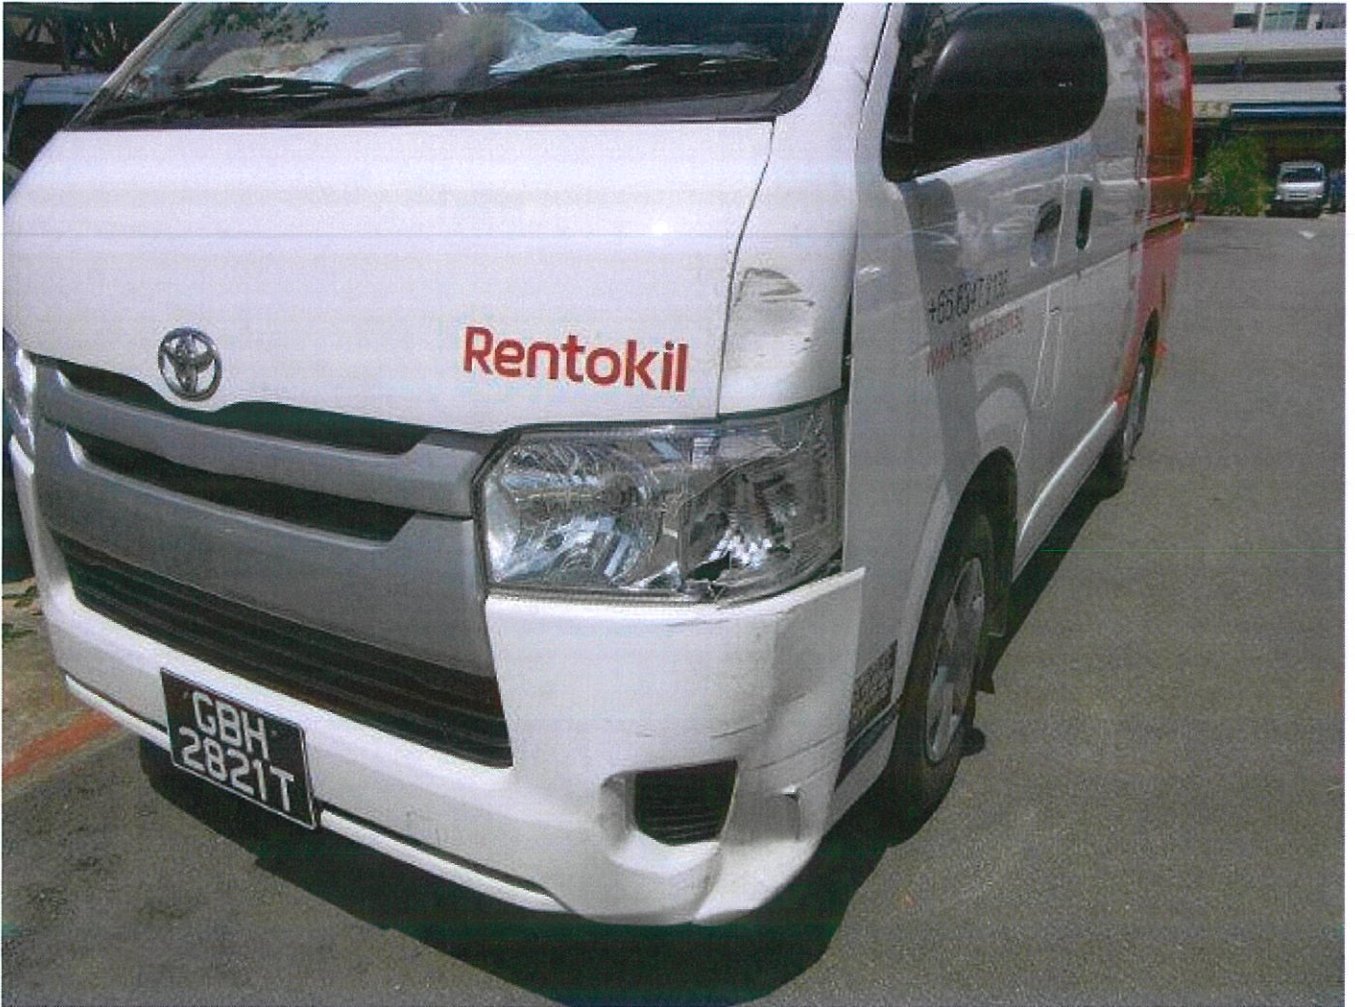
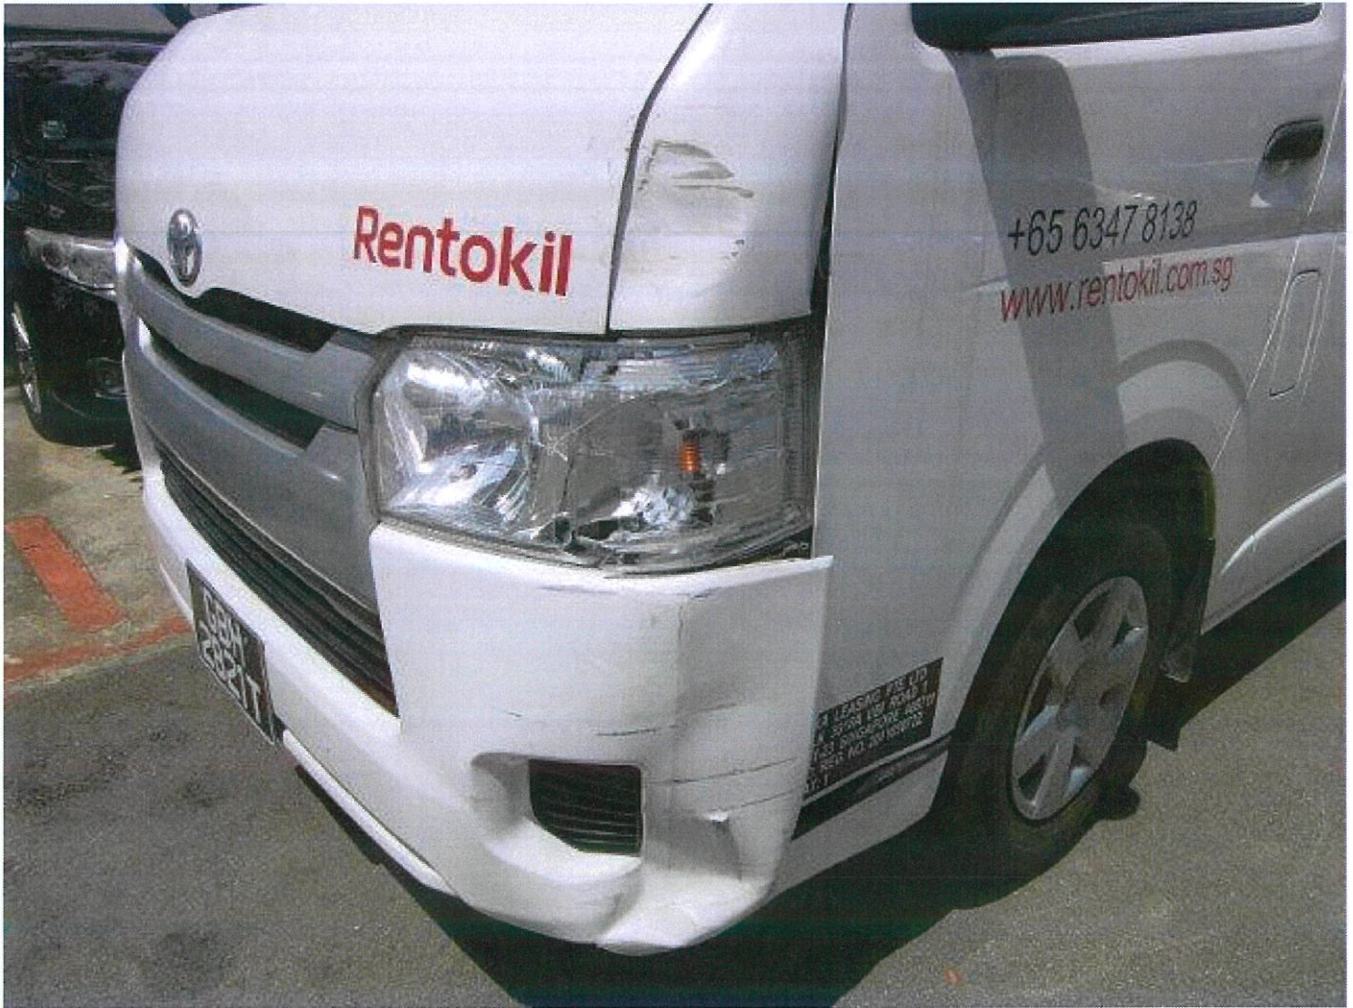
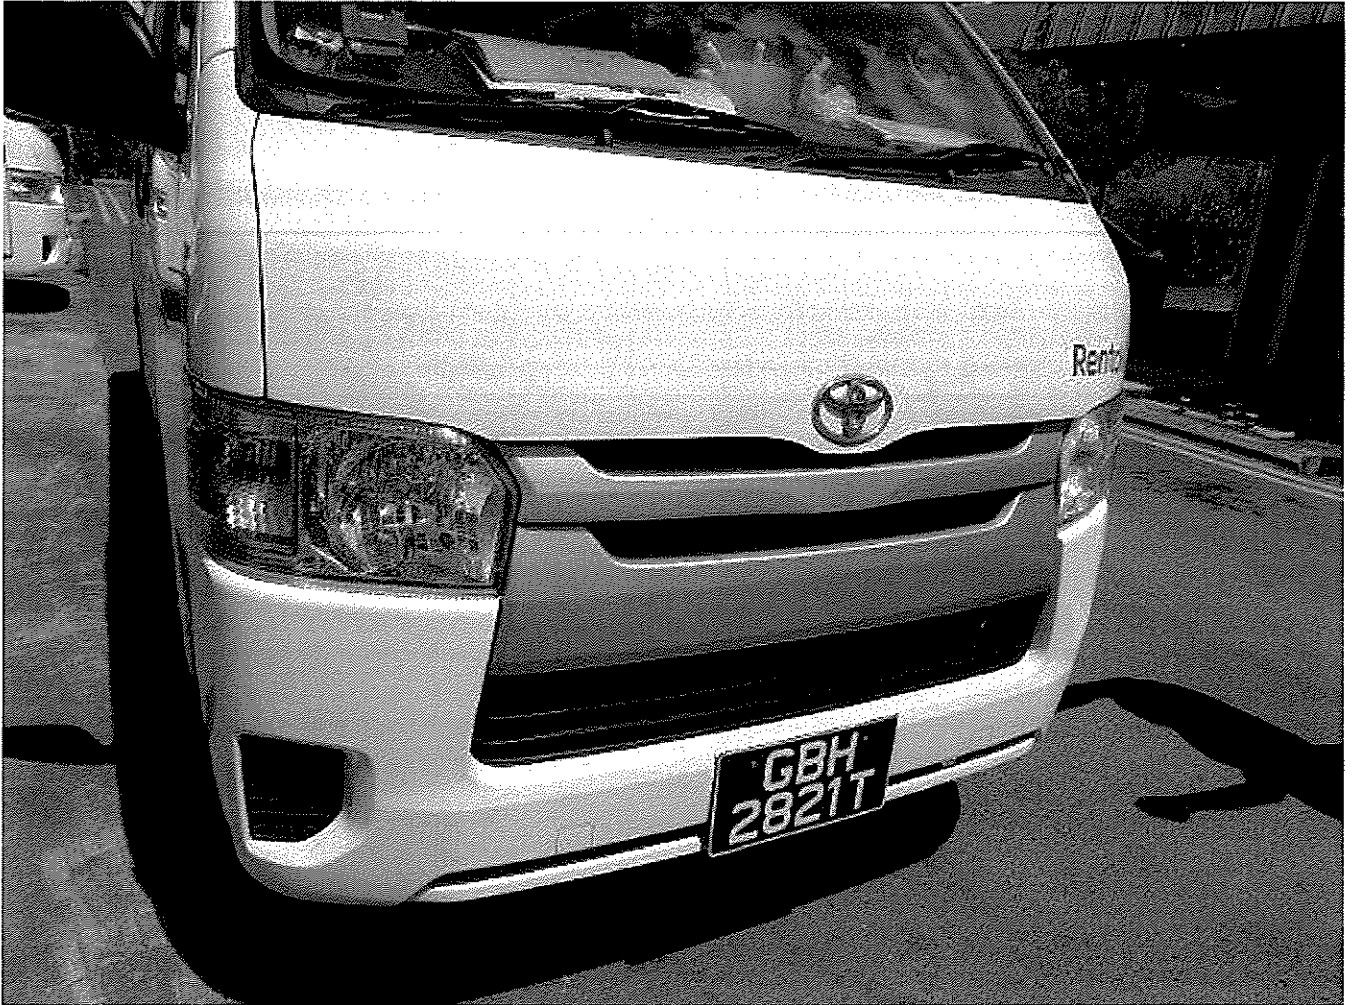
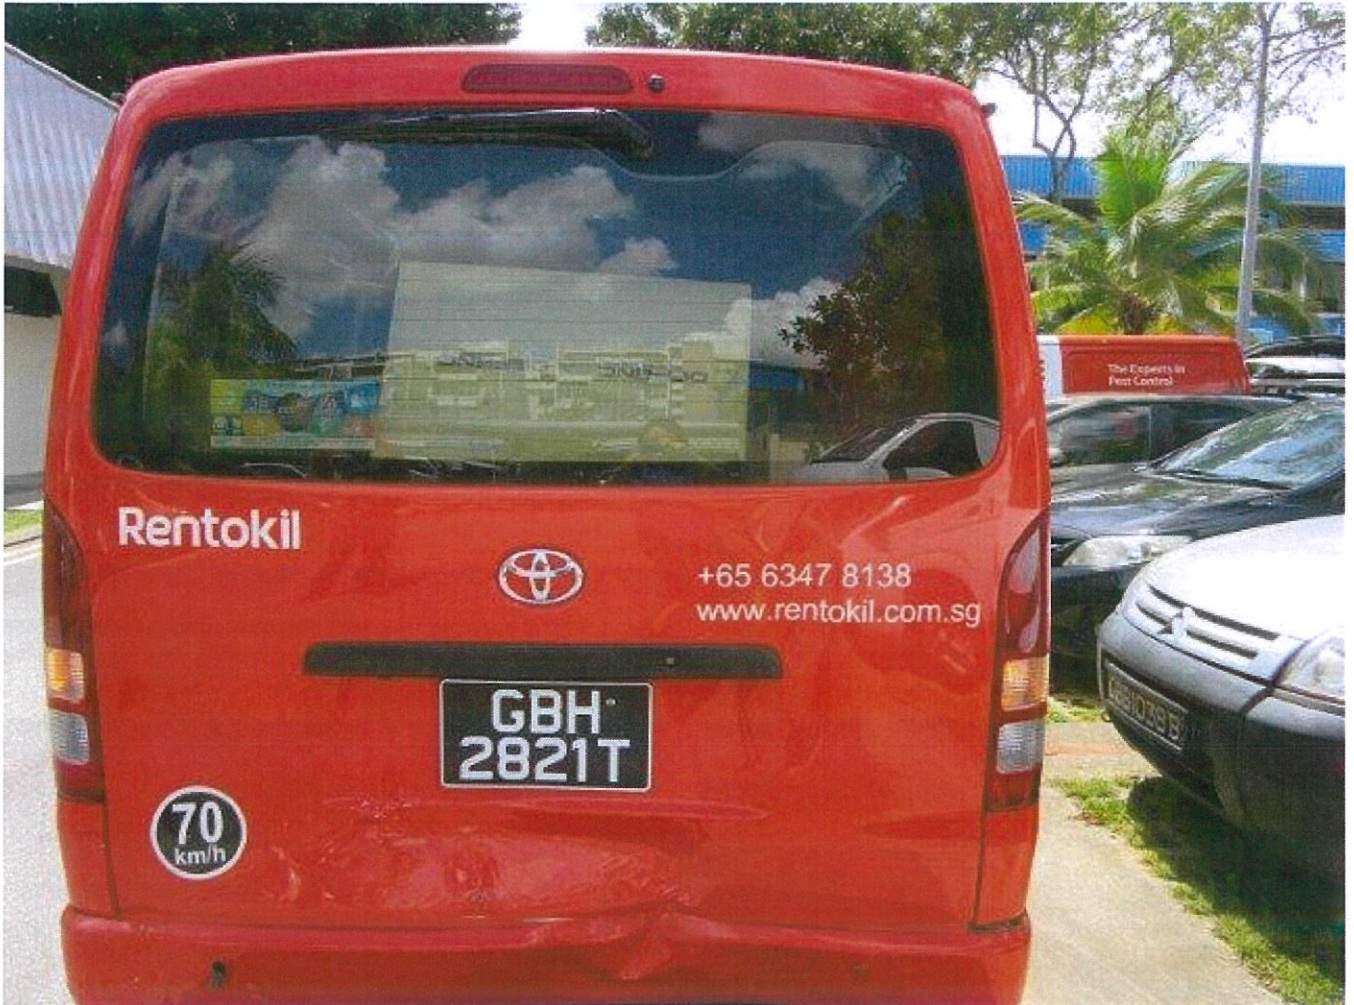
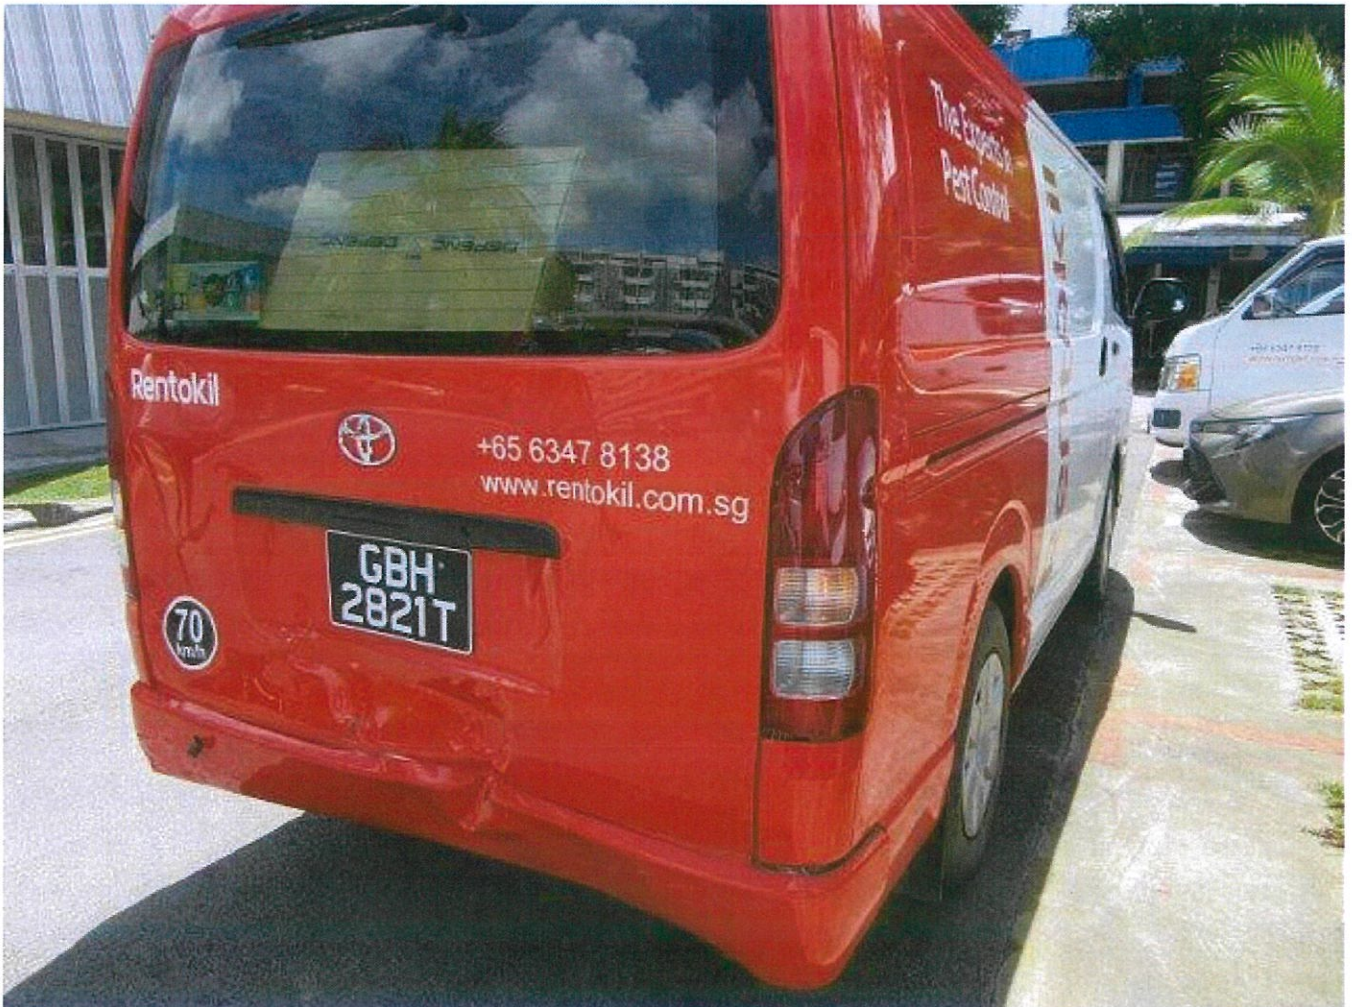
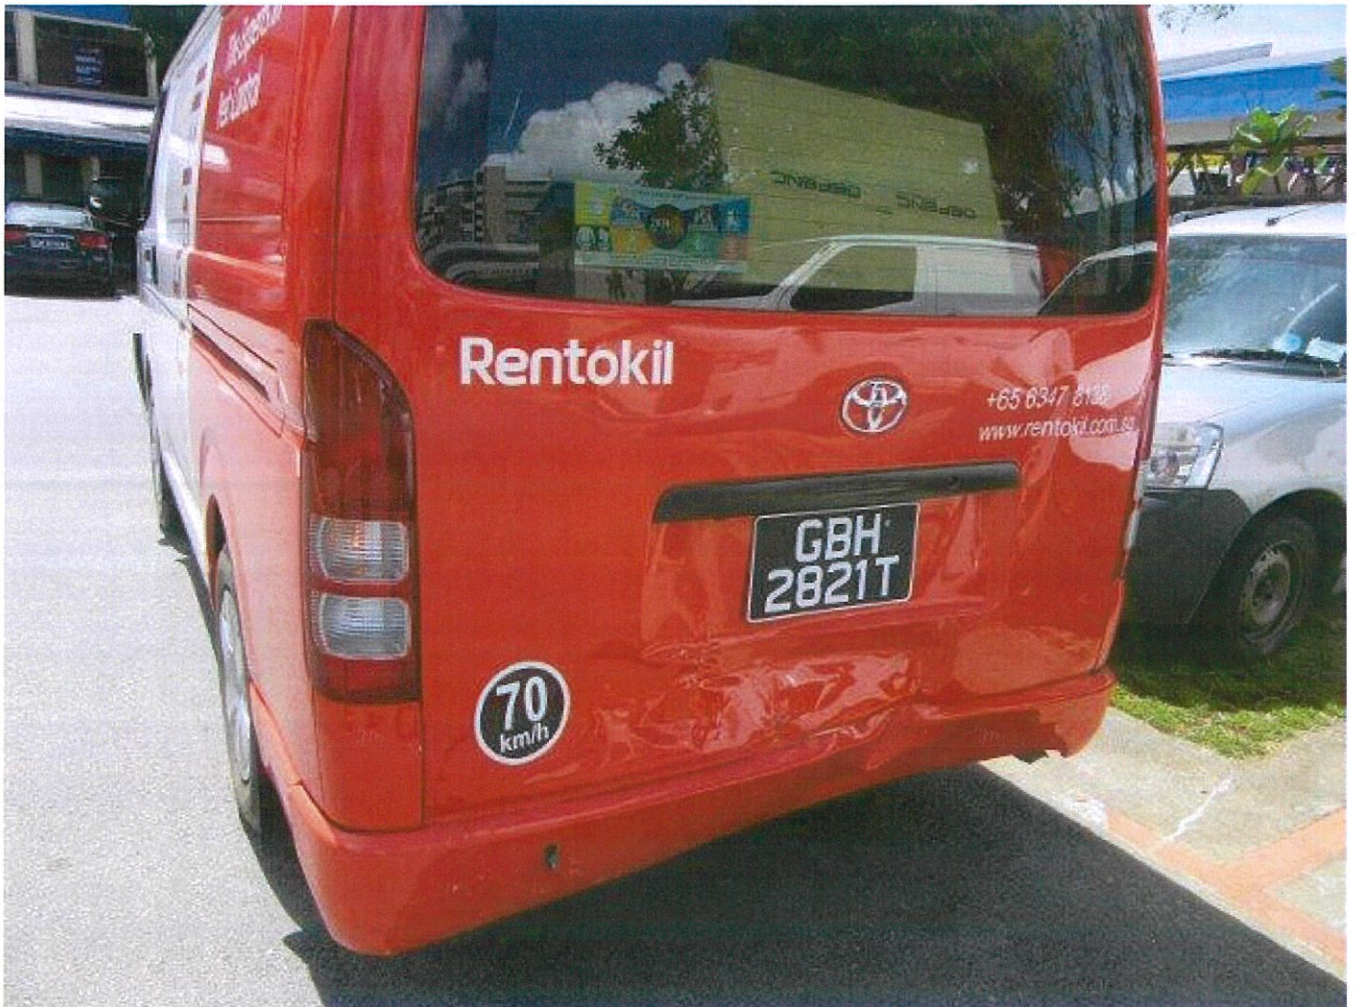
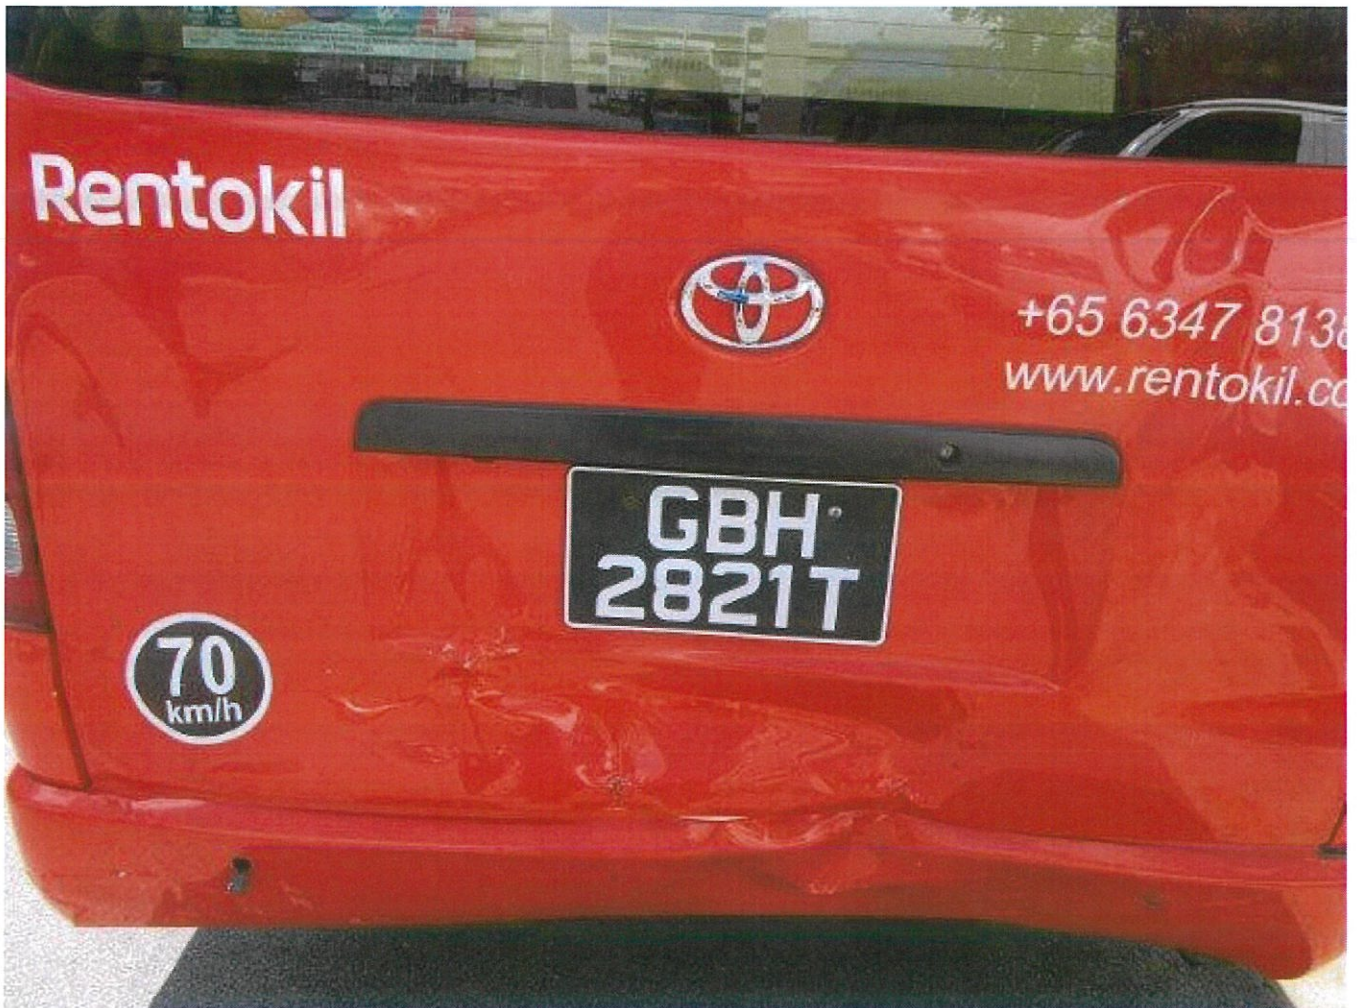
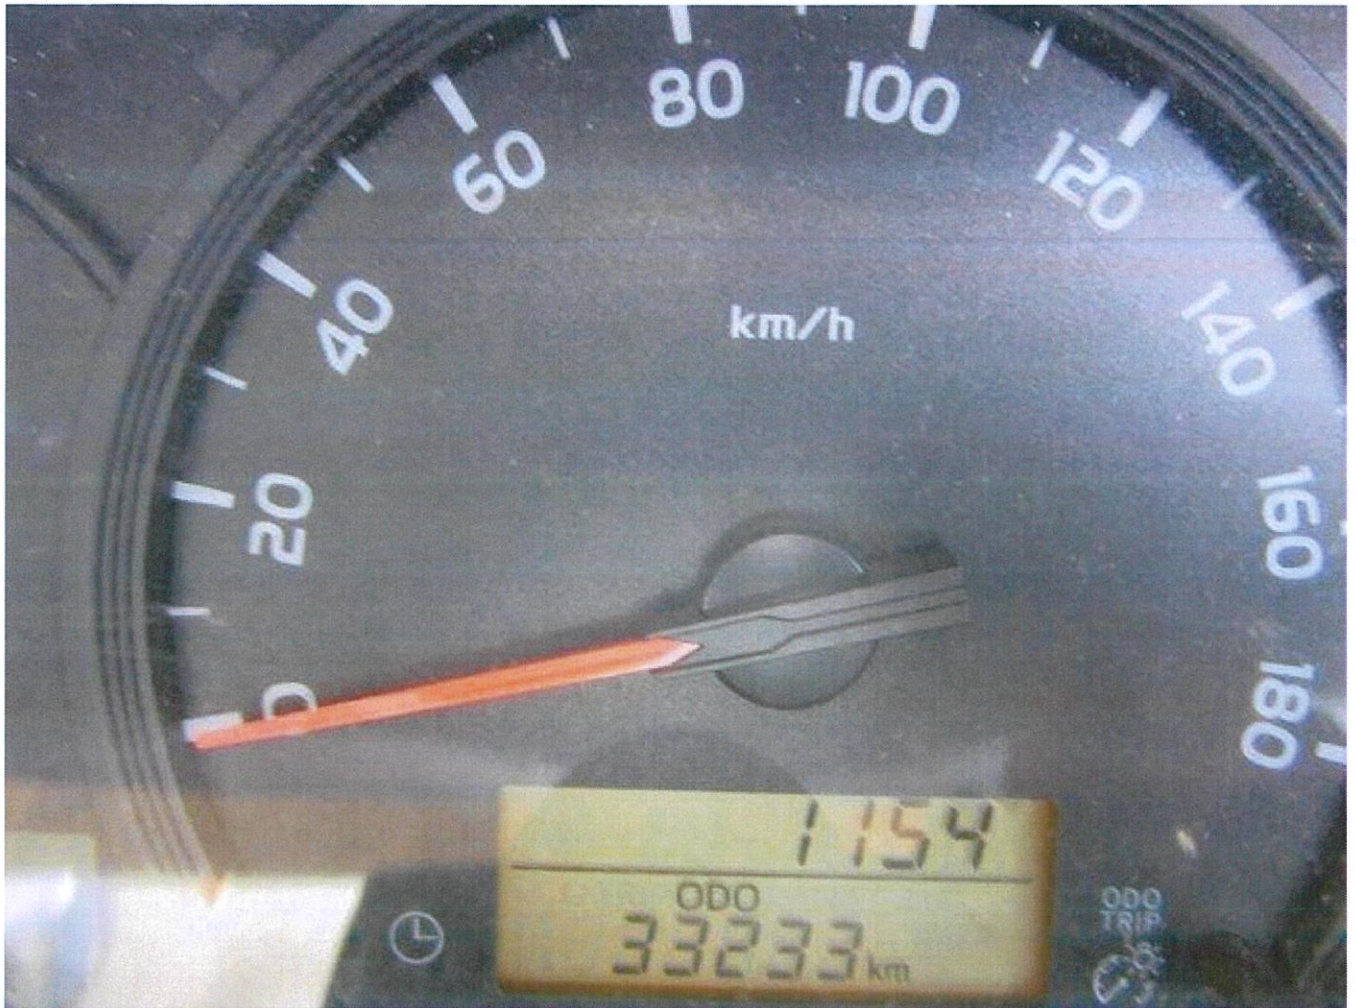
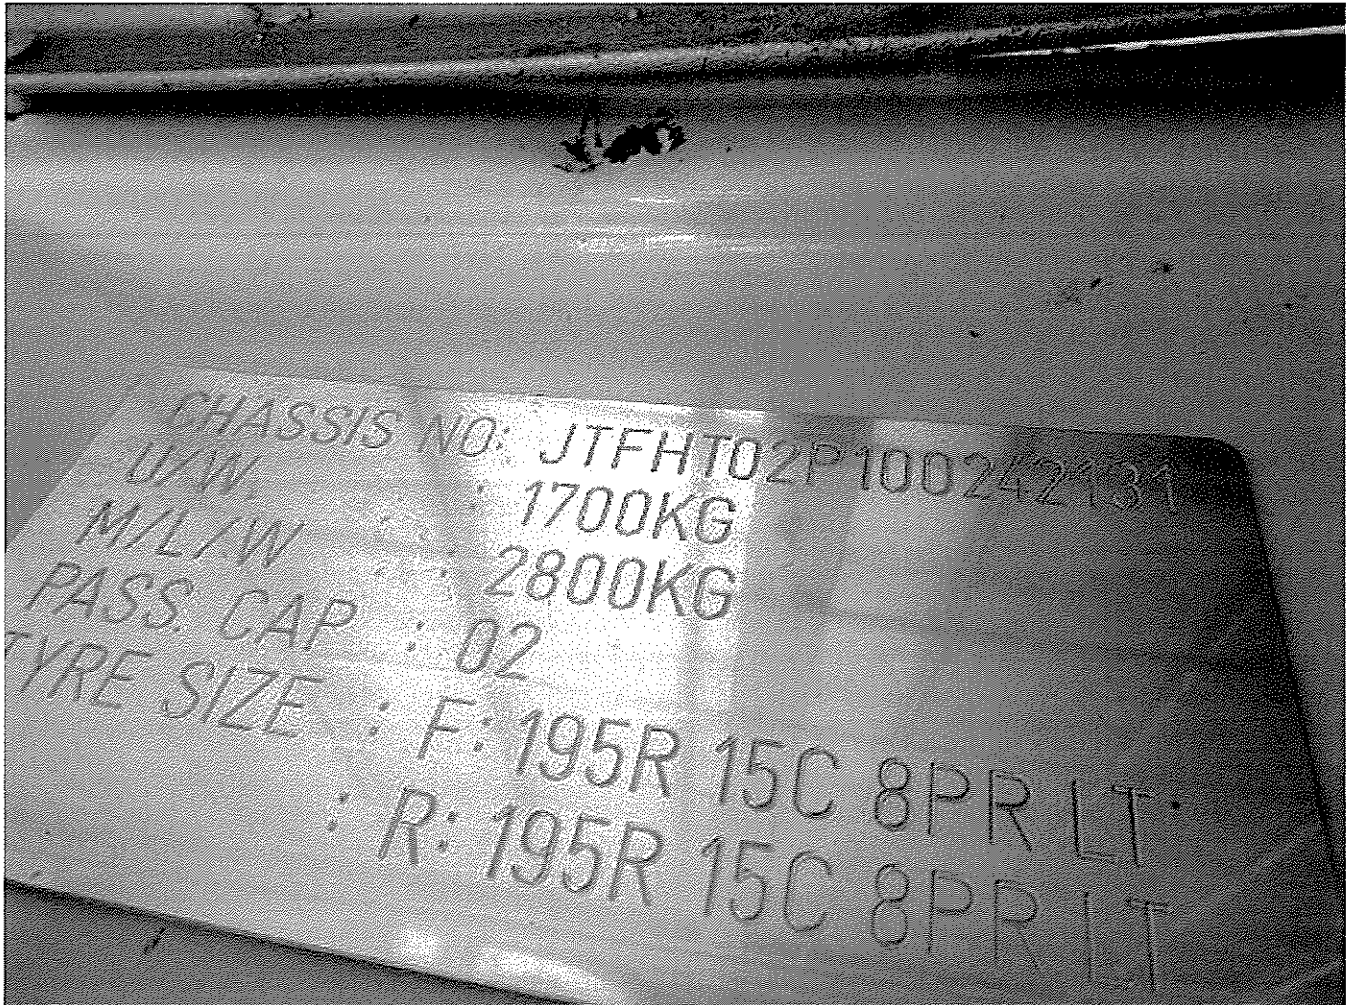
Accident Photo

Our visual inspection of the vehicle revealed that the damages noted are at the front and rear portion.

We have inspected the actual damages found on the vehicle and recommend the replacement of parts and repairs accordingly. The estimated repair cost is \$16,210.00. The repairer has agreed to undertake the repairs at our adjusted lump sum amount of \$9,700.00.
