Remark: The veh had commenced its  
repair at the time of inspection.

**ACCIDENT REPAIR ESTIMATE**

Vehicle No. : SLM3239ZMake & Model : M/BENZ E 200Year of Manufacture : 2012Chassis No. : WDD2120482A598779Engine No. : Policy No. : Time of Accident : **In-house Vehicle Assessor**Case Owner : AndrewSignature :

# SINGAPORE ACCIDENT STATEMENT

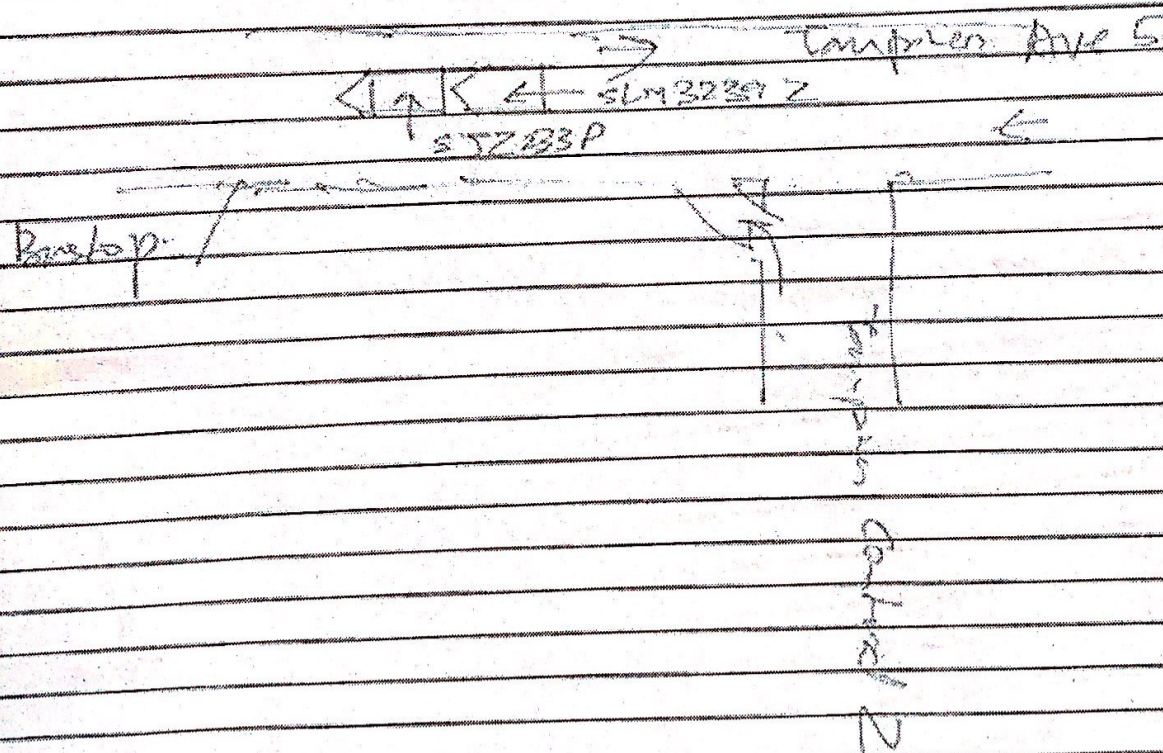
I was driving along Tampines Central 2. SLM32392. After exiting towards Tampines Ave 5 in the direction to PIE. There were a queue of vehicles just after the junction. The vehicle, SJZ 233P stopped suddenly. I stepped on the brake but was too late to avoid a collision.

Rear bumper of SJZ 233P was damaged. The front grille & bumper of SJZ 233P were damaged. A coolant or oil was leaking.
