ASSIGNMENT

Veh No: SGA12C Yr Regn: 27/09/2013

Make: Volkswagen Golf GTI 2.0c 1984

The U/C / Chassis frame / Body Structure affected due to collision.

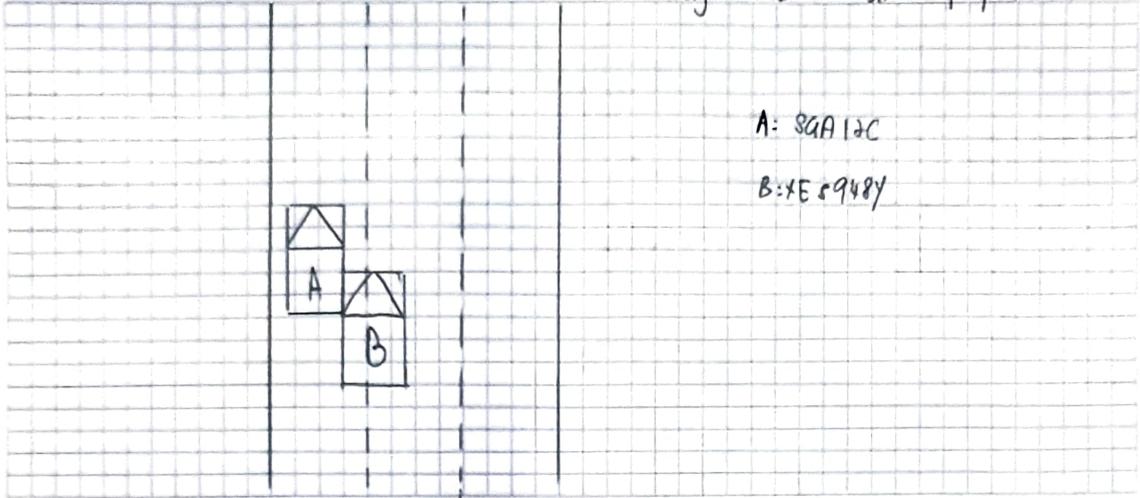
SKETCH PLAN

Along Pioneer Rd near Lamp post #13

On ~~about~~ at about 000hrs. I was traveling along Pioneer Rd. I was travelling straight along the said road when suddenly I felt an impact on my rear right side and realised that vehicle B had cut into my lane and hit onto my vehicle.

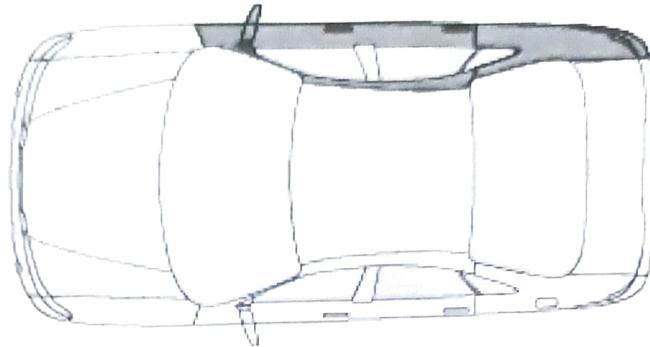
Damage Areas

All
Underbody

Code	Description	WU	Price SGD
	AND BOOT TRIM		
53 55 55 00	RENEW RIGHT SIDE PANEL	74.0	310.80
53 55 59 00	ASSEMBLE R/SIDE PANEL PARTS	16.0	67.20
	INCLUDES: DISMANTLED PARTS FIT IF NECESS		
	RENEW, LIGHT CHECK		
53 56 55 50)	RENEW R/LOWER SIDE PANEL (COMP WORK)	25.0	105.00
47 41 19 50)	DETACH + REFIT R/R BRAKE CALIPER	1.0	4.20
46 15 19 50)	R + R RIGHT REAR BRAKE CALIPER CARRIER	1.0	4.20
42 93 19 50)	DETACH + REFIT RIGHT REAR SHOCK ABSORBER	1.0	4.20
42 93 19 50)	R + R RIGHT REAR SHOCK ABSORBER	2.0	8.40
42 11 19 50)	R + R R/R LOWER CONTROL ARM (WHEEL AND COIL SPRING REMOVED) (CONTROL ARM DETACHED)	2.0	8.40
42 35 19 50)	R + R R/R UPPER CONTROL ARM (WHEEL AND COIL SPRING REMOVED) (CONTROL ARM DETACHED)	1.0	4.20
42 11 19 52)	R + R R/R CONTROL ARM	2.0	8.40
42 52 19 50)	R + R R/R WHEEL BEARING HOUSING (WHEEL REMOVED)	7.0	29.40
	INCLUDES: R + R COIL SPRING, DETACH + REFIT BRAKE CALIPER, CONTROL ARM AND COUPLING ROD

01 50 00 ZAX	DOES NOT INCLUDE: ALIGN FRONT AND REAR GFS / GUIDED FUNCTION (READ AND DELETE ERROR MEMORY AFTER REPAIR)	2.0	8.40
44 12 55 50)	RENEW R/R WHEEL (WHEEL REMOVED)	2.0	8.40
44 05 93 55	BALANCE R/R WHEEL (WHEEL REMOVED)	1.0	4.20
44 95 03 00	ALIGN FRONT AND REAR VEHICLE INCLUDES: CHECK TOE AND CAMBER, R + R BRACKET AND ALIGNMENT SENSOR	10.0	42.00
	DOES NOT INCLUDE: ADJUSTMENT		
44 94 15 50	REAR WHEEL CAMBER ALIGNMENT (COMPOSITE WORK)	2.0	8.40
44 93 15 50	(FRONT AND REAR VEHICLE ALIGNMENT) REAR WHEEL TOE ALIGNMENT (COMPOSITE WORK)	2.0	8.40
1482	(VEHICLE FRONT AND REAR ALIGNMENT) RIGHT FRONT DOOR REPAIR	20.0*	84.00
4102	R/R INNER SIDE PANEL REPAIR	30.0*	126.00
	Labour Cost	Hrs	WU
	Panel / Mechanical Labour	24.10	241.0
	Alignment		1,012.20
	Measuring Work	2.40	24.0
	Total of Labour		100.80
			1,113.00
