CS/CTI21003826/Qtfj.**ASSIGNMENT**

Veh No: SGA12C Yr Regn: 27/09/2013Type: M.Car / M.Cycle / Bus / Van / Lorry / Taxi / Prime Mover /

# SINGAPORE ACCIDENT STATEMENT

**Full Report**  
**Registration: SGA12C**  
**Printed: 24/03/2021 2:41 PM**

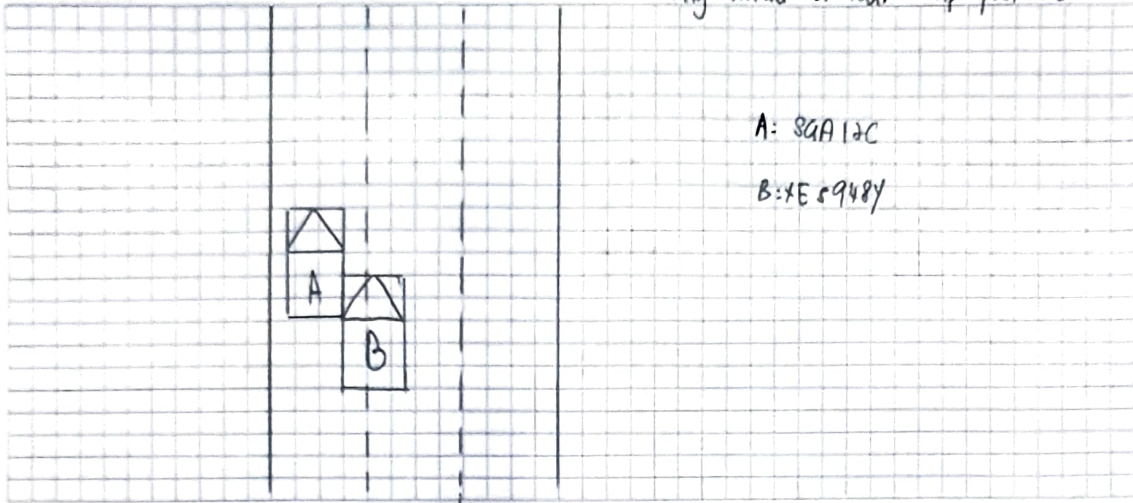
## SKETCH PLAN

Along Pioneer Rd near Lamp post #13

On ~~road~~ at about 000hrs. I was traveling along Pioneer Rd. I was travelling straight along the said road when suddenly I felt an impact on my rear right side and realised that vehicle B had cut into my lane and hit onto my vehicle.

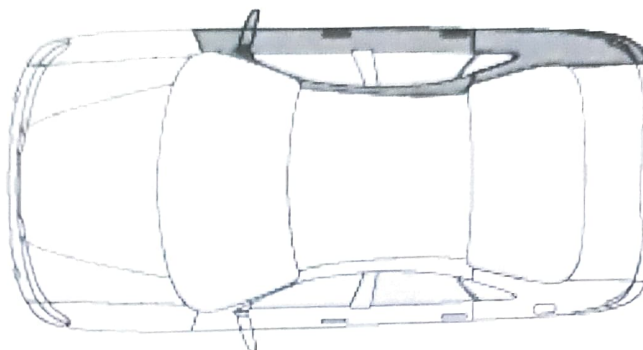
### Damage Areas

All ☐  
Underbody ☒
