**ASSIGNMENT**

To Inspect Vehicle No: YP 3249A

Make: Isuzu NMR85 G.C

## SINGAPORE ACCIDENT STATEMENT

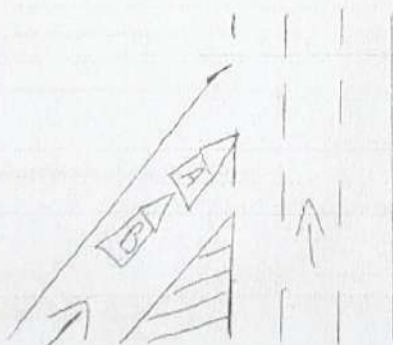
**Sketch Plan**

A - YP3249A

B - 6BF1282R

I was at the slip road of Runggel (entrance towards Runggel Way). I was behind the stopline waiting for the major road to clear before I went out. Out of sudden, I hit a great impact from my vehicle rear position. The great impact caused my vehicle to thrust forward. I got down my vehicle and realised that I was hit my vehicle (157).
