Your Ref: BMW Engine  
(number 2049C345N20B20C)  
Our Ref : CI/TP21005593/D

**INSPECTION REPORT OF A BMW ENGINE WITH NUMBER  
2049C345N20B20C**

**Inspection of the BMW Engine**

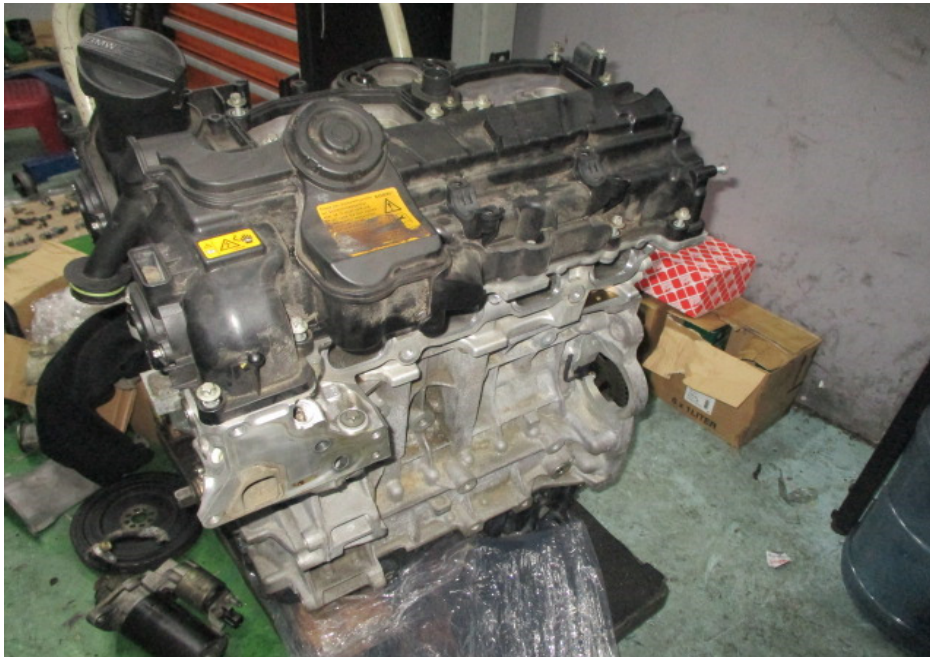
**Photo 1** shows a general view of the BMW engine that I had inspected. The BMW engine was observed to be a used engine and was not fitted on any motor car. It was also observed to be a complete assembly with all mechanical parts still intact, within the engine housing.

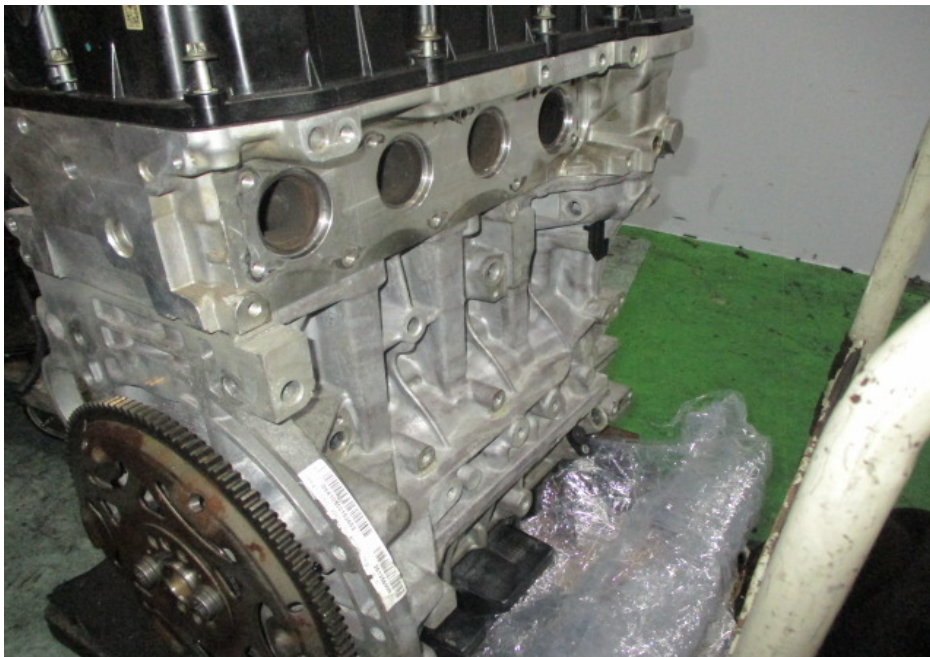
**Photo 2** shows a general view of the BMW engine that I had inspected. My visual examination of the engine housing revealed the housing to be of serviceable/satisfactory condition. There was no crack and/or hole observed on the engine housing.

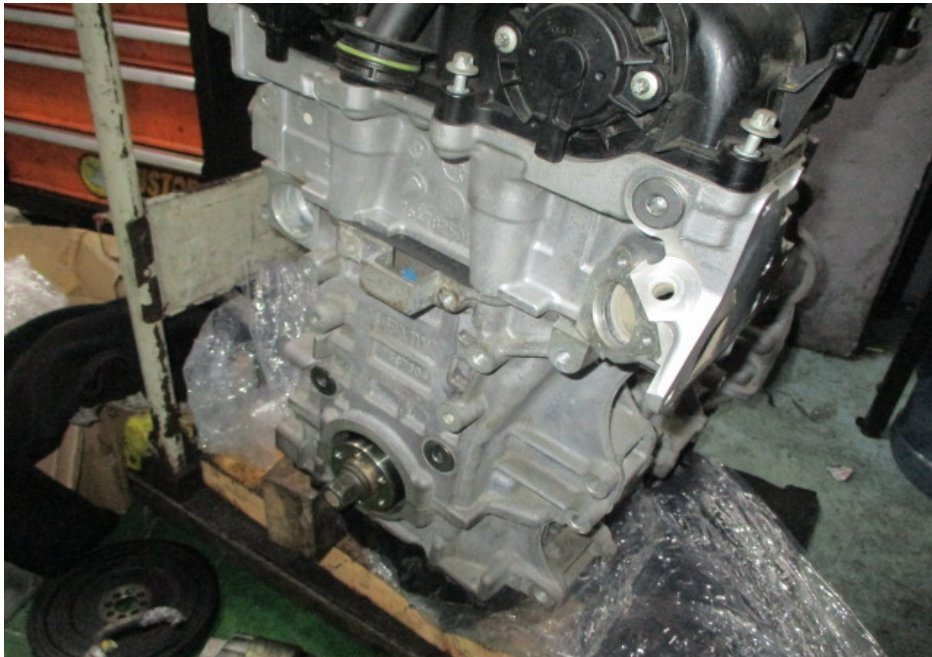
**Photo 3** shows a general view of the BMW engine that I had inspected. My visual examination of the engine housing revealed the housing to be of serviceable/satisfactory condition. There was no crack and/or hole observed on the engine housing.

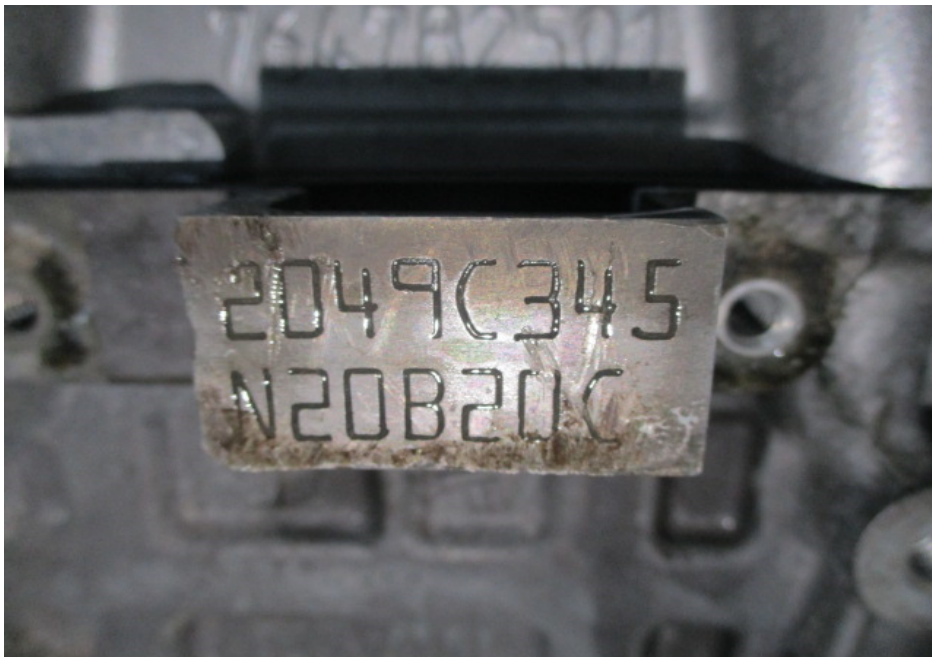
**Photo 4** shows the engine number engraved on the housing of the BMW engine that I had inspected. The engine number was 2049C345N20B20C.

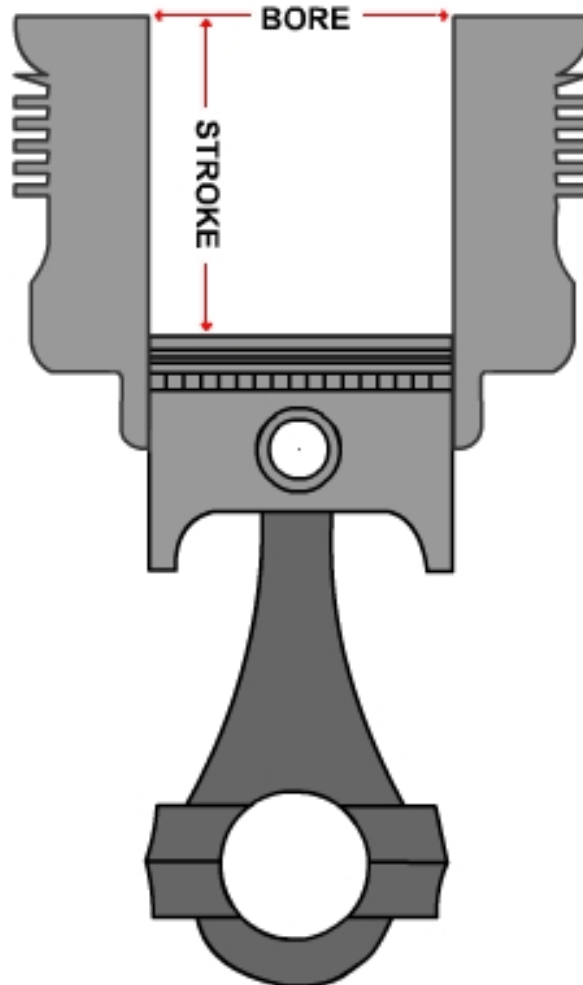
9. The bore refers to the measurement of the inside diameter of the cylinder while the stroke refers to the distance the piston moves in one direction of upward or downward movement in the cylinder. See diagram below for illustration purposes.

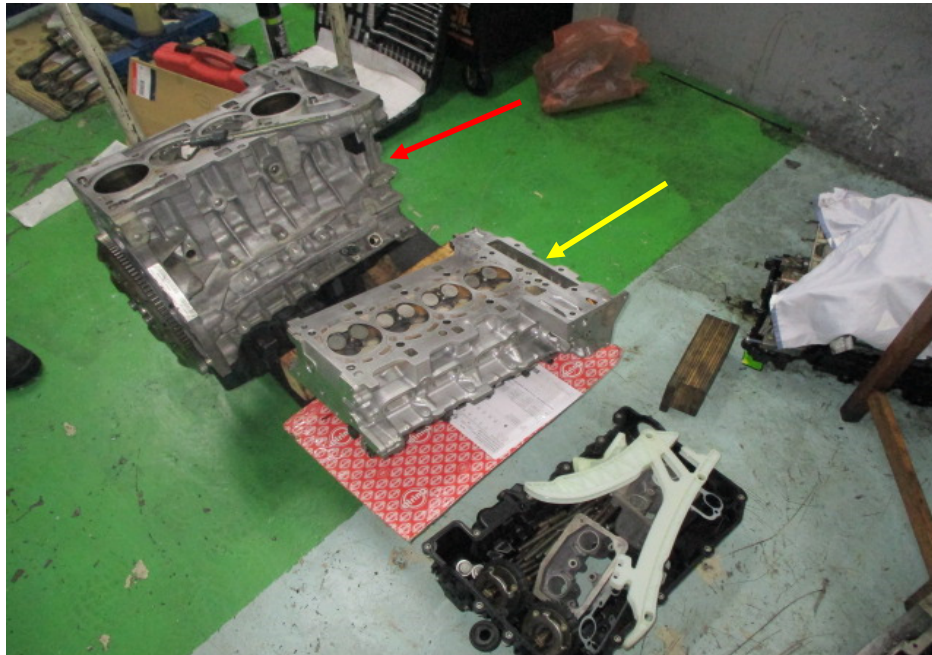
**Photo 5** shows the top block (yellow arrow) of the BMW engine separated from its bottom block (red arrow). This was to enable me to carry out measurements of its cylinders, in particular the bore and stroke measurements of each cylinder, which typically can be used to determine the engine displacement or more commonly referred to as engine cc.

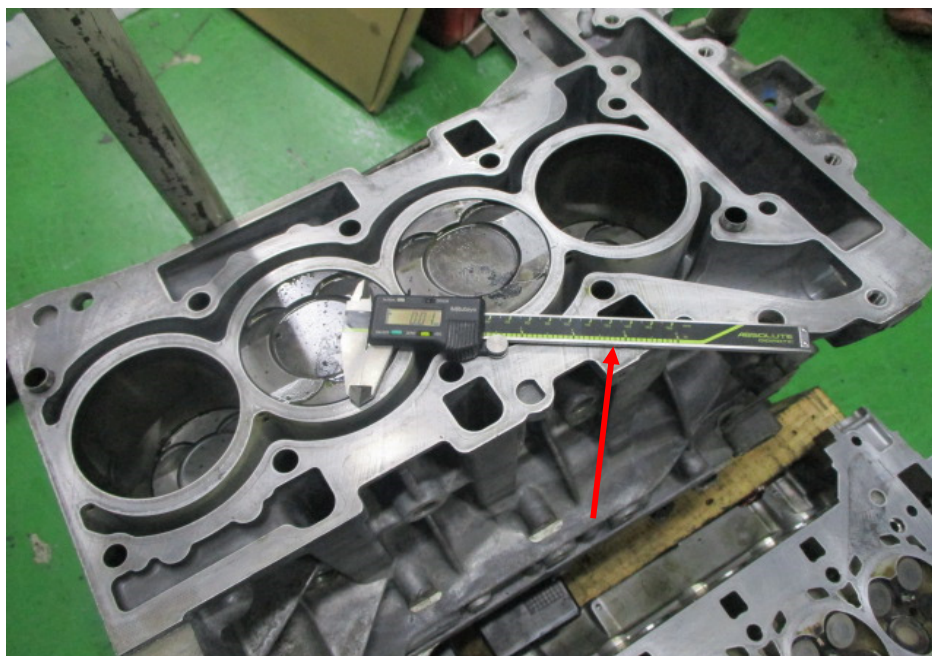
**Photo 6** shows the bottom block of the BMW engine and the digital Vernier Caliper (arrowed) that was used to measure the bore and stroke measurements of each cylinder, which typically can be used to determine the engine displacement or more commonly referred to as engine cc. The digital Vernier Caliper was calibrated before the start of the measurements.

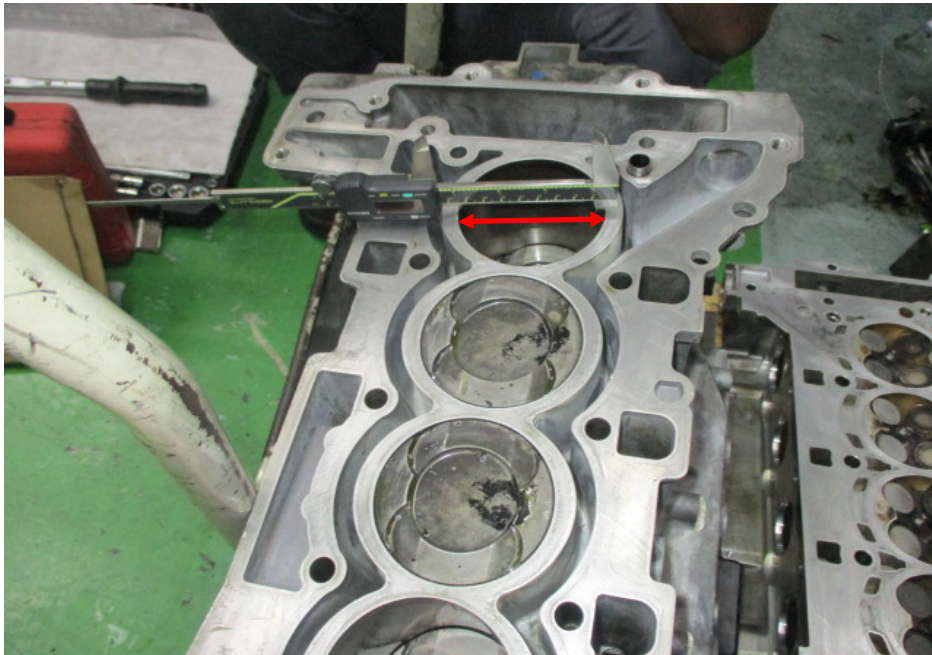
**Photo 7** shows measurement being carried out to the bore (arrowed) of cylinder 1 of the BMW engine. The measurements were carried out using a digital Vernier Caliper that was calibrated before the start of the measurements.

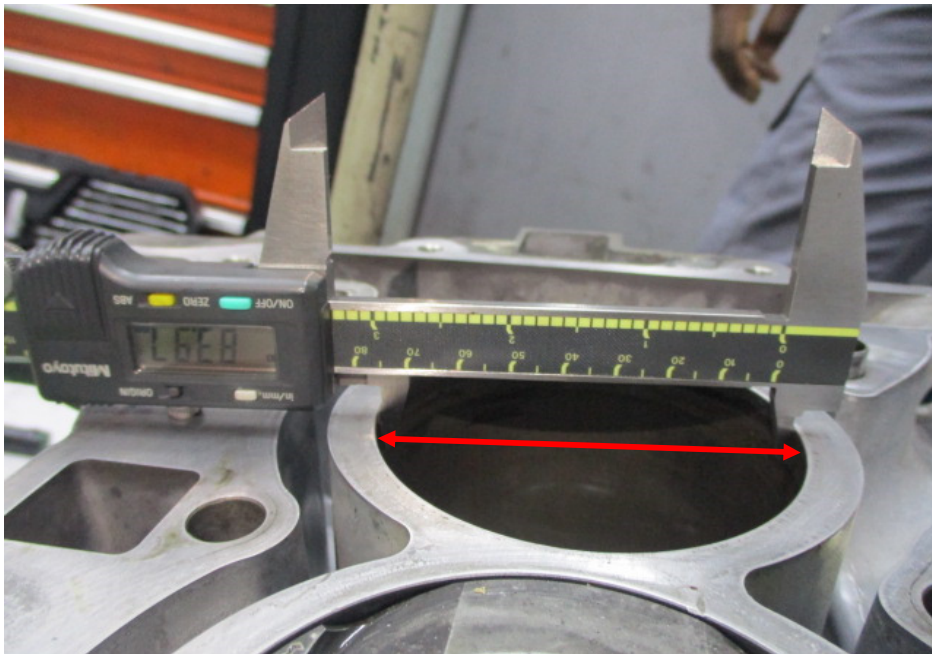
**Photo 8** shows the bore (arrowed) measurement of cylinder 1, which was recorded to be 83.97mm.

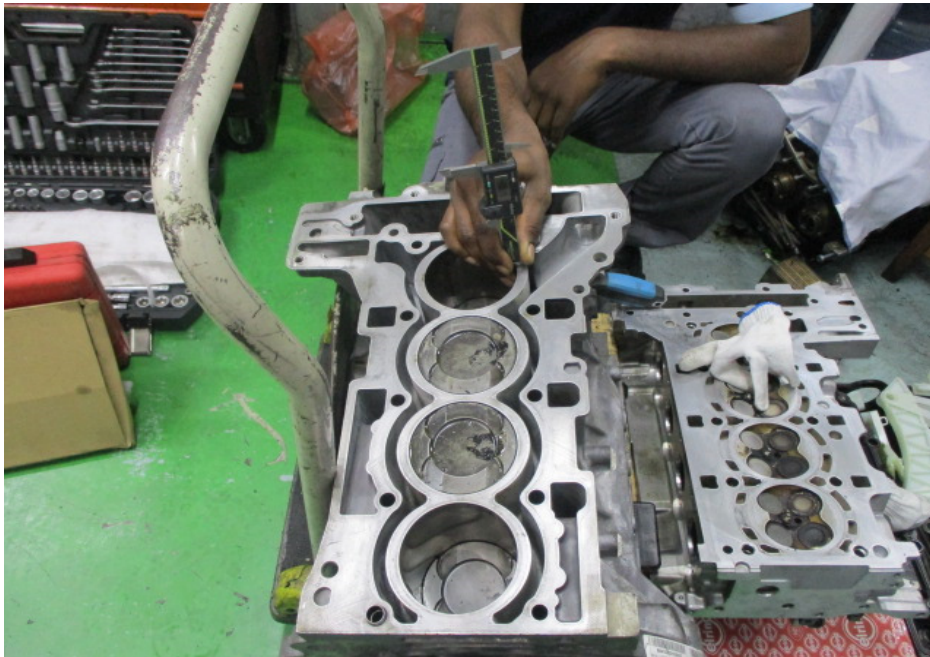
**Photo 9** shows measurement being carried out to the stroke of cylinder 1 of the BMW engine. The bore and stroke measurements of the BMW engine were carried out using a digital Vernier Caliper.

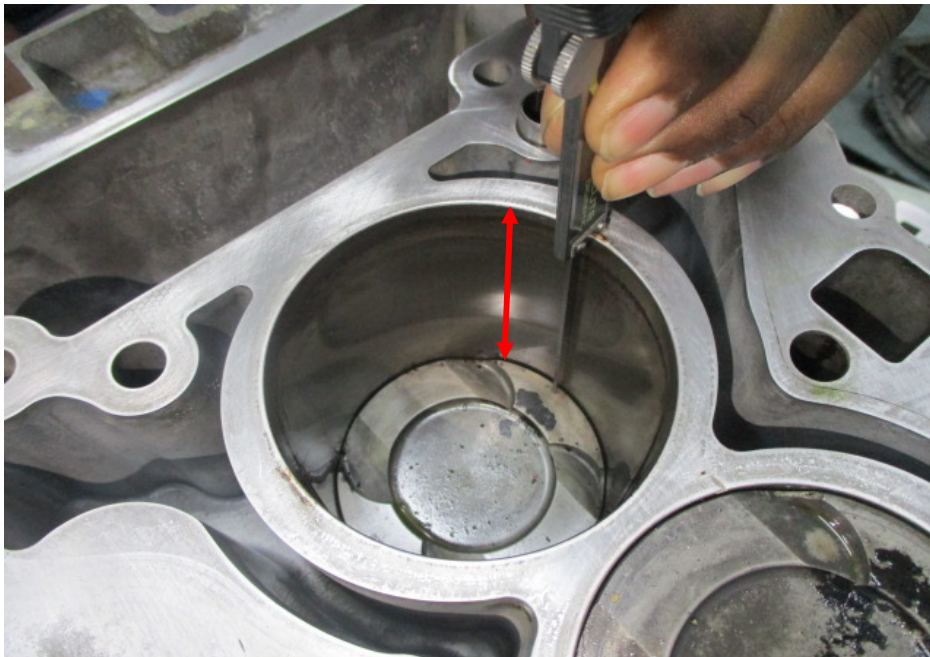
**Photo 10** shows measurement being carried out to the stroke (arrowed) of cylinder 1 of the BMW engine. The bore and stroke measurements of the BMW engine were carried out using a digital Vernier Caliper that was calibrated before the start of the measurements,

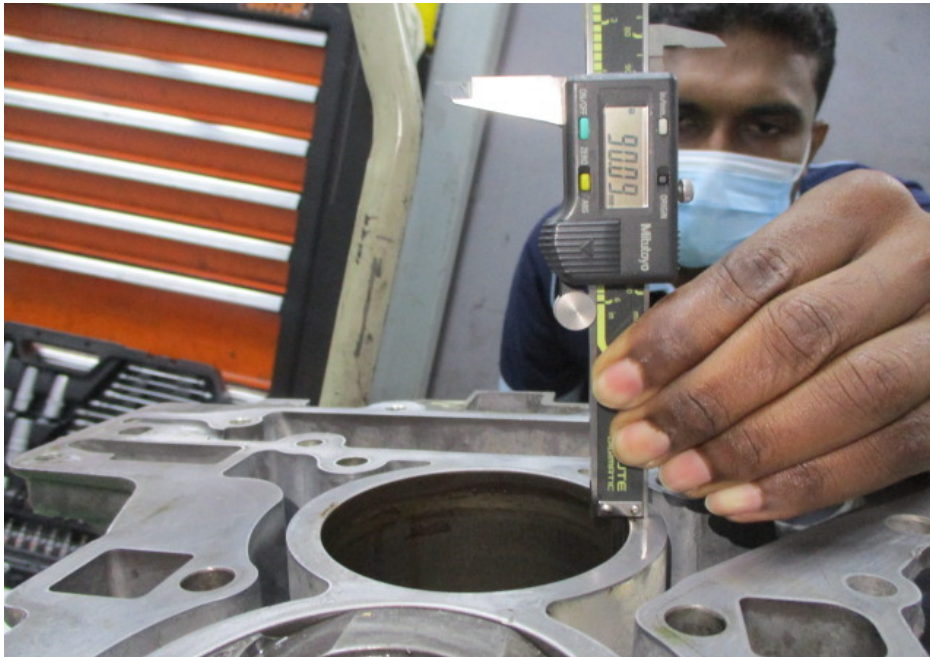
**Photo 11** shows the stroke measurement of cylinder 1, which was recorded to be 90.09mm.

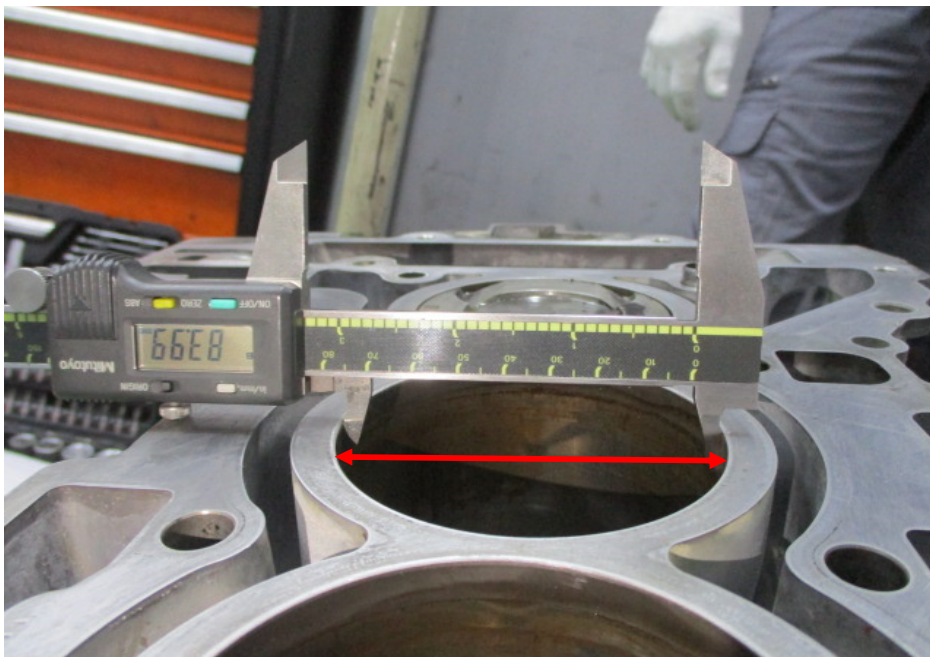
**Photo 12** shows measurement being carried out to the bore (arrowed) of cylinder 2 of the BMW engine. The bore measurement of cylinder 2 was recorded to be 83.99mm.

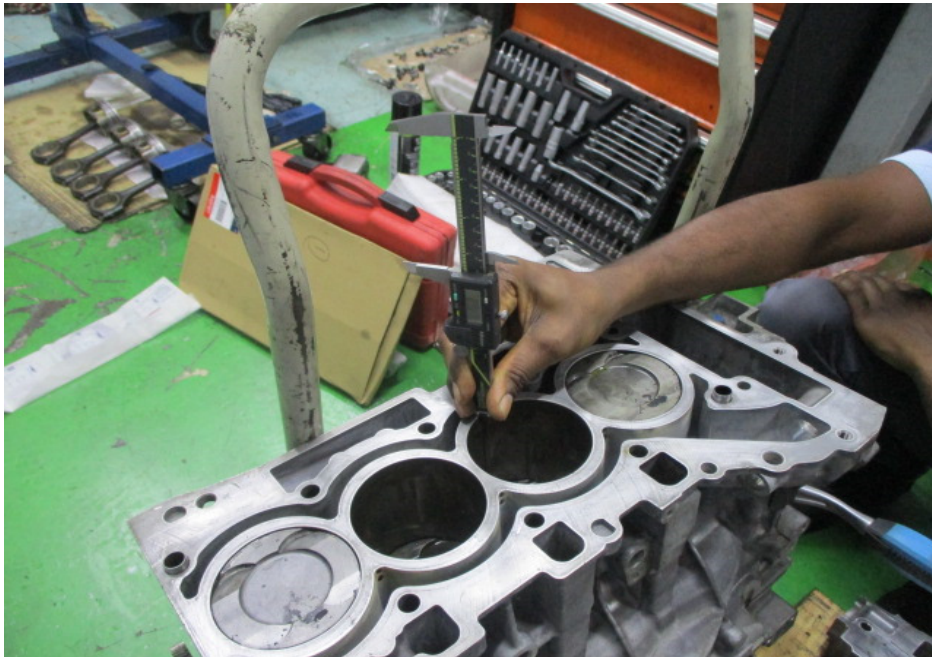
**Photo 13** shows measurement of the stroke for cylinder 2 of the BMW engine that I had inspected.

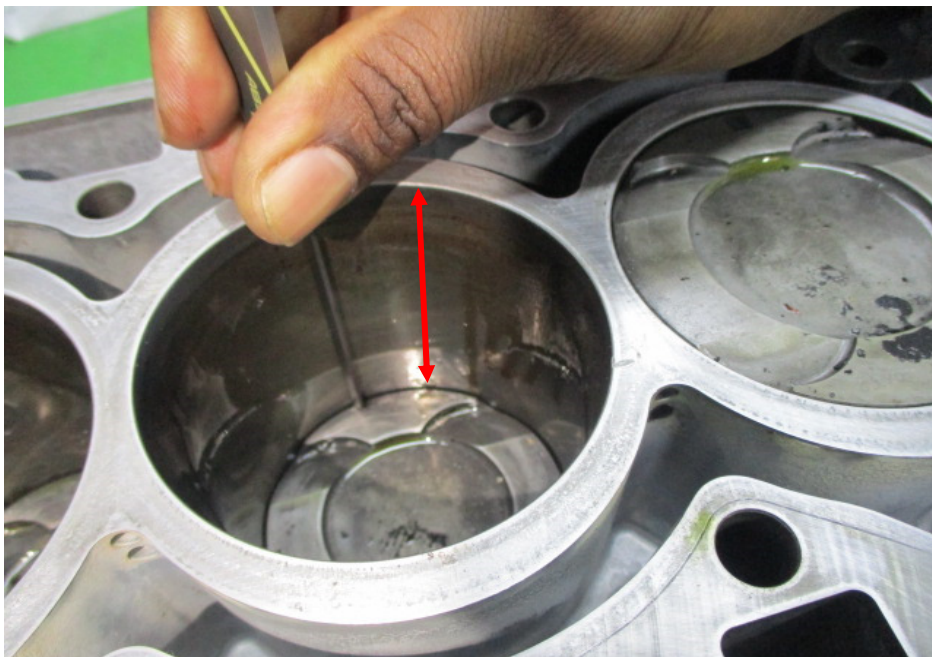
**Photo 14** shows measurement of the stroke (arrowed) for cylinder 2 of the BMW engine that I had inspected.

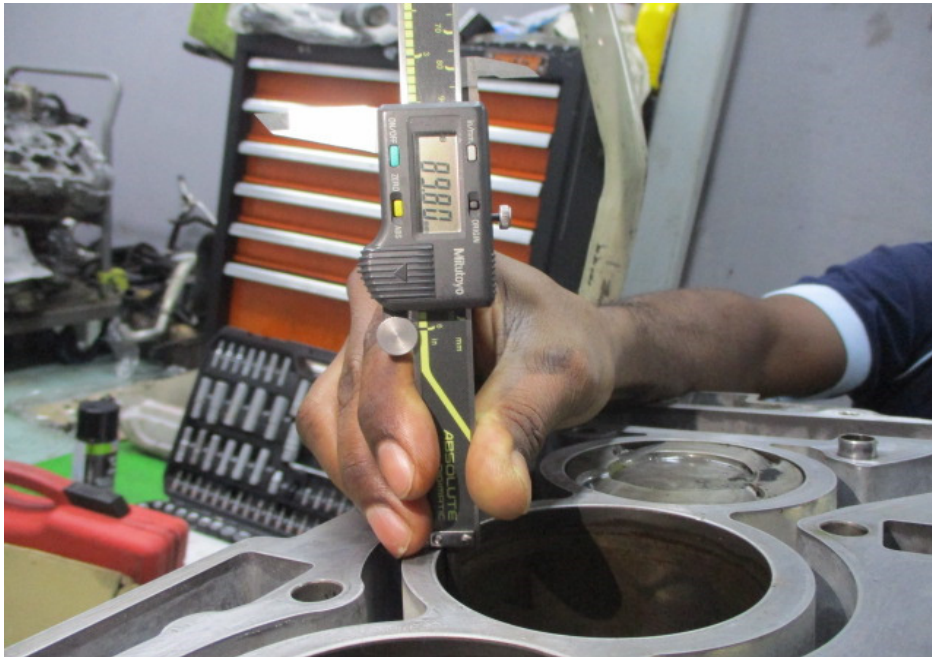
**Photo 15** shows the stroke measurement of cylinder 2, which was recorded to be 89.80mm.

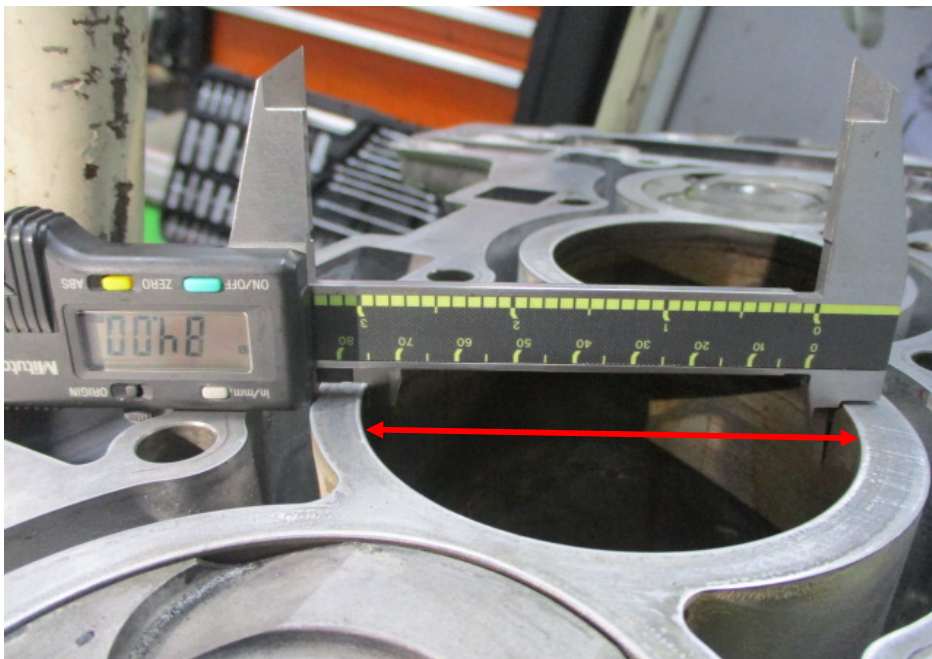
**Photo 16** shows measurement being carried out to the bore (arrowed) of cylinder 3 of the BMW engine. The bore and stroke measurements of the BMW engine were carried out using a digital Vernier Caliper. The bore measurement of cylinder 3 was recorded to be 84.00mm.

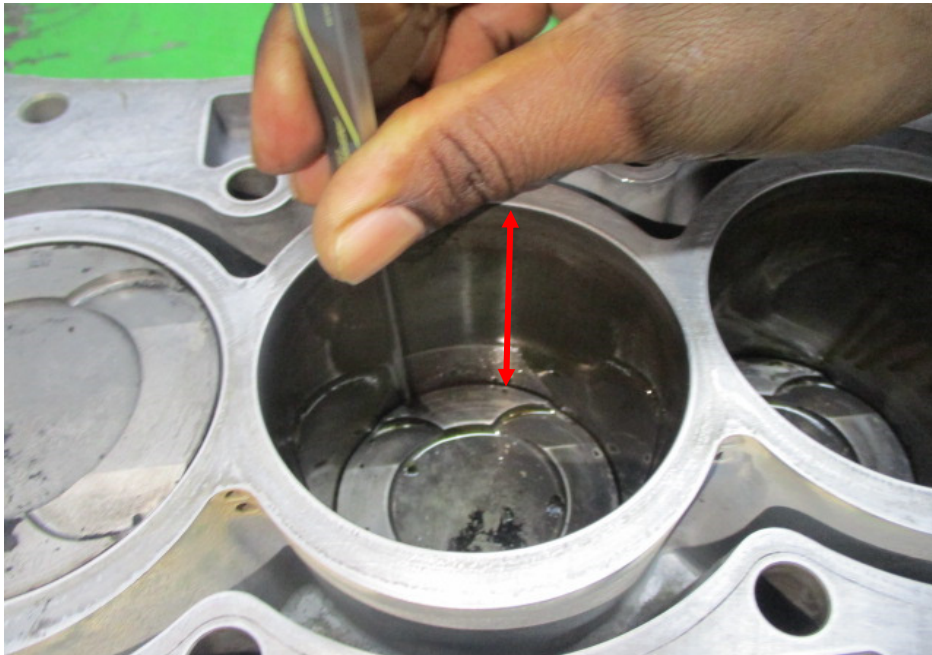
**Photo 17** shows measurement of the stroke (arrowed) for cylinder 3 of the BMW engine that I had inspected. The bore and stroke measurements of the BMW engine were carried out using a digital Vernier Caliper that was calibrated before the start of measurements.

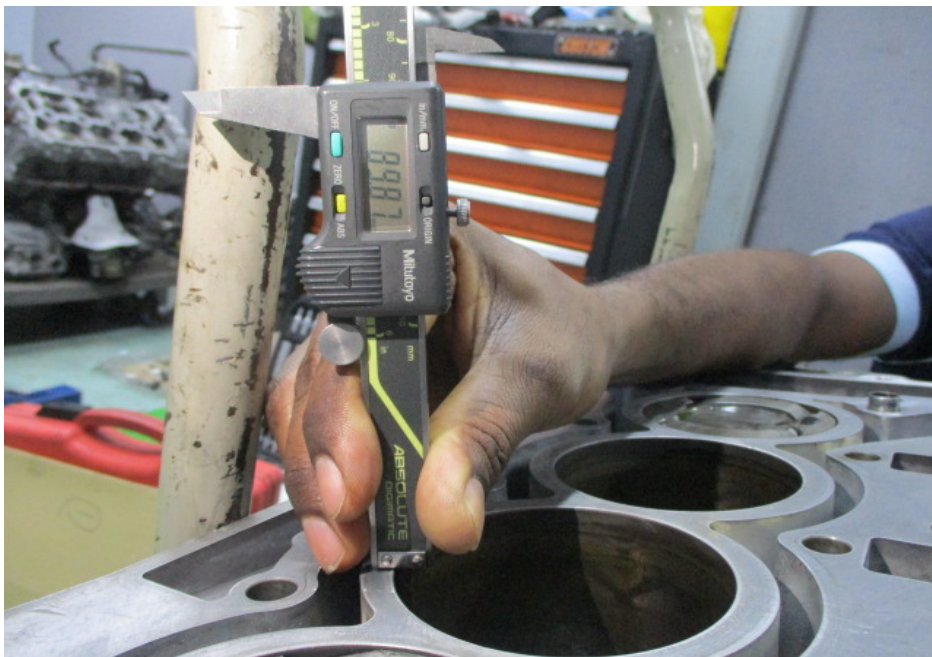
**Photo 18** shows the stroke measurement of cylinder 3, which was recorded to be 89.87mm.

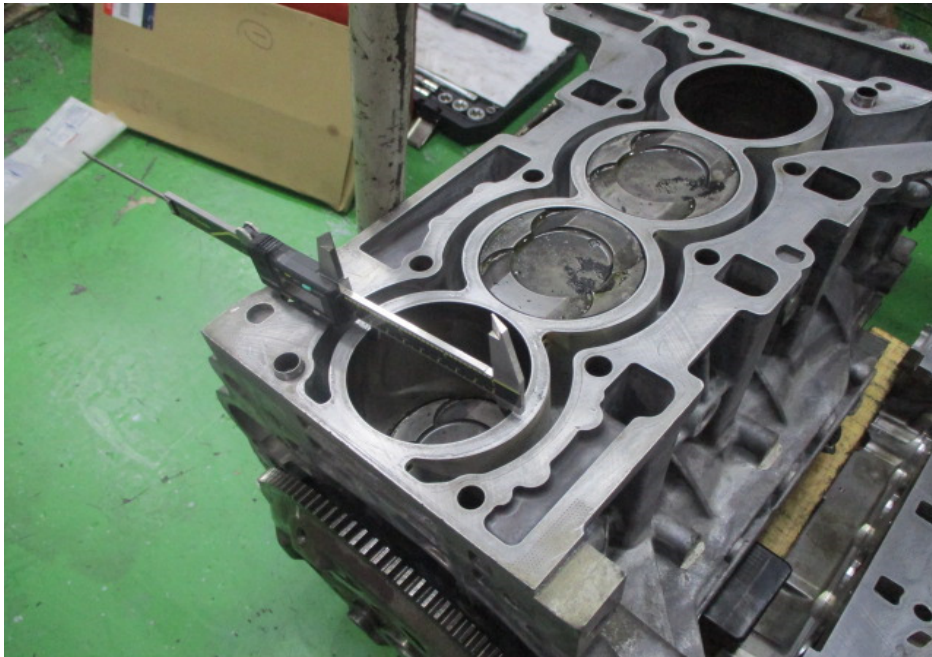
**Photo 19** shows measurement being carried out to the bore of cylinder 4 of the BMW engine. The bore and stroke measurements of the BMW engine were carried out using a digital Vernier Caliper.

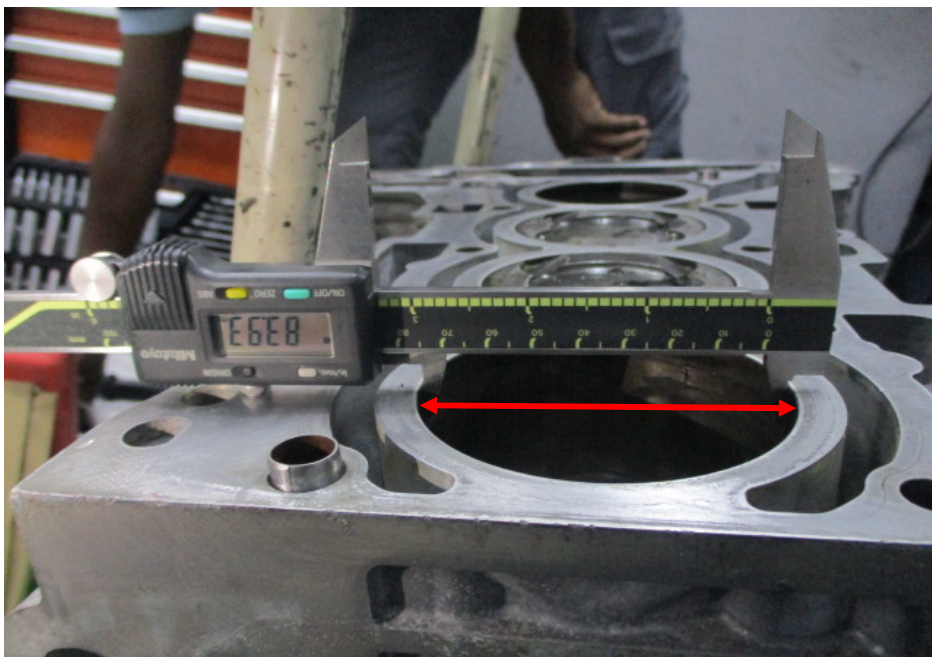
**Photo 20** shows the bore (arrowed) measurement of cylinder 4, which was recorded to be 83.93mm.

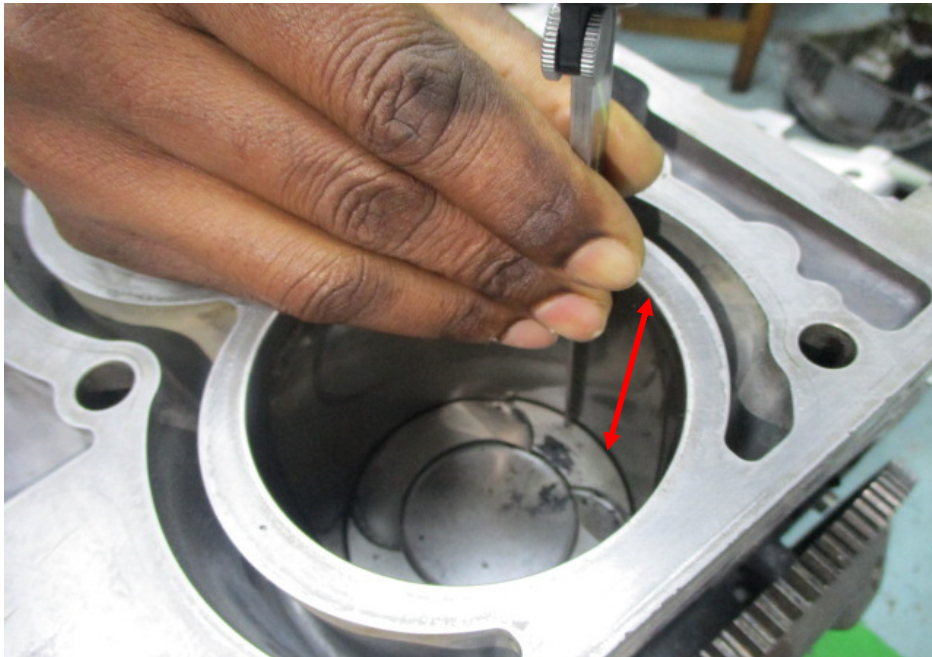
**Photo 21** shows measurement being carried out to the stroke (arrowed) of cylinder 4 of the BMW engine. The bore and stroke measurements of the BMW engine were carried out using a digital Vernier Caliper that was calibrated prior to the start of measurements.

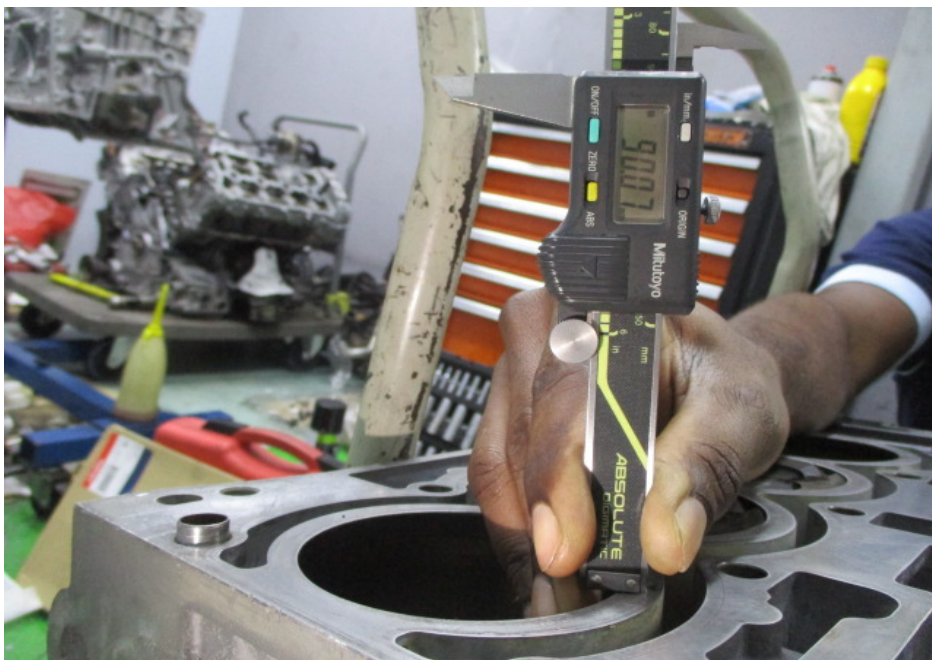
**Photo 22** shows the stroke measurement of cylinder 4, which was recorded to be 90.07mm.
