Your Ref: Toyota Engine  
(number 1AZ3121238)  
Our Ref : CI/TP21005767/D

**INSPECTION REPORT OF A TOYOTA ENGINE WITH NUMBER 1AZ3121238**

**Inspection of the Toyota Engine**

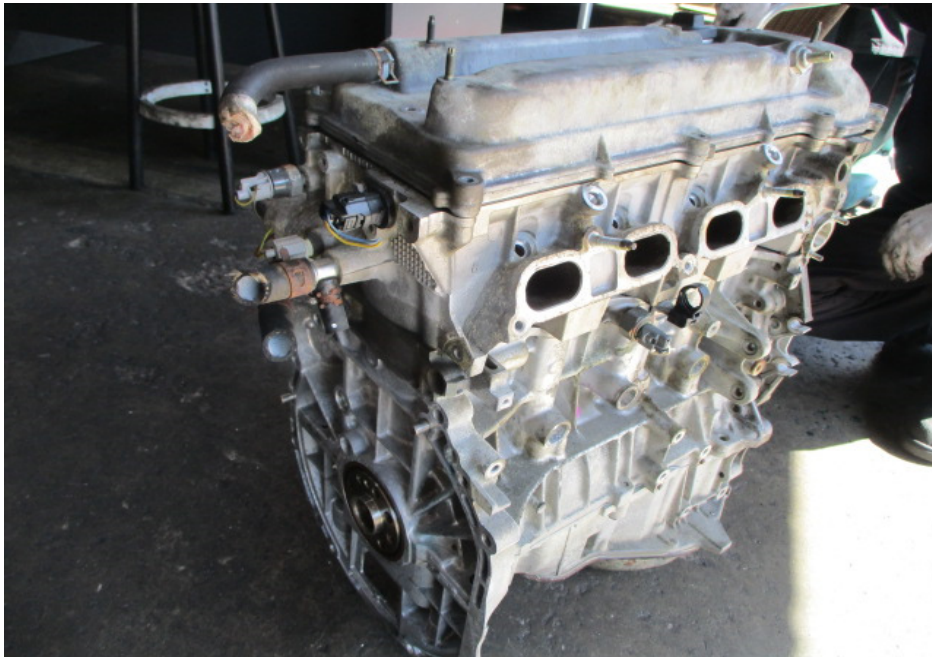
**Photo 1** shows a general view of the Toyota engine that I had inspected. The Toyota engine was observed to be a used engine and was not fitted on any motor car. It was also observed to be a complete assembly with all mechanical parts still intact, within the engine housing.

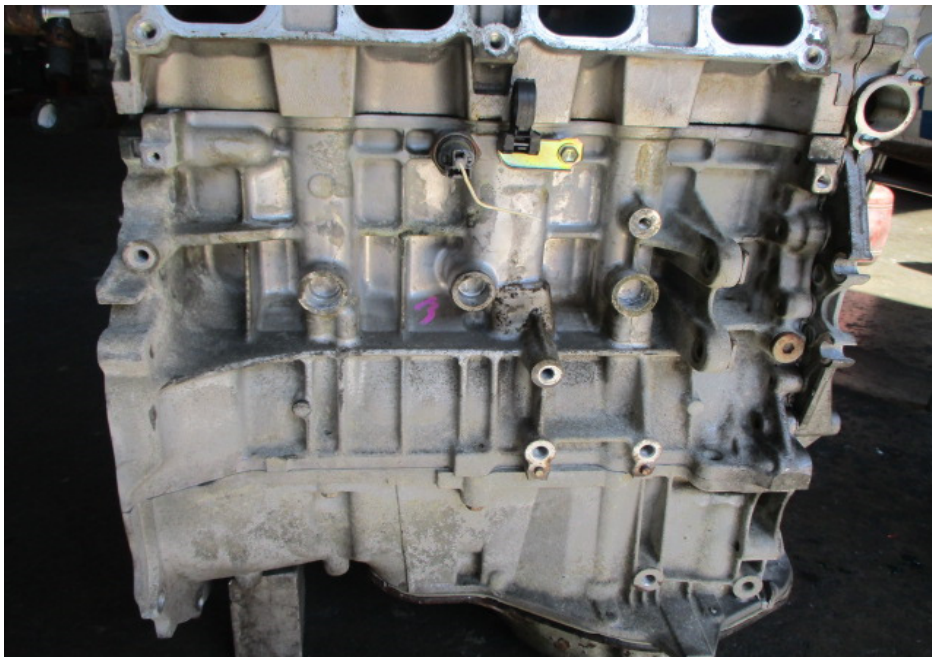
**Photo 2** shows a closer view of the Toyota engine that I had inspected. My visual examination of the engine housing revealed the housing to be of serviceable/satisfactory condition. There was no crack and/or hole observed on the engine housing.

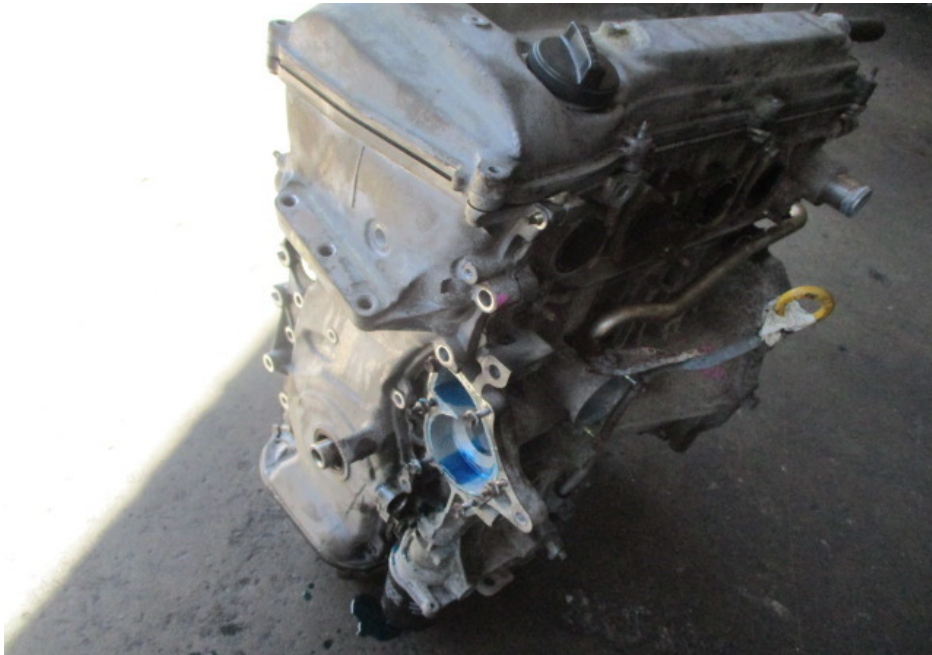
**Photo 3** shows a general view of the Toyota engine that I had inspected. My visual examination of the engine housing revealed the housing to be of serviceable/satisfactory condition. There was no crack and/or hole observed on the engine housing.

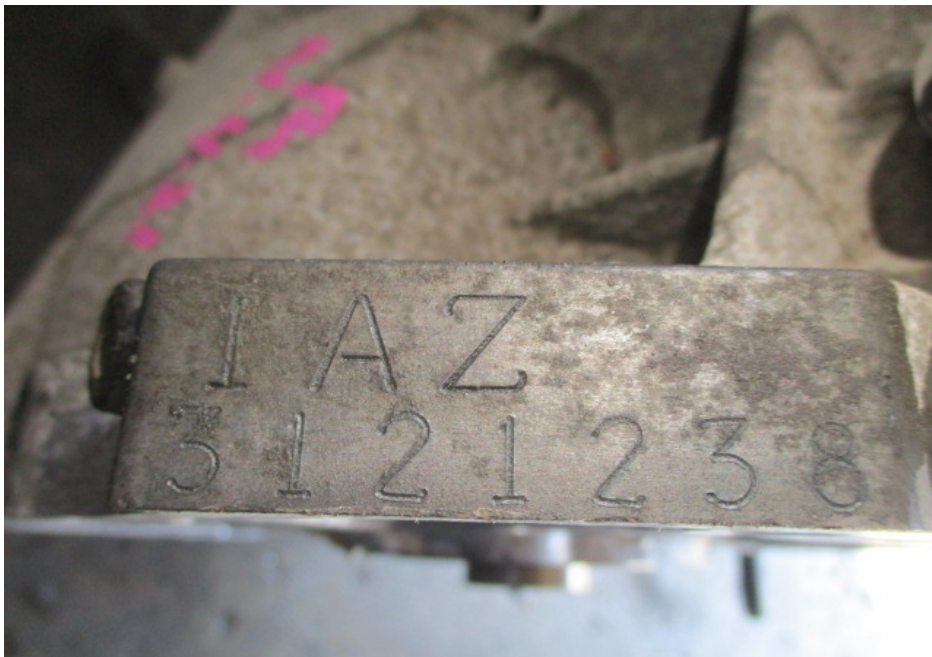
**Photo 4** shows the engine number engraved on the housing of the Toyota engine that I had inspected. The engine number was 1AZ3121238.

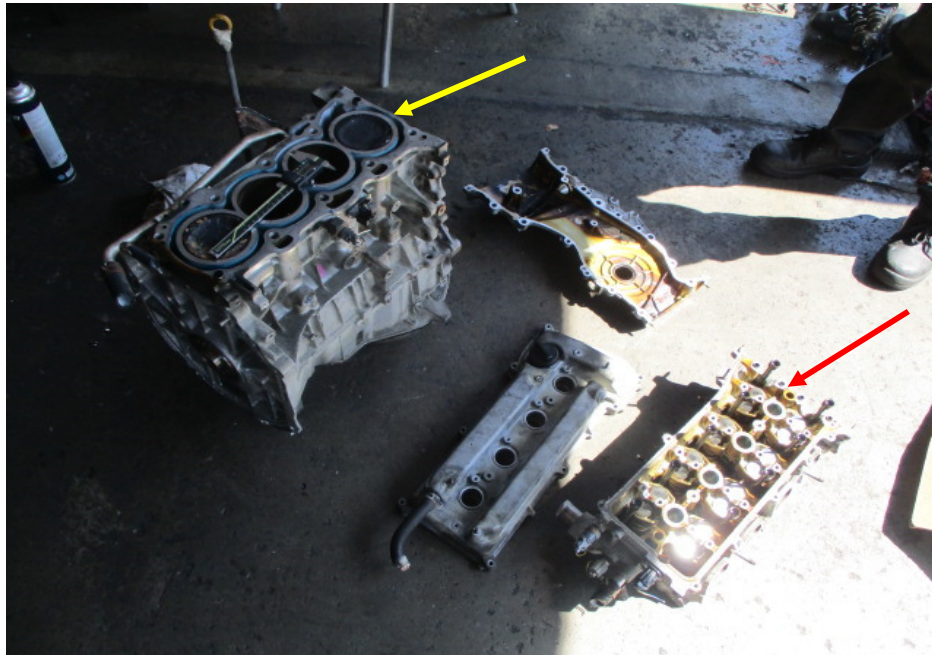
**Photo 5** shows the top block (red arrow) of the Toyota engine separated from its bottom block (yellow arrow). This was to enable me to carry out measurements of its cylinders, in particular the bore and stroke measurements of each cylinder, which typically can be used to determine the engine displacement or more commonly referred to as engine cc.

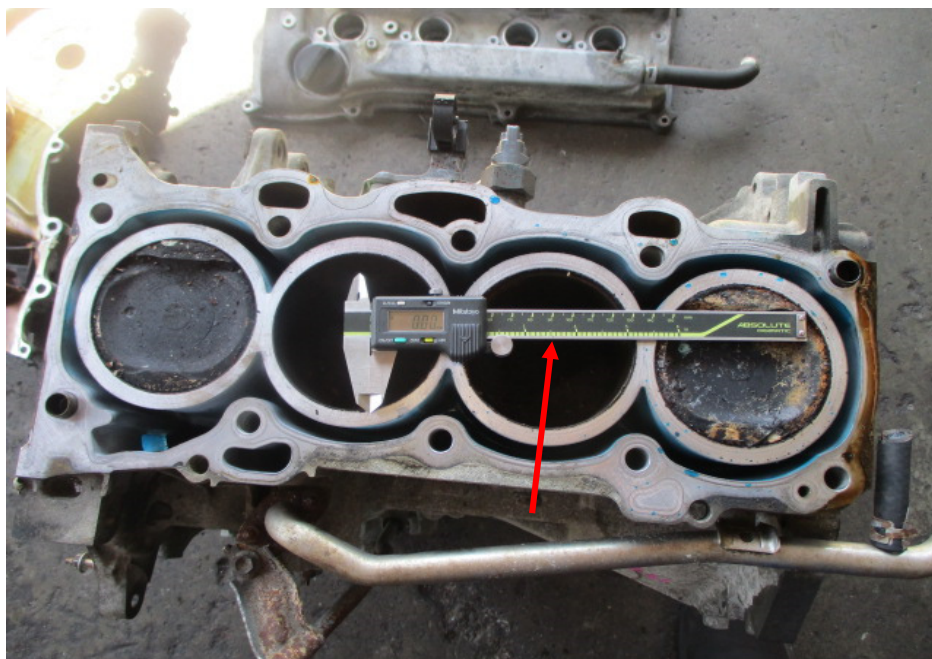
**Photo 6** shows the bottom block of the Toyota engine and the digital Vernier Caliper (arrowed) that was used to measure the bore and stroke measurements of each cylinder, which typically can be used to determine the engine displacement or more commonly referred to as engine cc. The digital Vernier Caliper was calibrated before the start of the measurements.

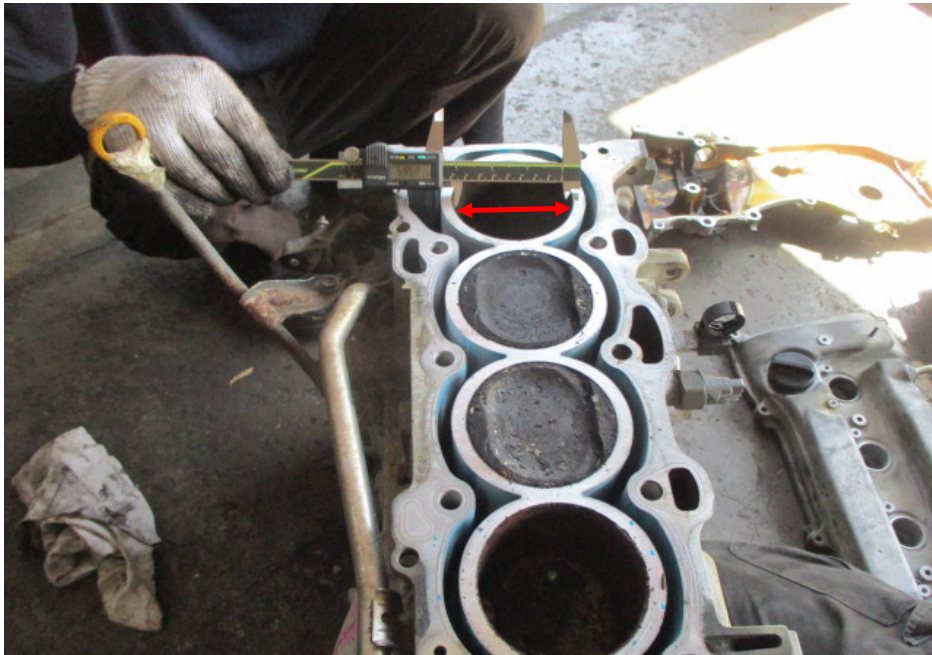
**Photo 7** shows measurement being carried out to the bore (arrowed) of cylinder 1 of the Toyota engine. The measurements were carried out using a digital Vernier Caliper that was calibrated before the start of the measurements.

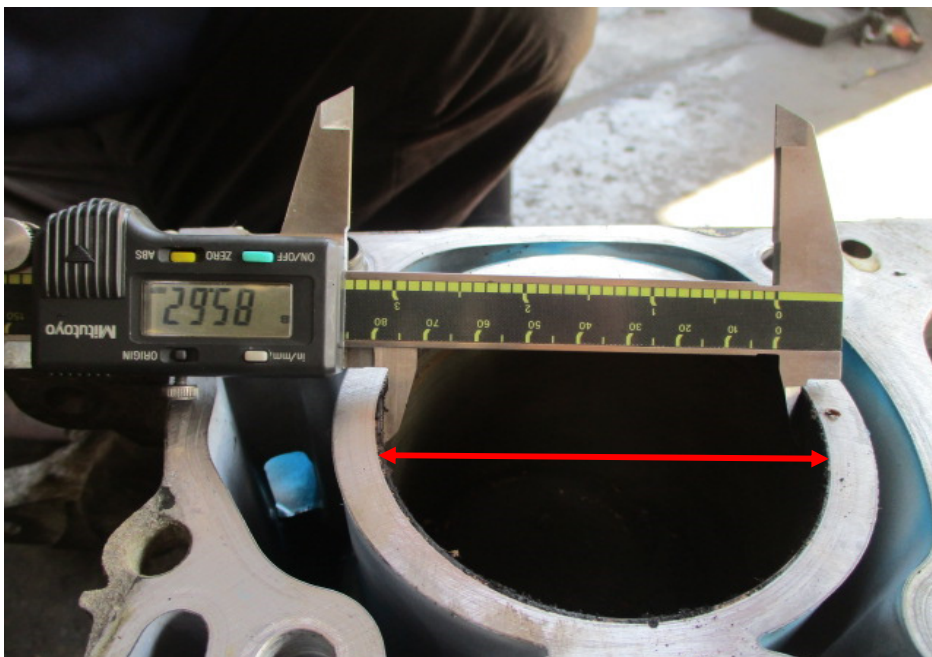
**Photo 8** shows the bore (arrowed) measurement of cylinder 1, which was recorded to be 85.62mm.

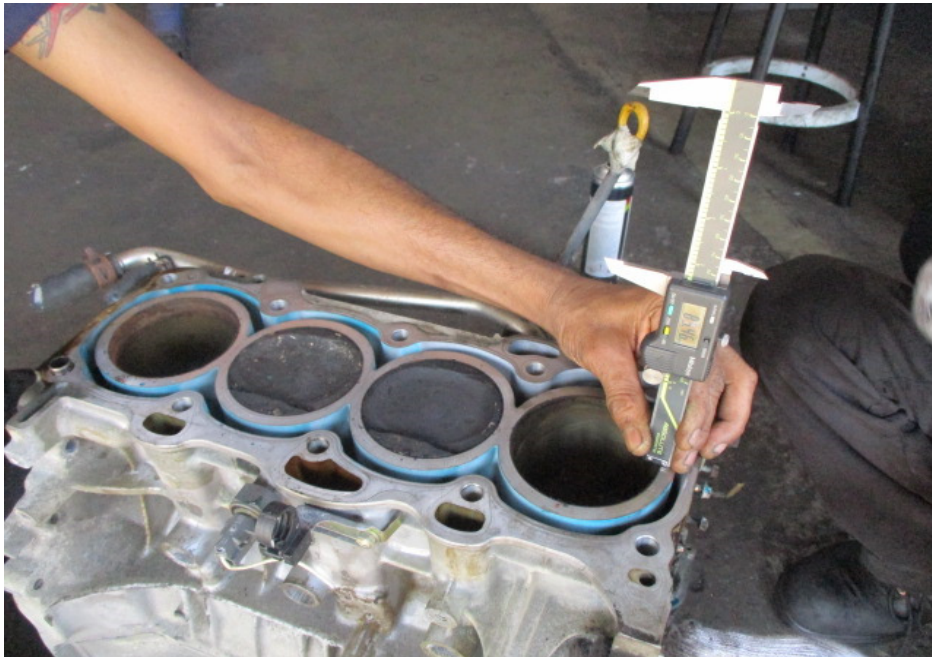
**Photo 9** shows measurement being carried out to the stroke of cylinder 1 of the Toyota engine. The bore and stroke measurements of the Toyota engine were carried out using a digital Vernier Caliper.

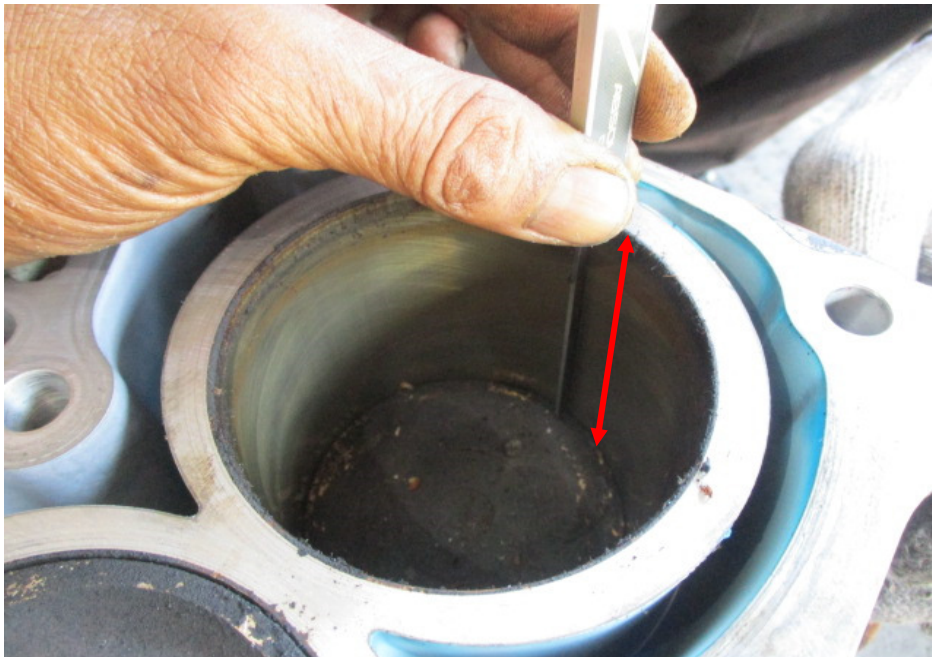
**Photo 10** shows measurement being carried out to the stroke (arrowed) of cylinder 1 of the Toyota engine. The bore and stroke measurements of the Toyota engine were carried out using a digital Vernier Caliper that was calibrated before the start of the measurements,

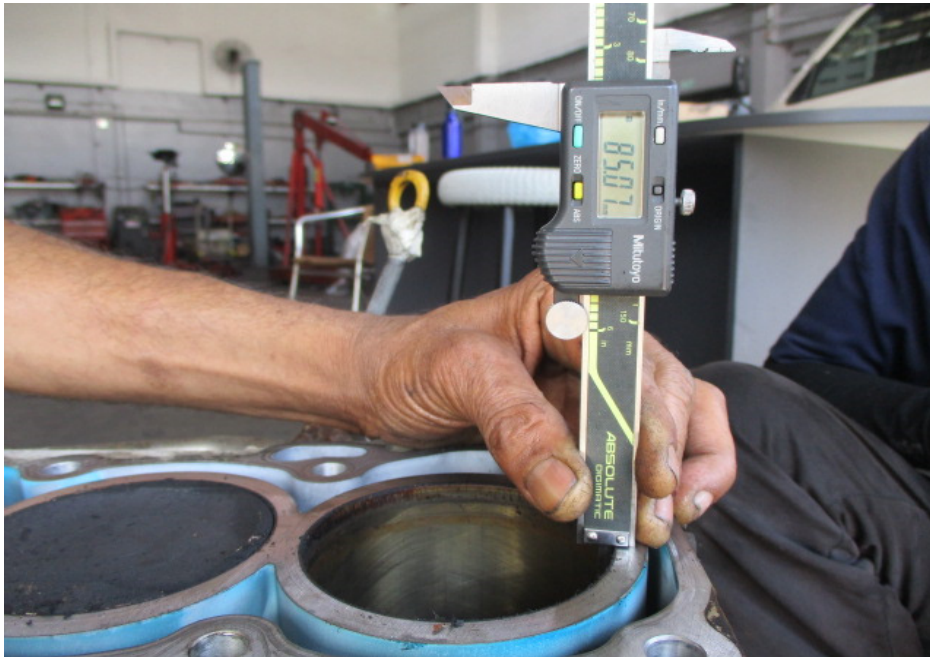
**Photo 11** shows the stroke measurement of cylinder 1, which was recorded to be 85.07mm.

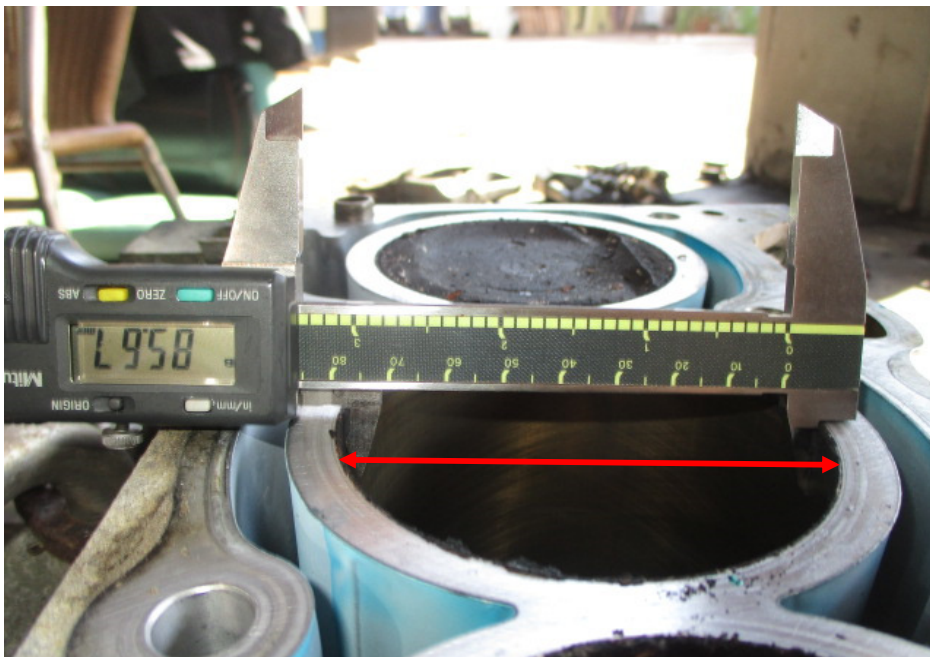
**Photo 12** shows measurement being carried out to the bore (arrowed) of cylinder 2 of the Toyota engine. The bore measurement of cylinder 2 was recorded to be 85.67mm.

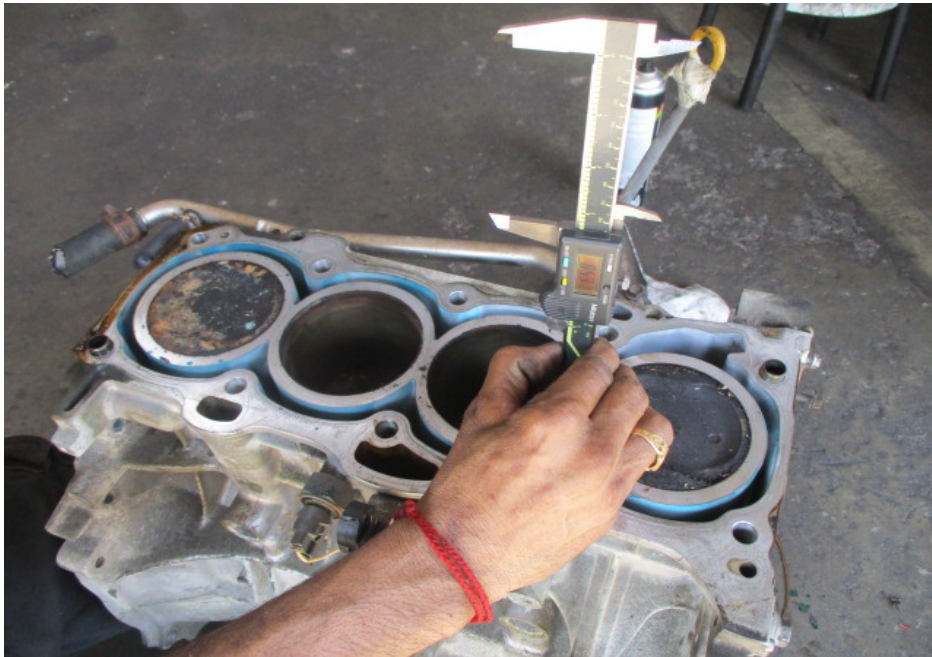
**Photo 13** shows measurement being carried out to the stroke of cylinder 2 of the Toyota engine that I had inspected.

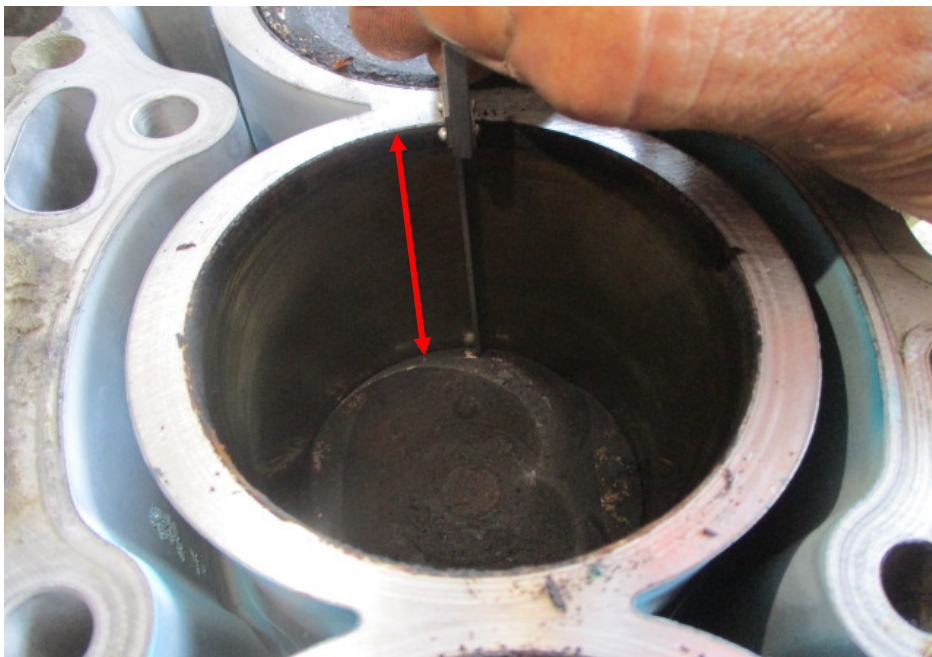
**Photo 14** shows measurement of the stroke (arrowed) for cylinder 2 of the Toyota engine that I had inspected.

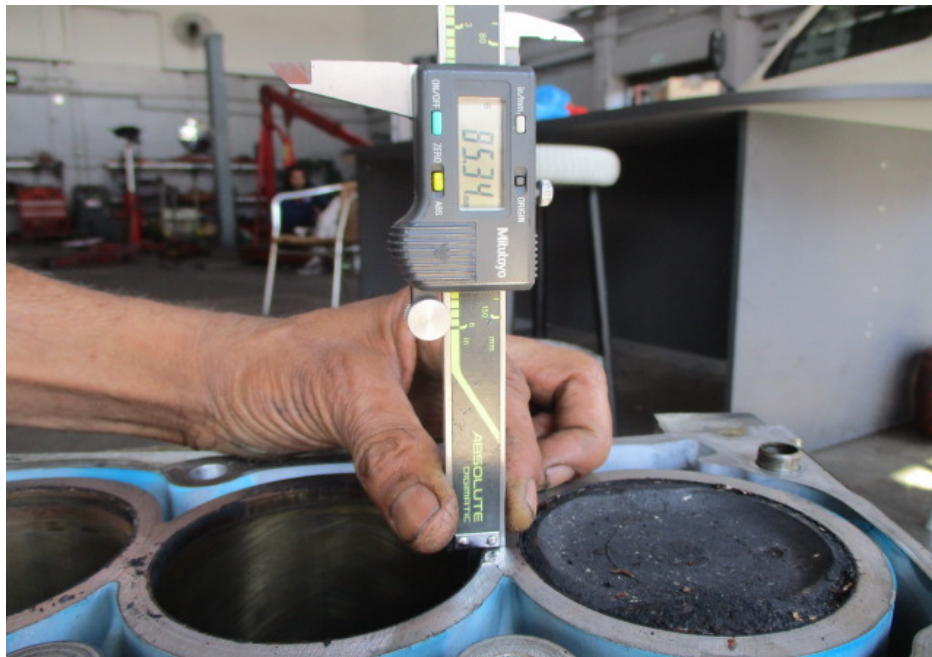
**Photo 15** shows the stroke measurement of cylinder 2, which was recorded to be 85.34mm.

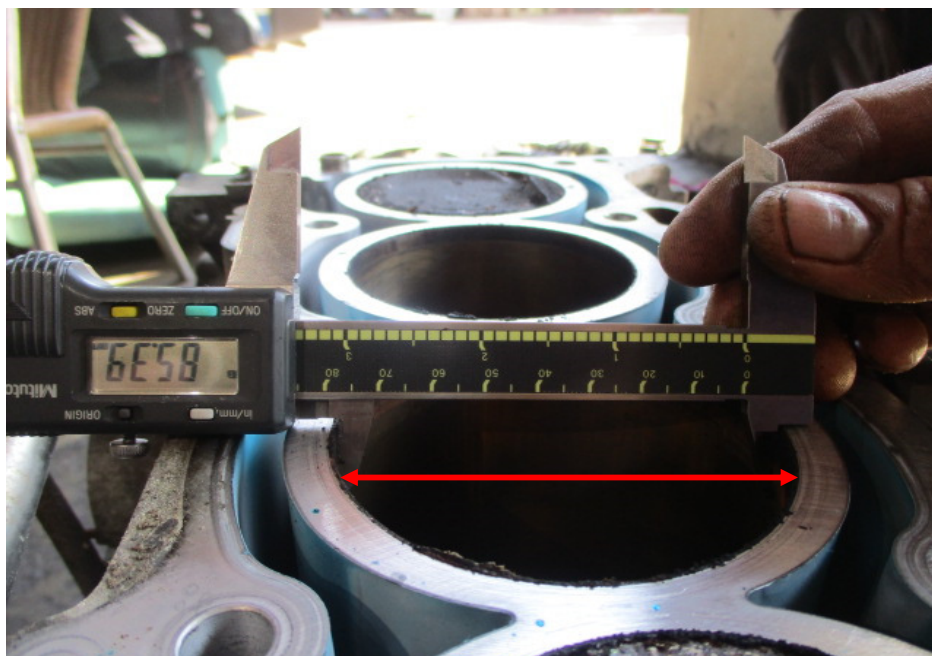
**Photo 16** shows measurement being carried out to the bore (arrowed) of cylinder 3 of the Toyota engine. The bore and stroke measurements of the Toyota engine were carried out using a digital Vernier Caliper. The bore measurement of cylinder 3 was recorded to be 85.39mm.

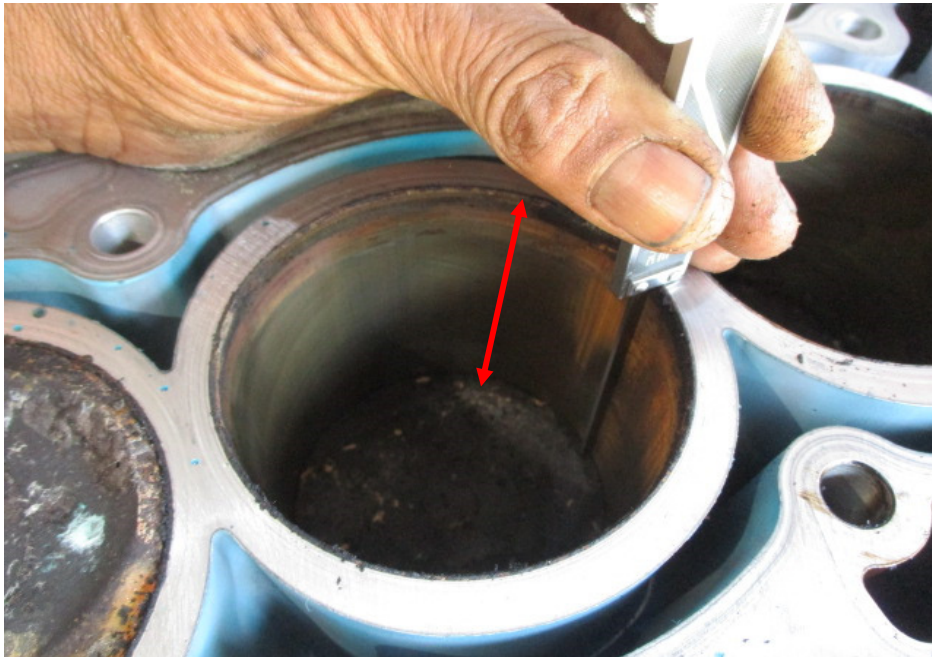
**Photo 17** shows measurement being carried out to the stroke (arrowed) of cylinder 3 of the Toyota engine. The bore and stroke measurements of the Toyota engine were carried out using a digital Vernier Caliper that was calibrated before the start of measurements.

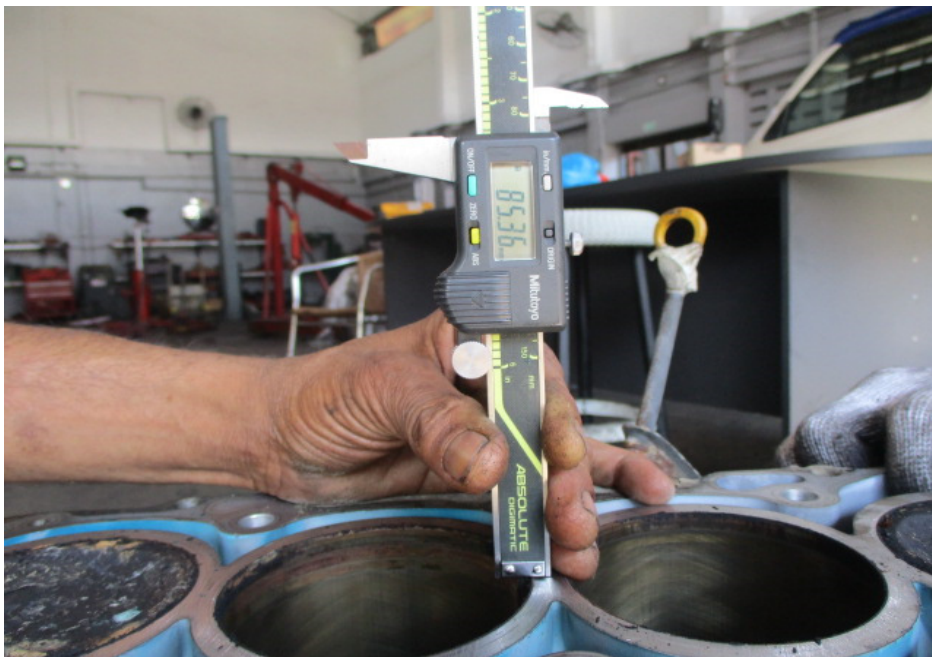
**Photo 18** shows the stroke measurement of cylinder 3, which was recorded to be 85.36mm.

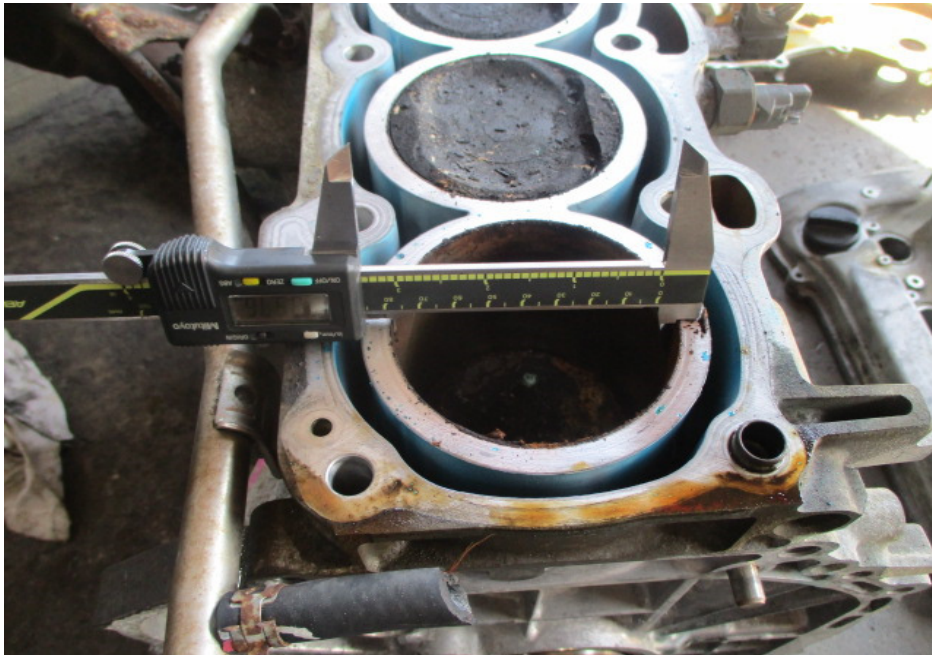
**Photo 19** shows measurement being carried out to the bore of cylinder 4 of the Toyota engine. The bore and stroke measurements of the Toyota engine were carried out using a digital Vernier Caliper.

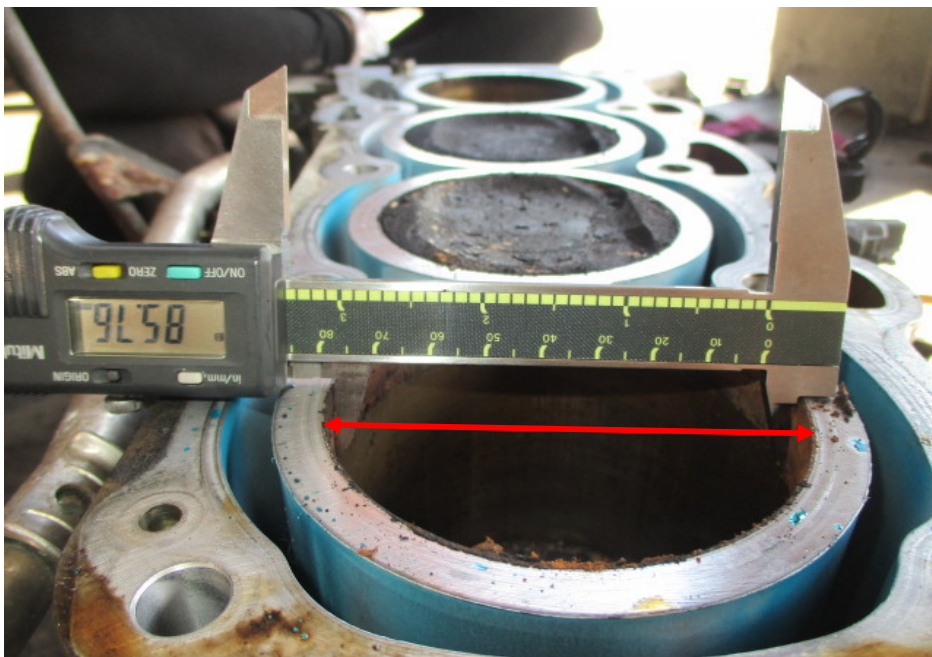
**Photo 20** shows the bore (arrowed) measurement of cylinder 4, which was recorded to be 85.76mm.

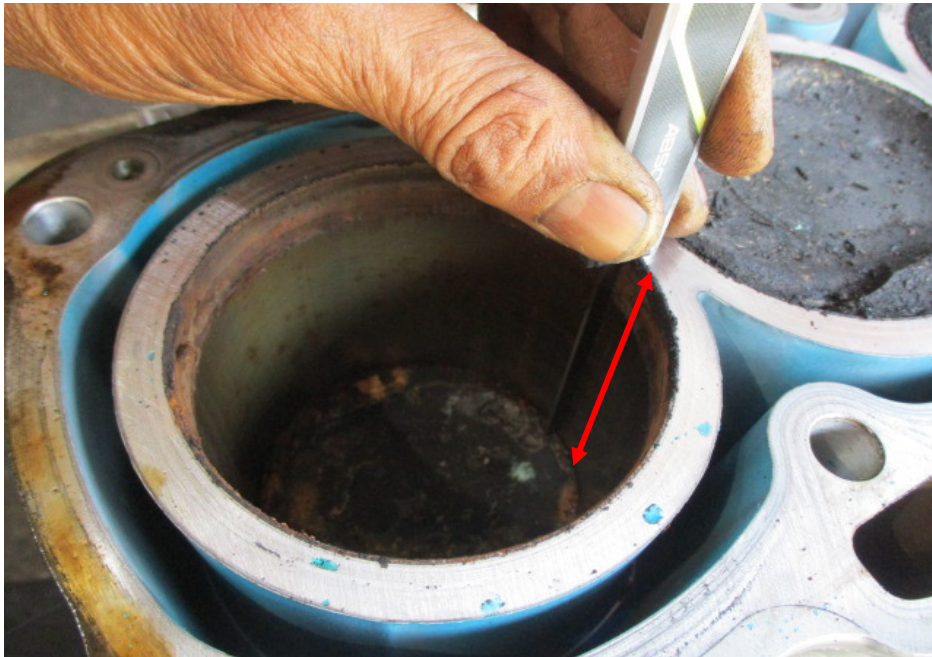
**Photo 21** shows measurement being carried out to the stroke (arrowed) of cylinder 4 of the Toyota engine. The bore and stroke measurements of the Toyota engine were carried out using a digital Vernier Caliper that was calibrated prior to the start of measurements.

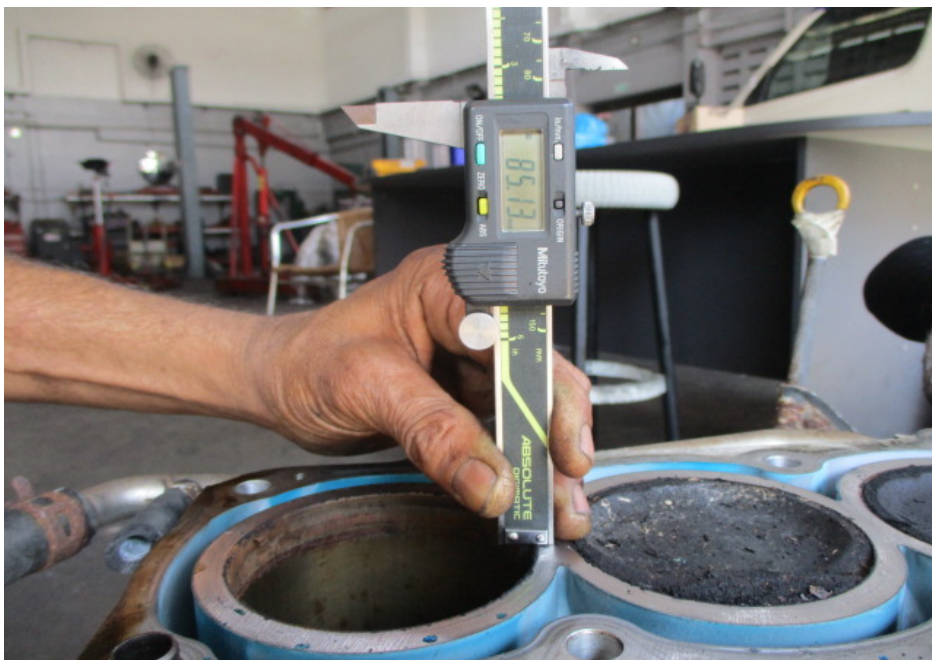
**Photo 22** shows the stroke measurement of cylinder 4, which was recorded to be 85.13mm.
