**RE: [Seek Instruction] - AIG Ref: 2940273368SG// LKK Ref: CC4/AIG21006059/Kpa3
[ACCIDENT INVOLVING SKT 1933R(OI) AND SMZ 1535B(TP) ON 14/05/2021]**

**AUTOMOBILE TECHNICAL INVESTIGATION REPORT OF ACCIDENT
INVOLVING SKT 1933R AND SMZ 1535B ON 14 MAY 2021**

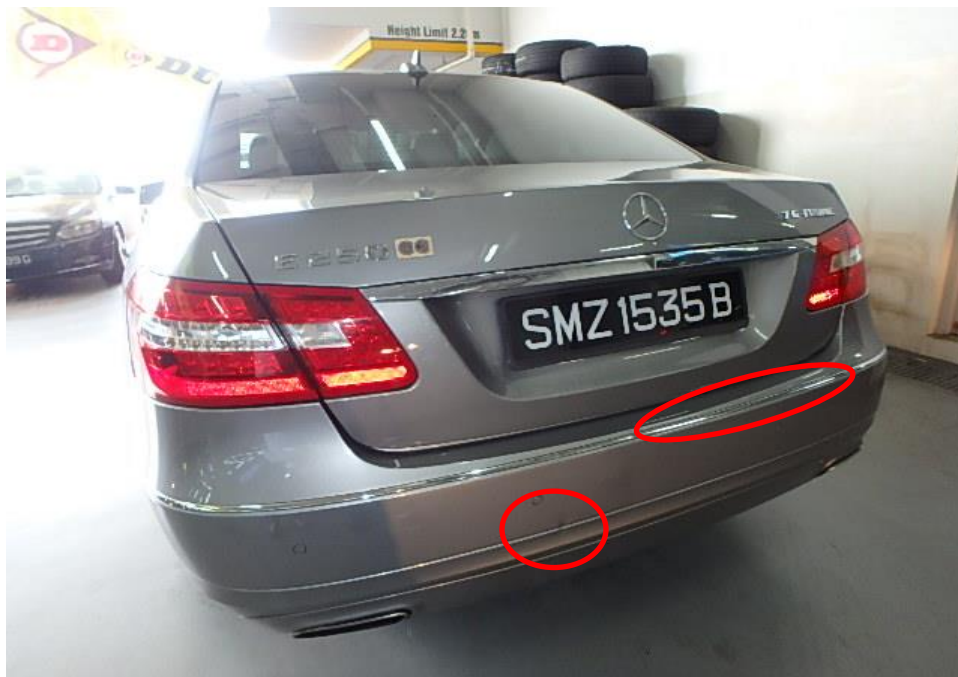
8. From the Vehicle Damage Inspection Report of Third Party by LKK Auto Consultants Pte. Ltd., we note that the Third Party had sustained damage onto its rear bumper portion. The main body part(s) listed as damaged in the report was the rear bumper and this was depicted in the photographs that were attached in the aforesaid report.
9. Examination of these photographs showed the rear bumper had been damaged. It was also noted that there were paint crack marks and dents on the rear bumper of Third Party. However there was neither a dislodgement nor misalignment of the rear bumper at the rear portion of Third Party See photos 1 – 4 below.

Photo 1 shows the general view of the rear portion of Third Party at the time of inspection. The rear bumper had been damaged. It was also noted that there were paint crack marks and dents (circled) on the rear bumper of Third Party.

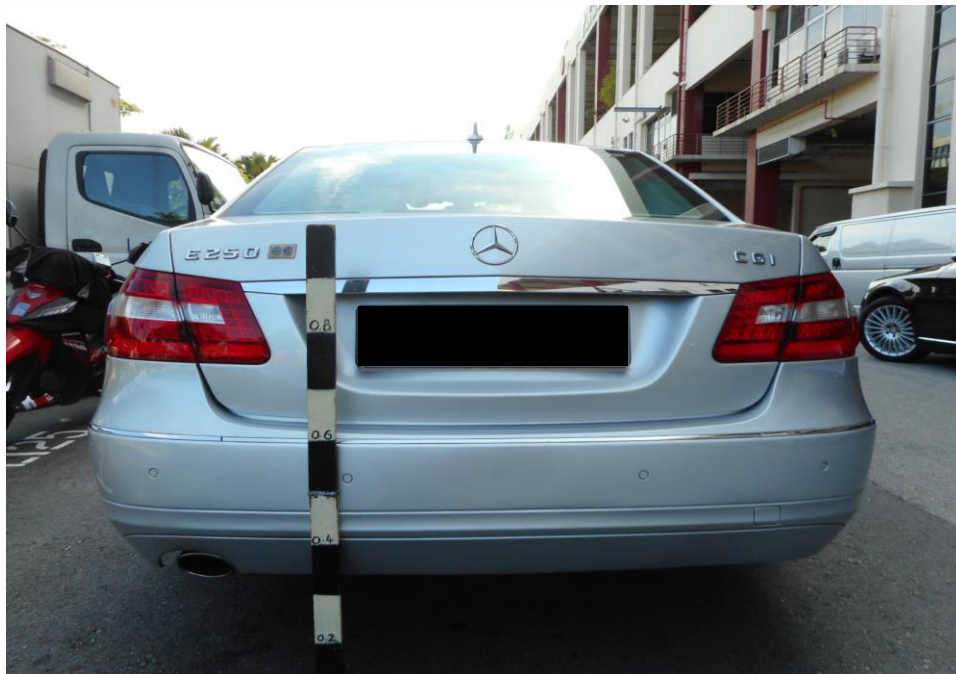
16. We had conducted a height configuration test to determine whether the damage observed on the rear portion of Third Party could have possibly been caused by the front portion of Insured. In order to determine this, we had measured the height above ground level of the damaged area on the rear portion of Third Party. We had thereafter compared this measured height against the front portion of Insured. See photos 8 -11 below.

Photo 8 shows the general view of the height measurement being conducted on the rear portion of Third Party. The height above ground level of where the damages were found to the rear bumper of the Third Party was at 58cm and 46cm.

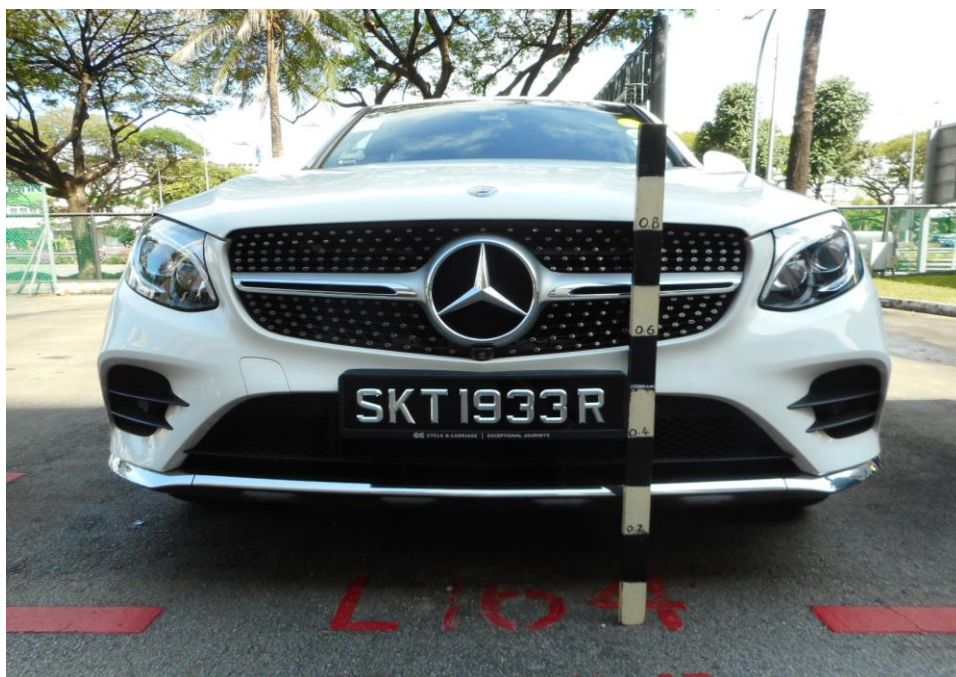
Photo 9 shows a general view of the height measurement being conducted on the front portion of Insured. The crack marks found on the front number plate holder was measured to be between 48cm to 53cm above ground level.
