## ASSIGNMENT

Insured: SLX 55Z

Veh No: SMW 7030 Yr Regn: 12, 20

Make: Honda Shuttle c.c. 1496

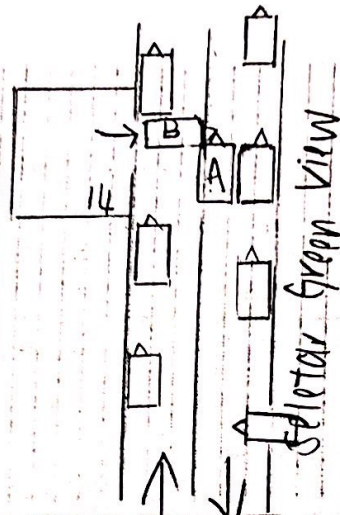
# Sketch Plan

A: SMW 7030S  
(alone)

B: SLX 55Z  
Porsche  
lady driver (alone)

I was driving along Selekar Green View towards the main road. Out of a sudden, felt an impact on my car front LH portion. Motor car SLX 55Z had drove out of her house without checking and collided onto my bypass vehicle front LH portion. Upon alighting, driver of SLX 55Z merely told me to leave it the legal way, called out her hubby to talk to me and drove another family car out. As her hubby has refused to provide any other information on driver of SLX 55Z, i took some scene photos and called for towing services to the nearest Authorised workshop. No one was injured.
