Your Ref: Honda Engine
(number K20C11002418)
Our Ref : CI/TP21006888/D

INSPECTION REPORT OF A HONDA ENGINE WITH NUMBER K20C11002418

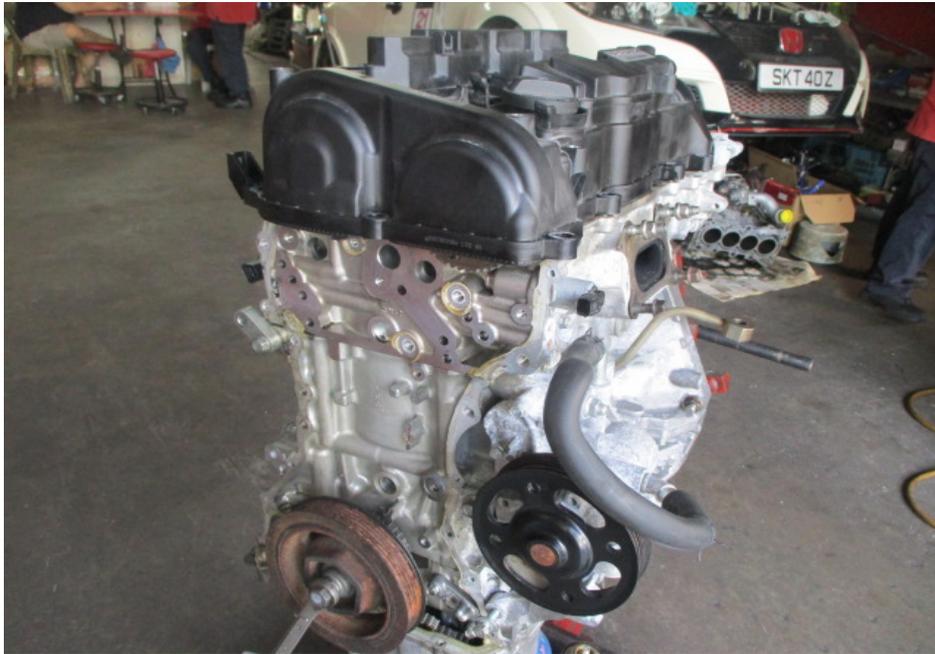
Photo 1 shows a general view of the Honda engine that I had inspected. The Honda engine was observed to be a used engine and was not fitted on any motor car. It was also observed to be a complete assembly with all mechanical parts still intact, within the engine housing.

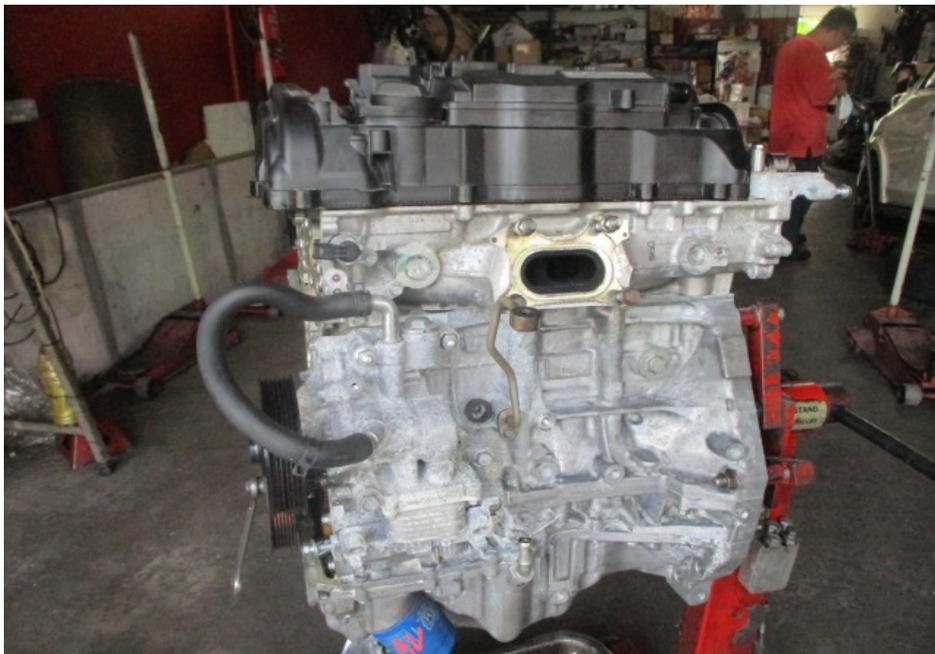
Photo 2 shows a general view of the Honda engine that I had inspected. My visual examination of the engine housing revealed the housing to be in serviceable/satisfactory condition. There was no crack and/or hole observed on the engine housing.

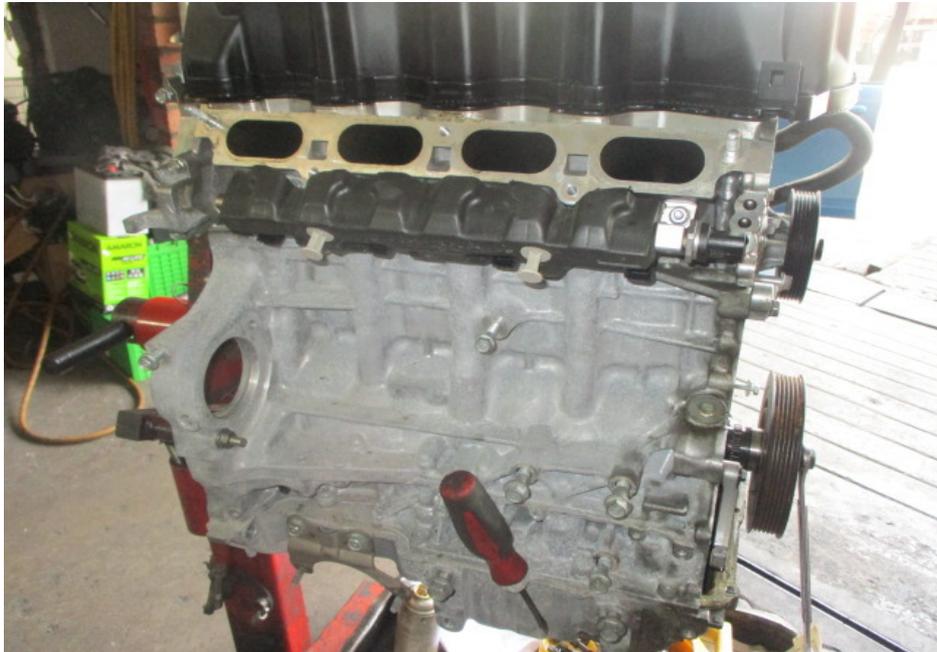
Photo 3 shows a general view of the Honda engine that I had inspected. My visual examination of the engine housing revealed the housing to be of serviceable/satisfactory condition. There was no crack and/or hole observed on the engine housing.

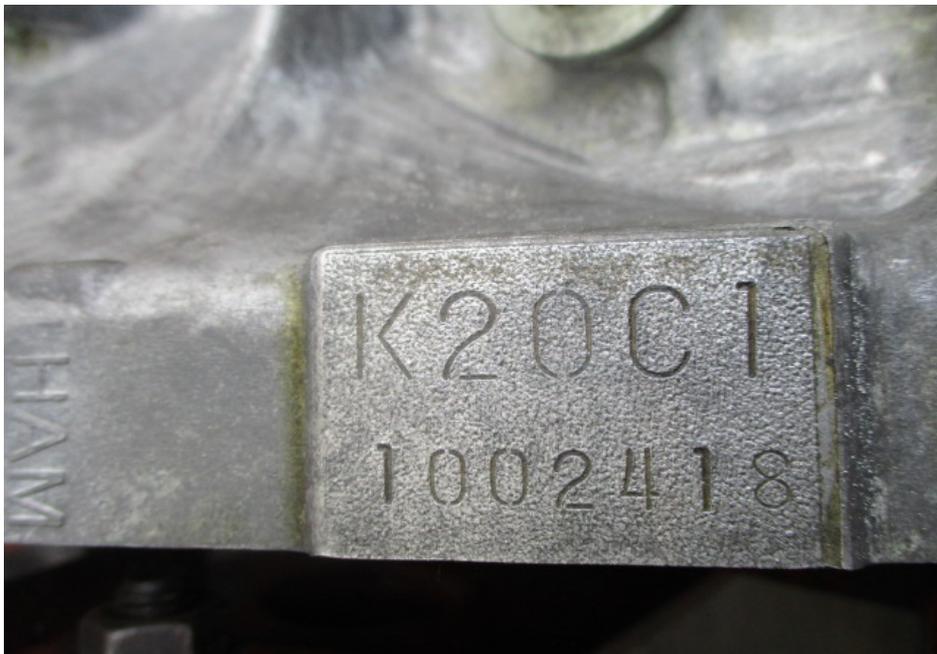
Photo 4 shows the engine number engraved on the housing of the Honda engine that I had inspected. The engine number was K20C11002418.

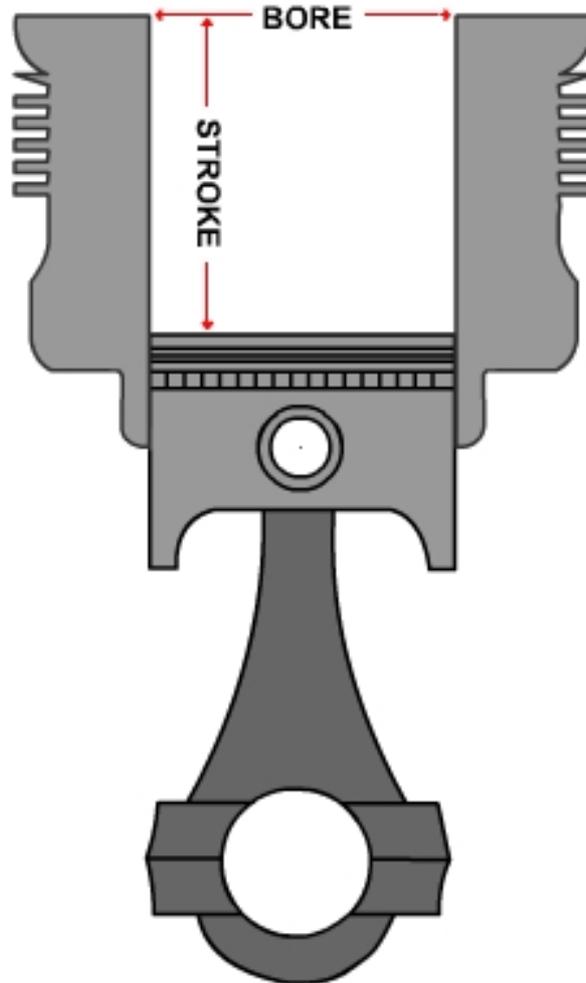
9. The bore refers to the measurement of the inside diameter of the cylinder while the stroke refers to the distance the piston moves in one direction of upward or downward movement in the cylinder. See diagram below for illustration purposes.

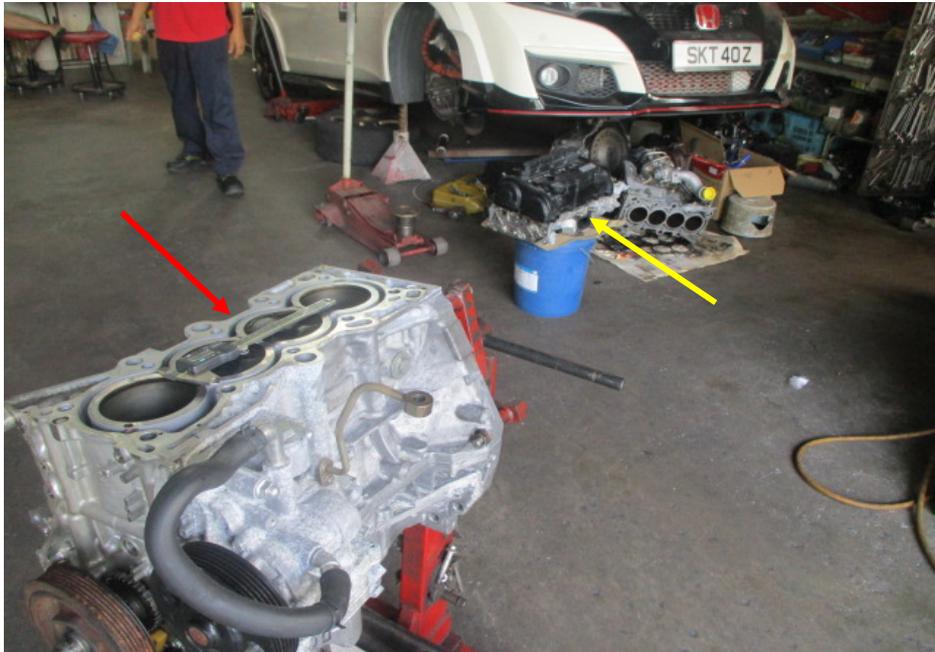
Photo 5 shows the top block (yellow arrow) of the Honda engine separated from its bottom block (red arrow). This was to enable me to carry out measurements of its cylinders, in particular the bore and stroke measurements of each cylinder, which typically can be used to determine the engine displacement or more commonly referred to as engine cc.

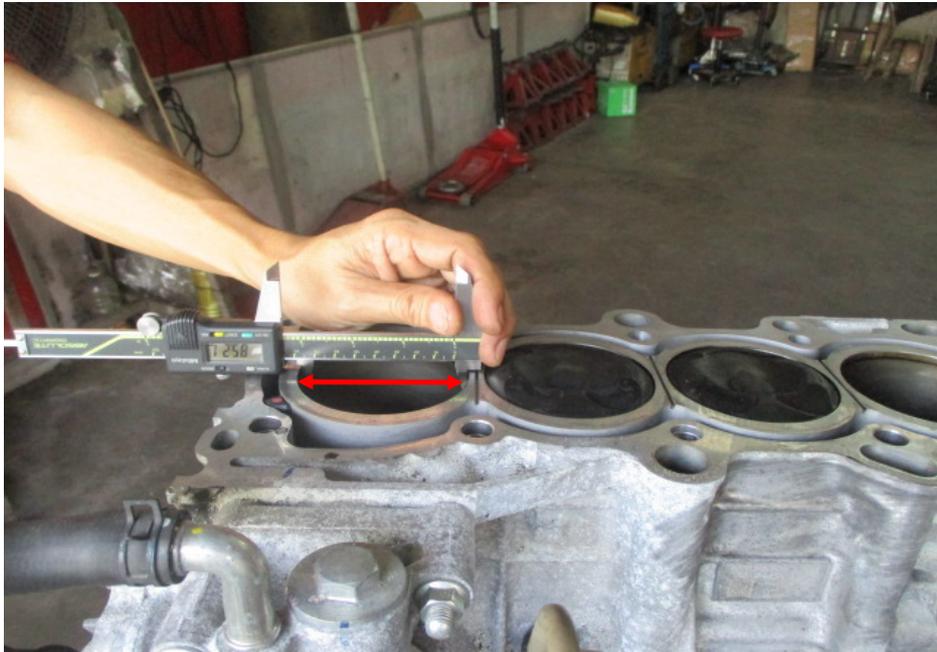
Photo 7 shows measurement being carried out to the bore (arrowed) of cylinder 1 of the Honda engine. The bore and stroke measurements were carried out using a digital Vernier Caliper that was calibrated before the start of the measurements.

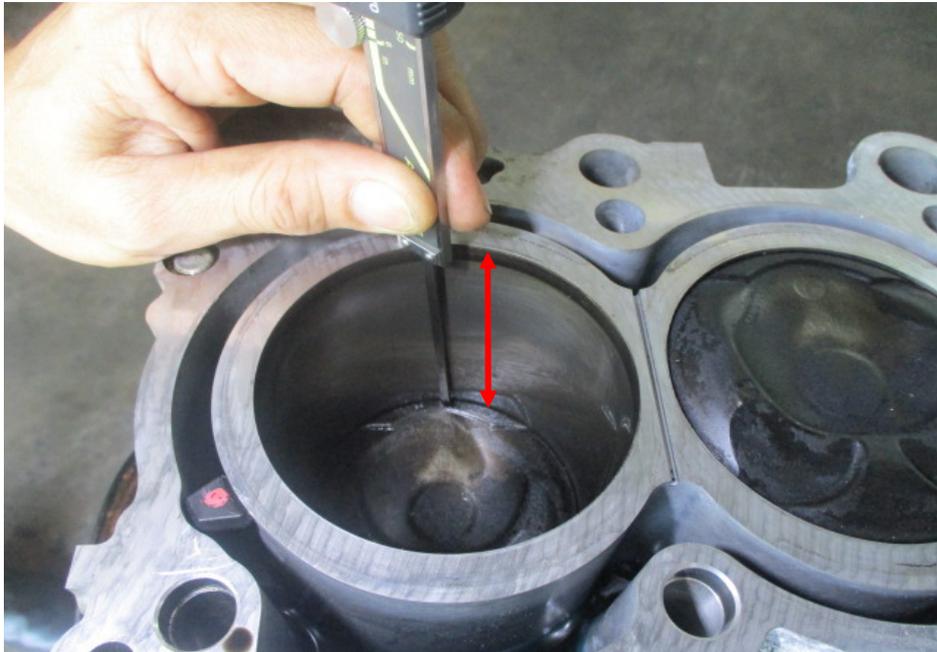
Photo 9 shows measurement being carried out to the stroke (arrows) of cylinder 1 of the Honda engine. The bore and stroke measurements were carried out using a digital Vernier Caliper that was calibrated before the start of the measurements.

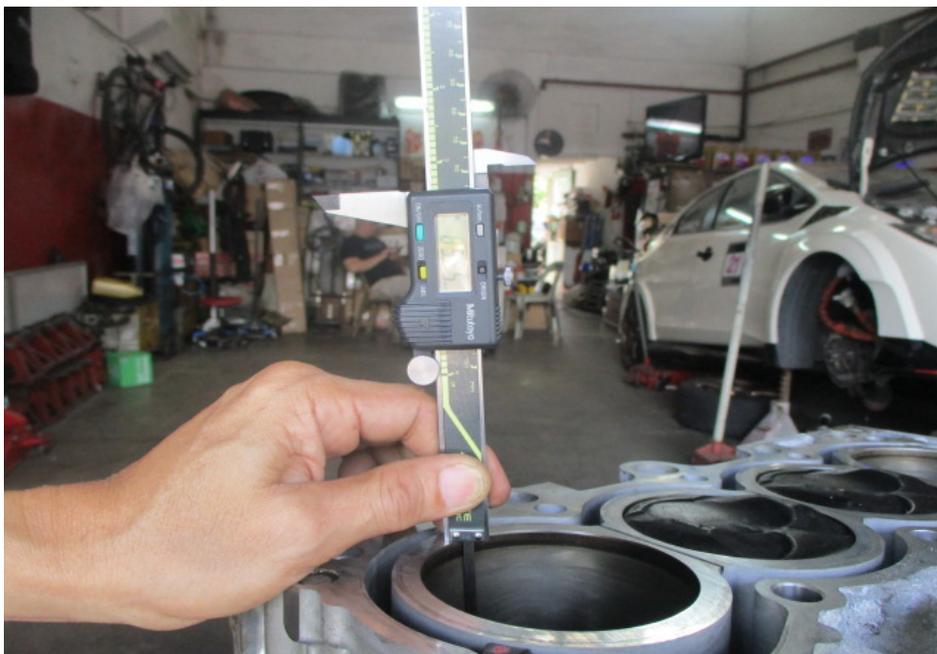
Photo 10 shows measurement being carried out to the stroke of cylinder 1 of the Honda engine. The bore and stroke measurements were carried out using a digital Vernier Caliper that was calibrated before the start of the measurements.

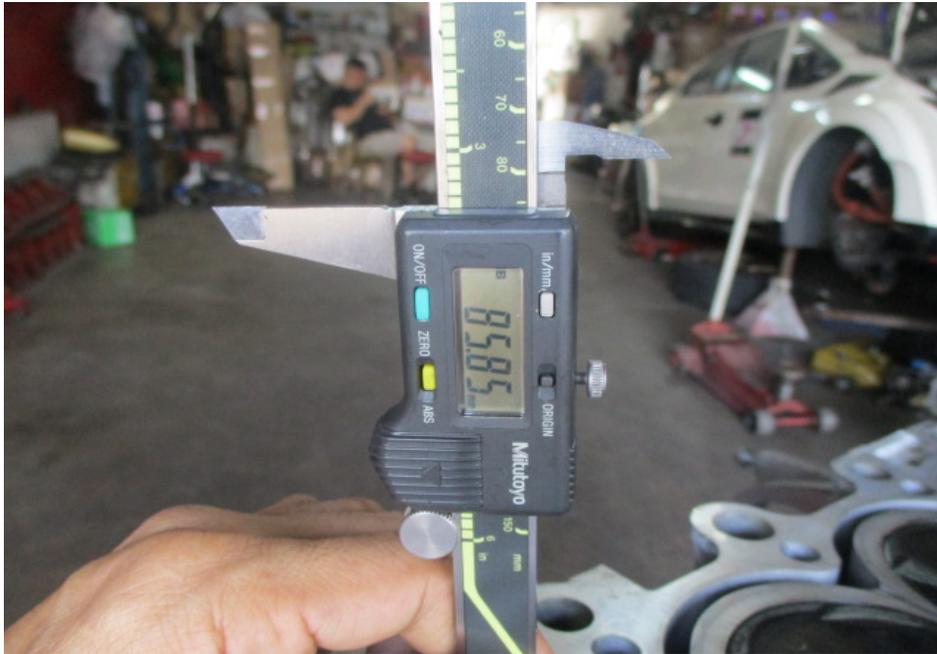
Photo 11 shows the stroke measurement of cylinder 1, which was recorded to be 85.85mm.

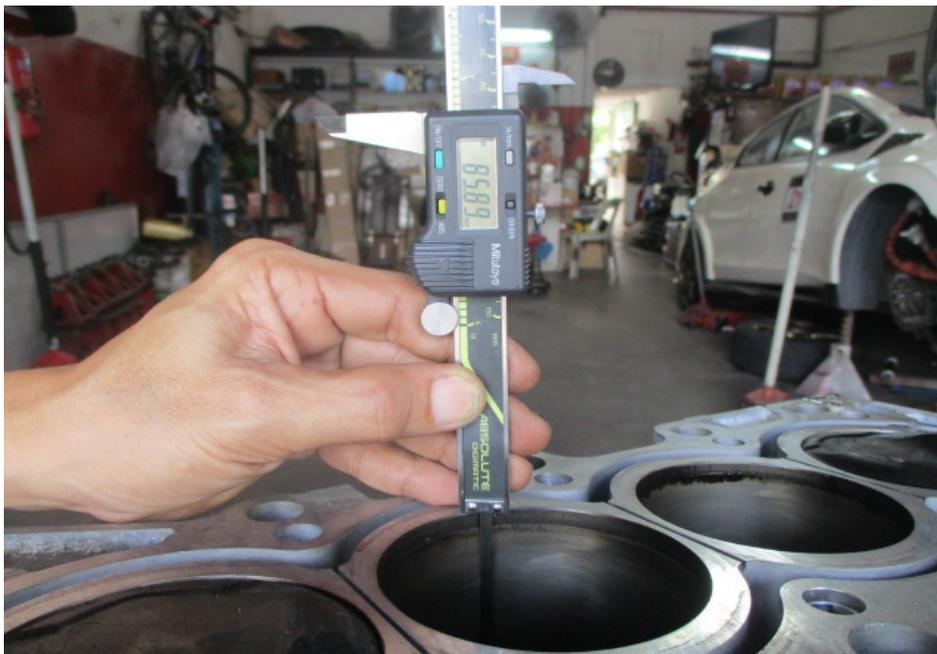
Photo 14 shows the stroke measurement of cylinder 2, which was recorded to be 85.89mm.

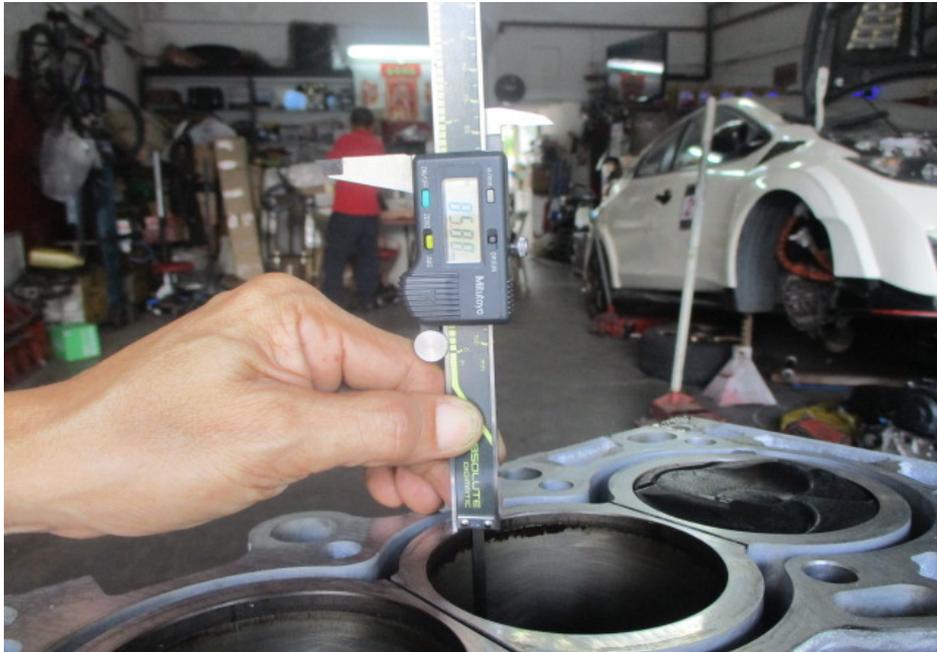
Photo 17 shows measurement of the stroke for cylinder 3 of the Honda engine that I had inspected. The bore and stroke measurements of the Honda engine were carried out using a digital Vernier Caliper that was calibrated before the start of measurements.

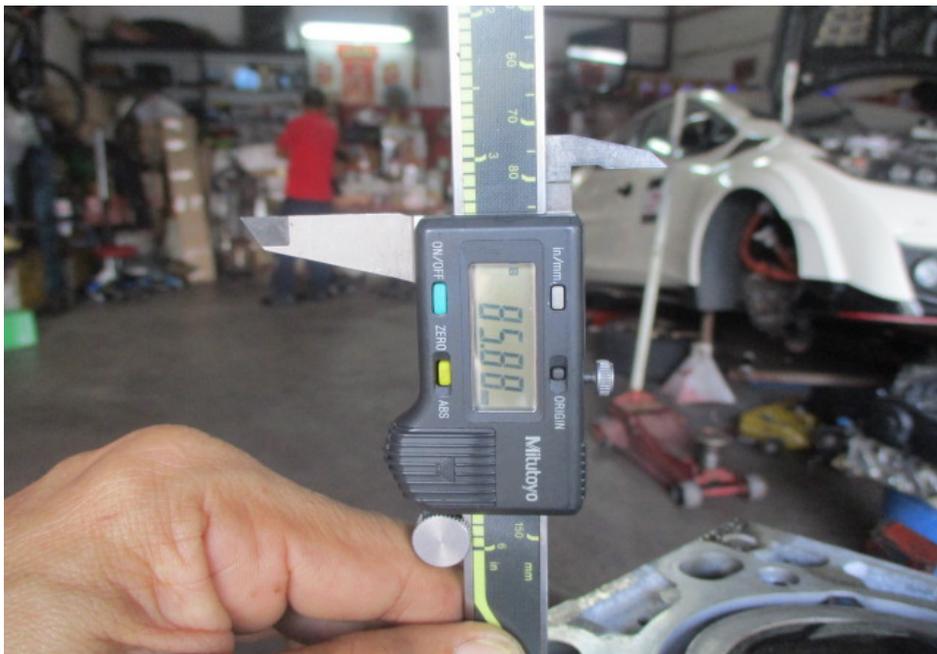
Photo 18 shows the stroke measurement of cylinder 3, which was recorded to be 85.88mm.

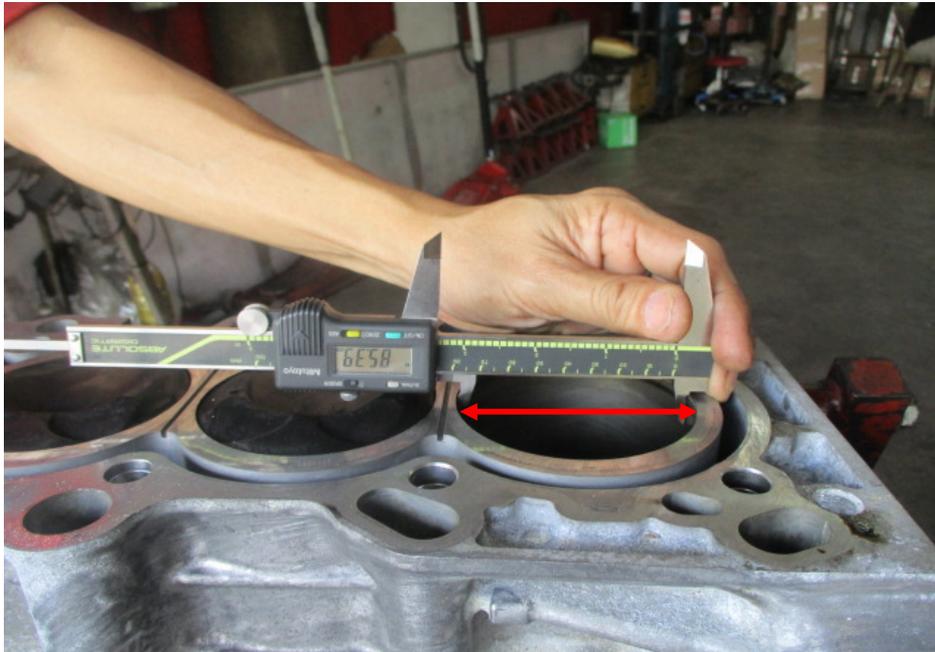
Photo 19 shows measurement being carried out to the bore (arrowed) of cylinder 4 of the Honda engine. The bore measurement of cylinder 4 was recorded to be 85.39mm.

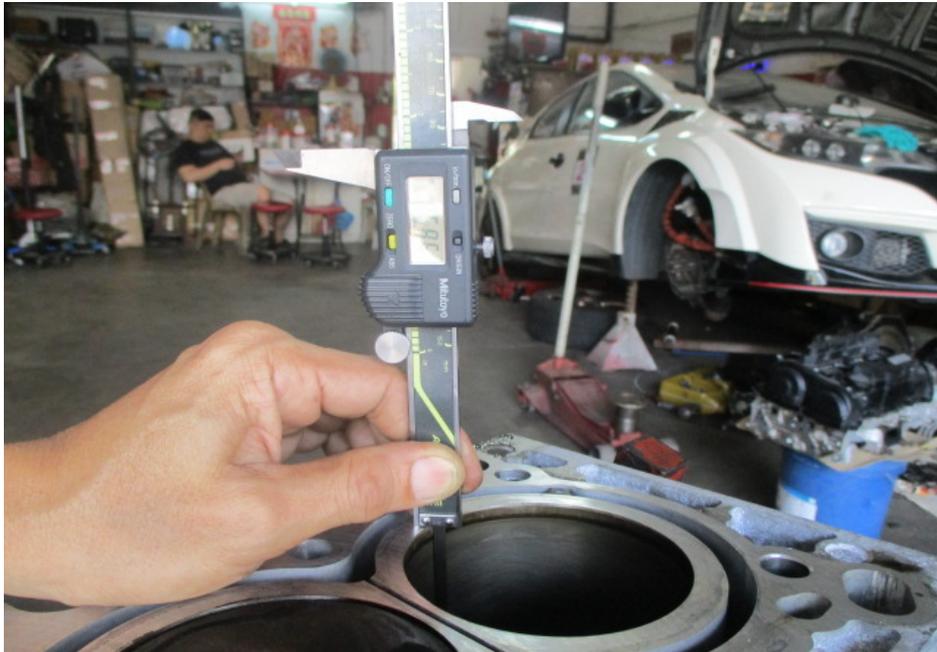
Photo 21 shows measurement being carried out to the stroke of cylinder 4 of the Honda engine. The bore and stroke measurements of the Honda engine were carried out using a digital Vernier Caliper that was calibrated prior to the start of measurements.

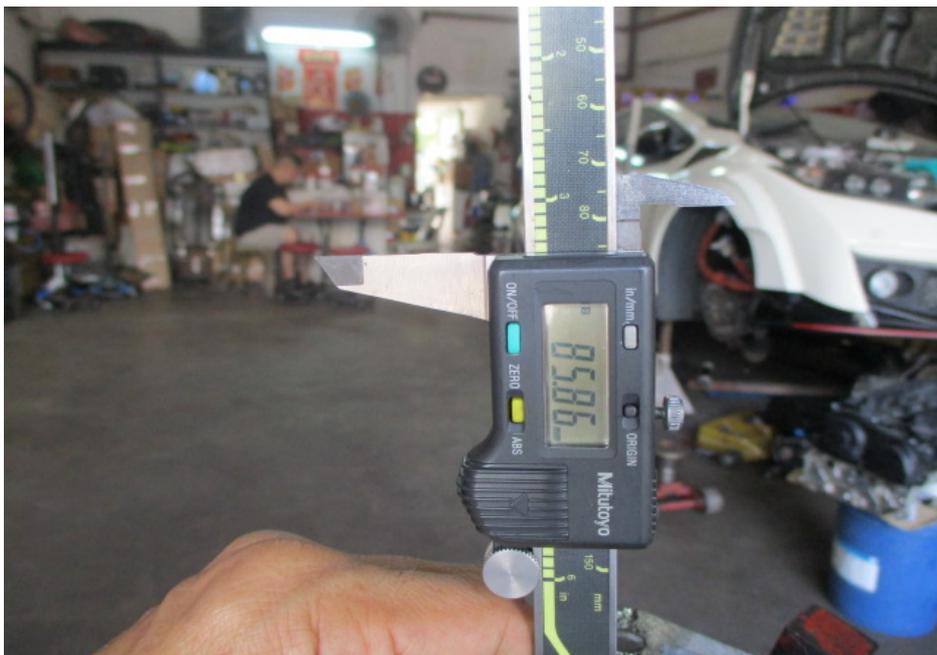
Photo 22 shows the stroke measurement of cylinder 4, which was recorded to be 85.86mm.

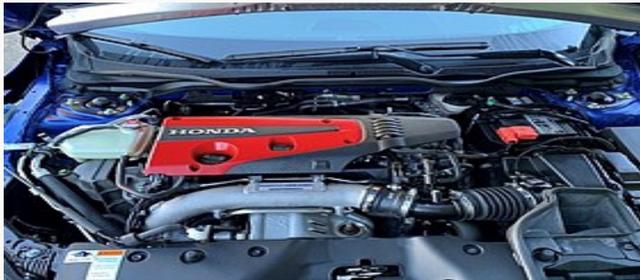
13. Since the bore and stroke of the Honda engine had corresponded to a Honda K20C model engine, the engine displacement of the Honda engine that I had inspected would then be 1996cc. See technical specifications of Honda K20C model engines below.

Overview	
Manufacturer	Honda Motor Co., Ltd.
Production	2015-present
Layout	
Configuration	L4
Displacement	2.0 L; 121.8 cu in (1,996 cc) ←
Cylinder bore	86 mm (3.386 in) ←
Piston stroke	85.9 mm (3.382 in) ←
