Your Ref: SGV 9594U
Our Ref : CI/TP21007549/D

AUTOMOBILE INSPECTION REPORT OF MOTOR CAR SGV 9594U

Vehicle Registration No.	: SGV 9594U
Make / Model	: BMW 320i
Chassis No	: WBACB22090FA05355
Year of Registration	: 1992 (April)
Mileage	: N.A.

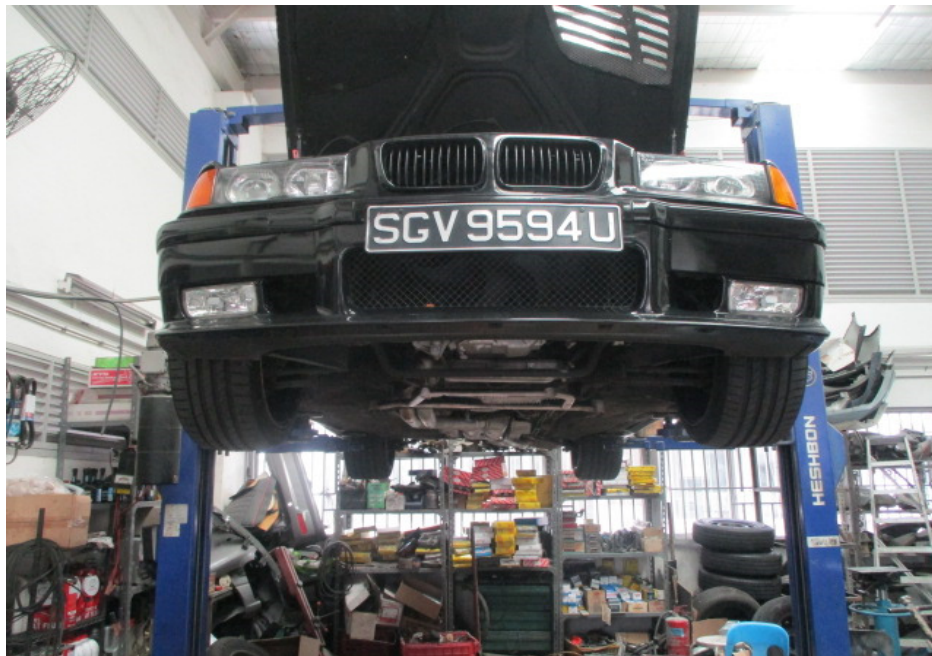
Photo 1 shows the Motor Car hoisted up at the time of my inspection.

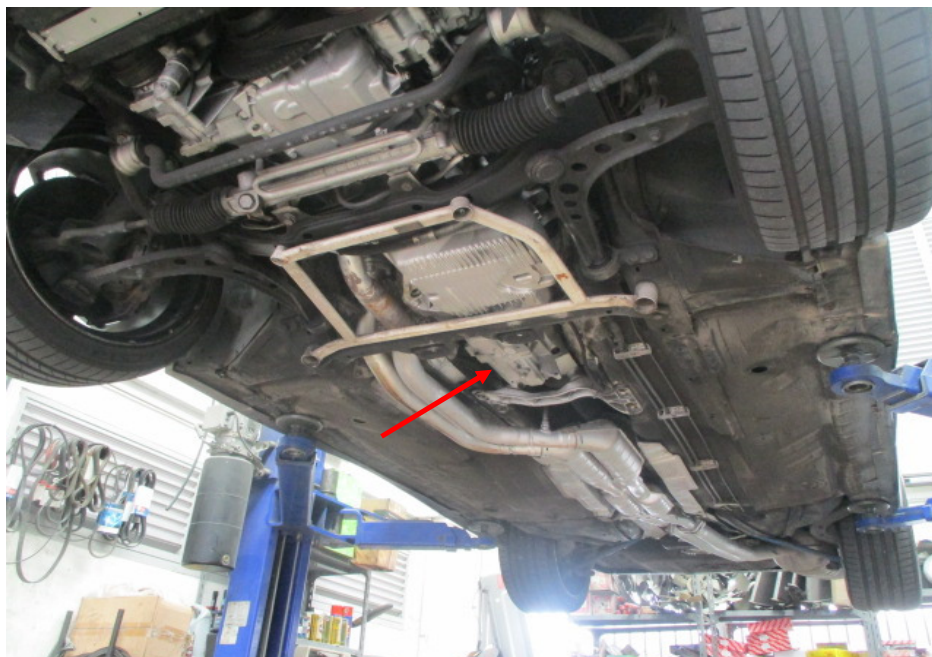
Photo 2 shows a general view of the transmission (arrowed) that was fitted on the Motor Car. The front (input) side of the transmission is bolted to the crankshaft side of the engine block while the rear (output) side of the transmission was connected to the propeller shaft, which links to the rear axle of the Motor Car.

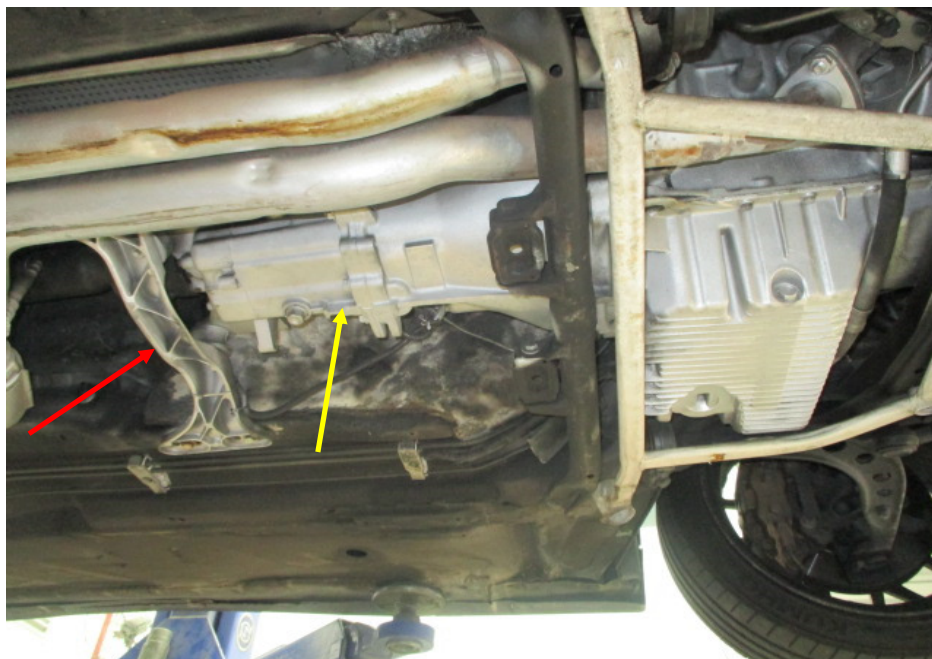
Photo 3 shows a general view of the transmission (yellow arrow) that was fitted on the Motor Car. A bracket (red arrow) was observed to be mounted to the underside of the Motor Car's floorboard of the Motor Car, via bolts and nuts. The bracket supports the rear (output) side of the transmission.

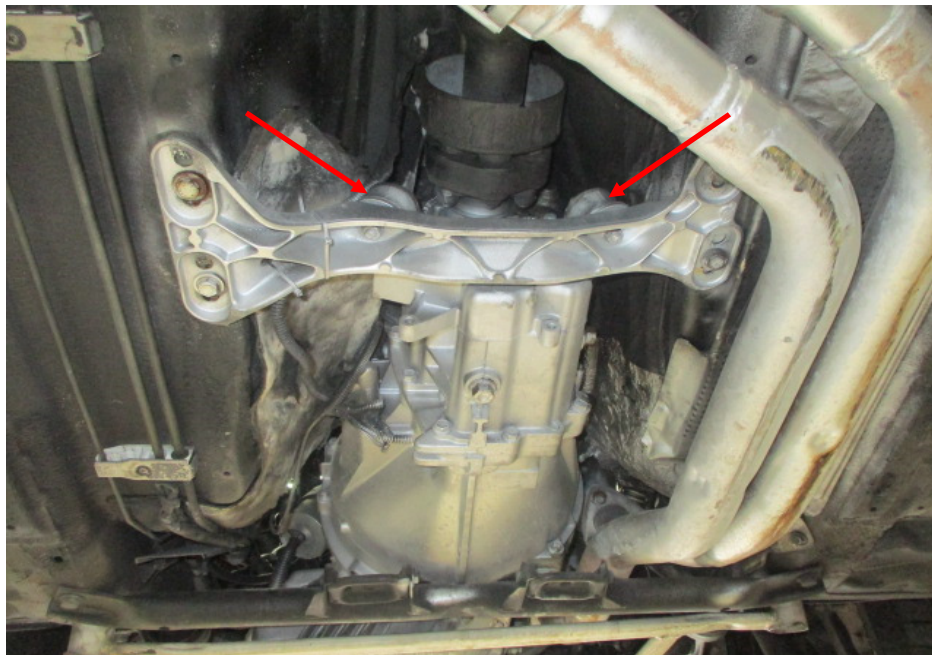
Photo 4 shows a closer view of the bracket that was mounted to the underside of the Motor Car's floorboard, via bolts and nuts. The bracket supports the rear (output) side of the transmission. A pair of rubber bushings (arrowed) absorbs any vibrations arising from the rotation of the transmission gears, minimising any stress to the bracket.

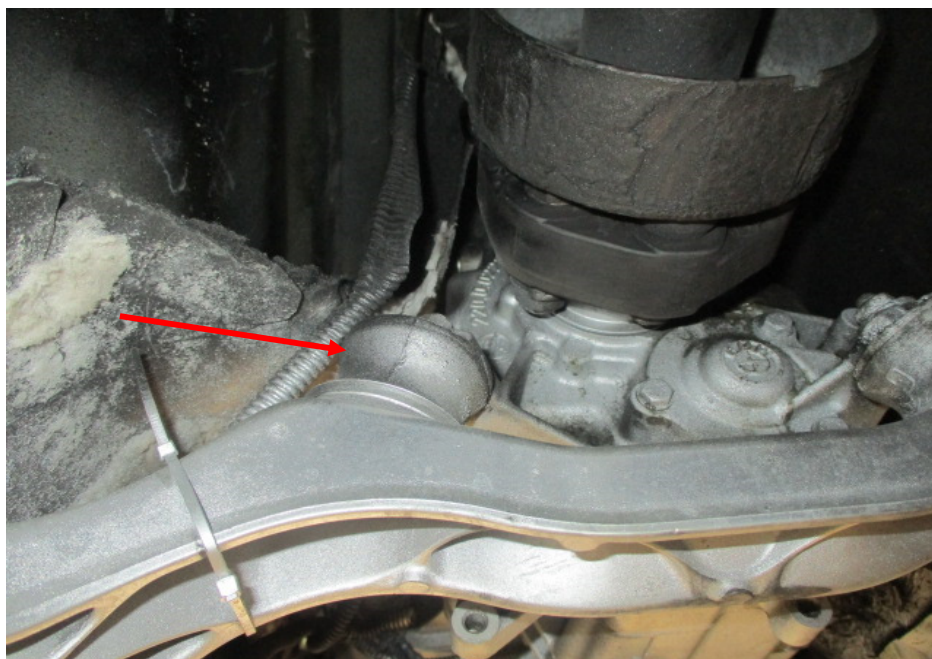
Photo 5 shows a closer view of one of the 2 rubber bushings (arrowed). The rubber bushing sits between the transmission and the bracket, absorbing any vibrations arising from the rotation of the transmission gears. This minimises any stress to the bracket.

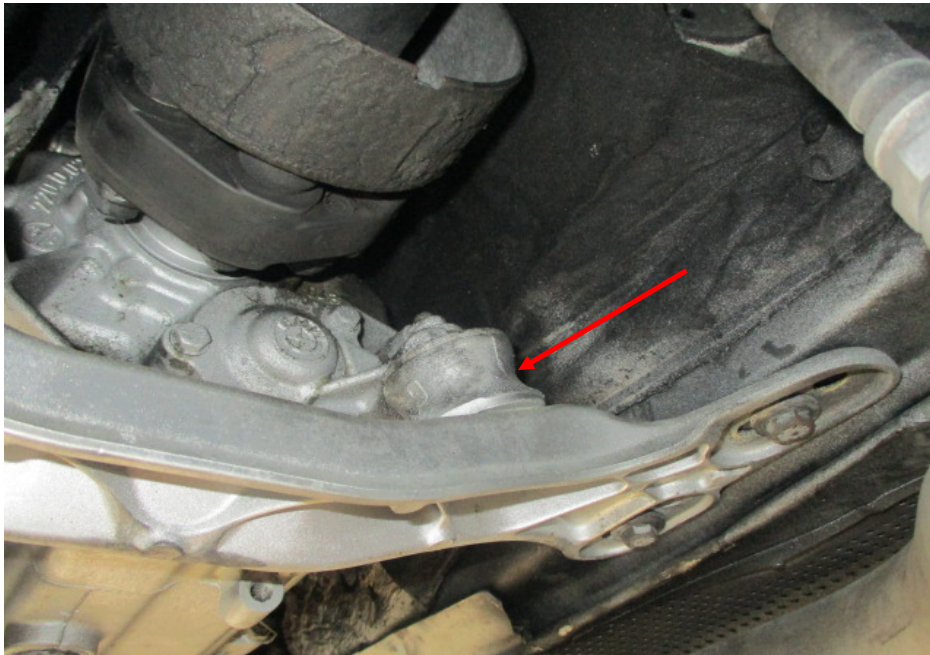
Photo 6 shows a closer view of the other rubber bushing (arrowed). The rubber bushing sits between the transmission and the bracket, absorbing any vibrations arising from the rotation of the transmission gears. This minimises any stress to the bracket.

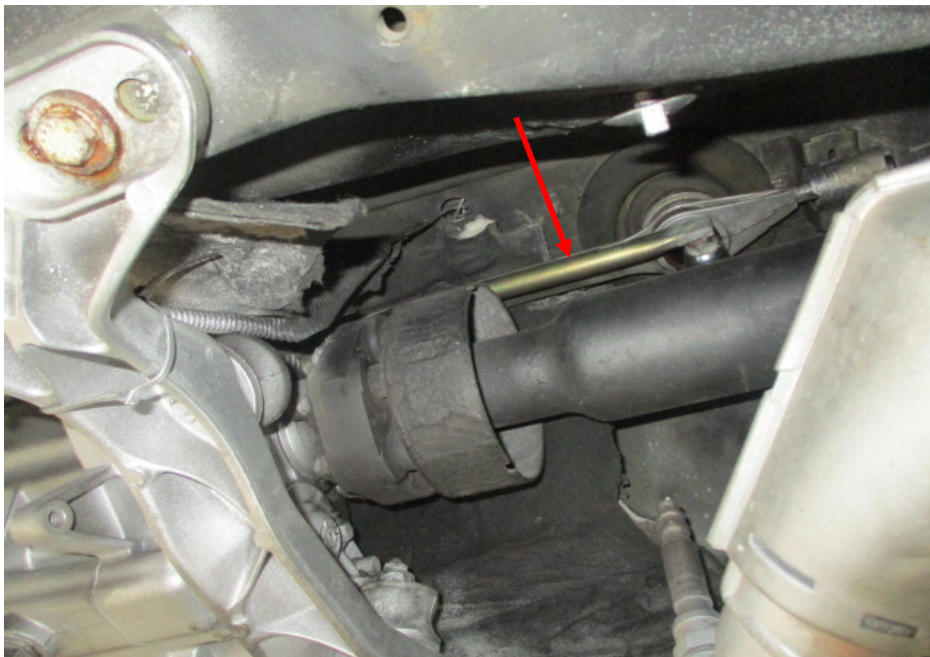
7. The gear selector fork from the transmission to the gear shifter of the Motor Car was observed to be securely fitted on the underside of the Motor Car. The gear selector fork connects to the gear shifter in the interior compartment of the Motor Car through the floorboard.

Photo 7 shows the gear selector fork (arrowed) from the transmission to the gear shifter of the Motor Car. The gear selector fork was observed to be securely fitted on the underside of the Motor Car. This gear selector fork connects to the gear shifter in the interior compartment of the Motor Car through the floorboard.

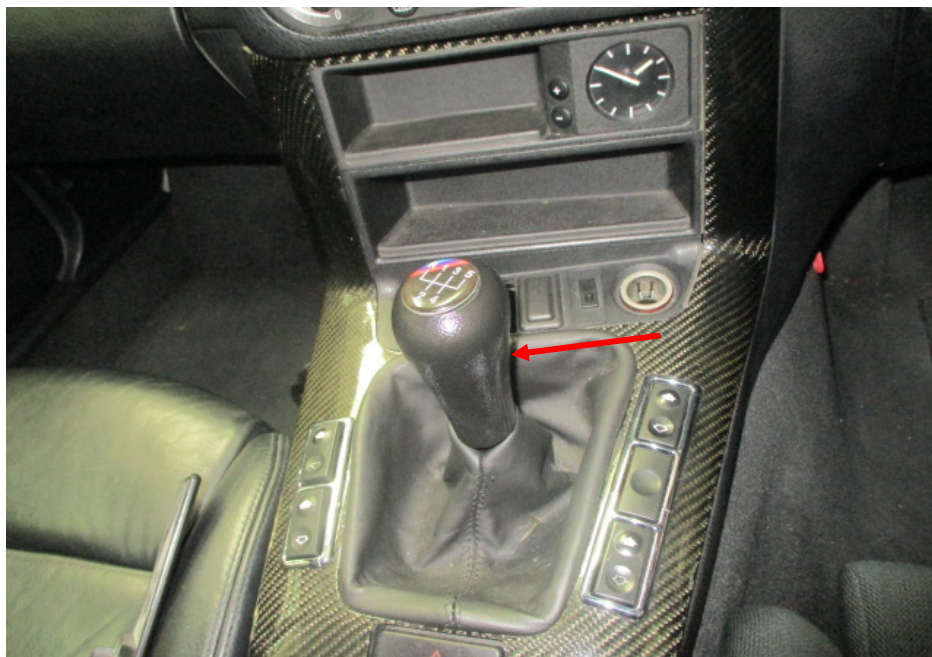
Photo 8 shows the gear shifter (arrowed) that was fitted on the Motor Car, for manually selecting the transmission gear to be engaged. The gear selector fork from the underside of the Motor Car (refer to photograph 7 above) connects to this gear shifter through the floorboard.

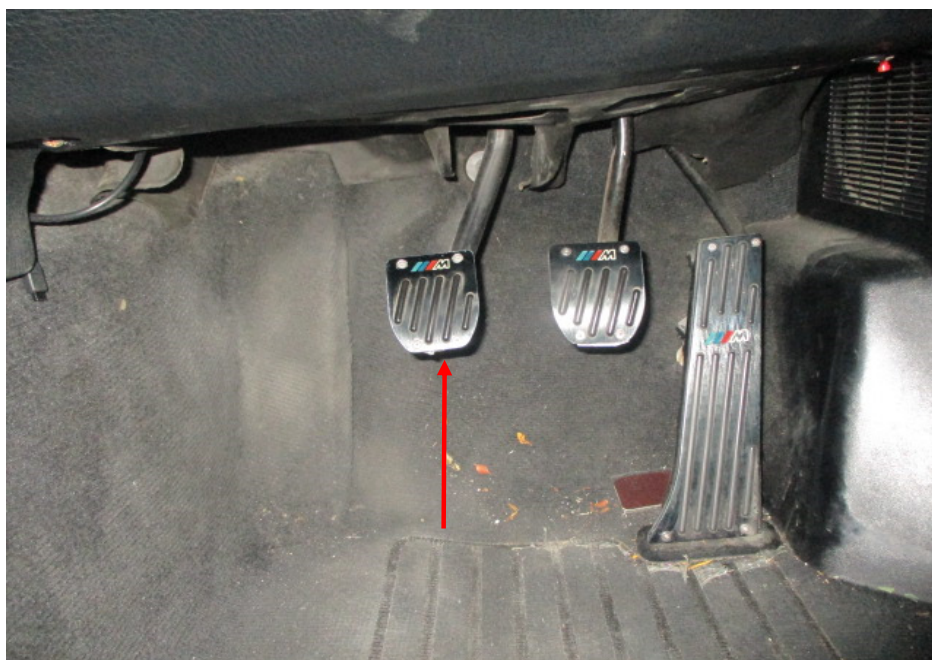
Photo 9 shows the clutch pedal (arrowed) for engaging and disengaging the transmission gears.
