SINGAPORE ACCIDENT STATEMENT

VEHICLE DAMAGE INSPECTION REPORT

Our File No: **MS18-GE-101150/FG**
Insurer Ref: **V0049058**
Insured Name: **TONG TENG WAH JIMMY**

Insured Veh No: **SKP9800J** Policy No: **V0097795**
Date of loss: **25-Sep-18**
Claimant Veh No: **SLL5469T**

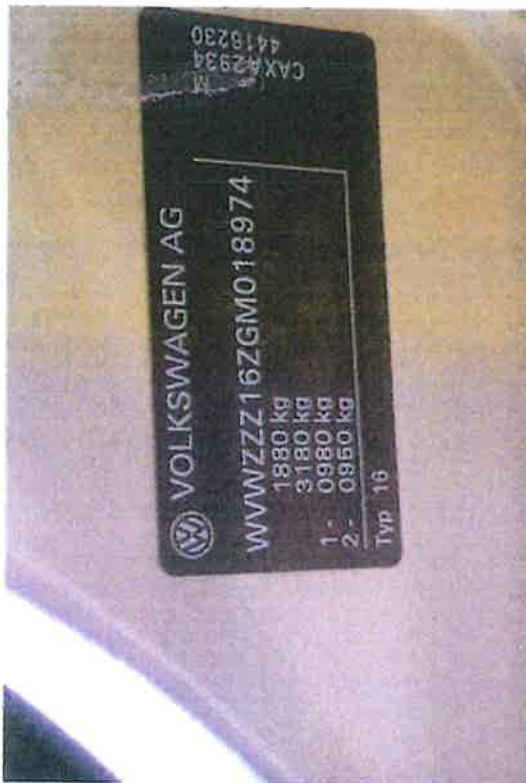
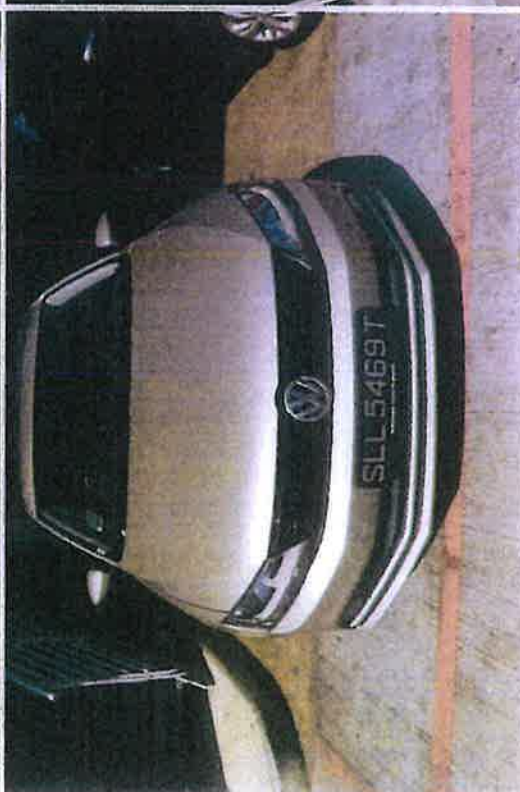
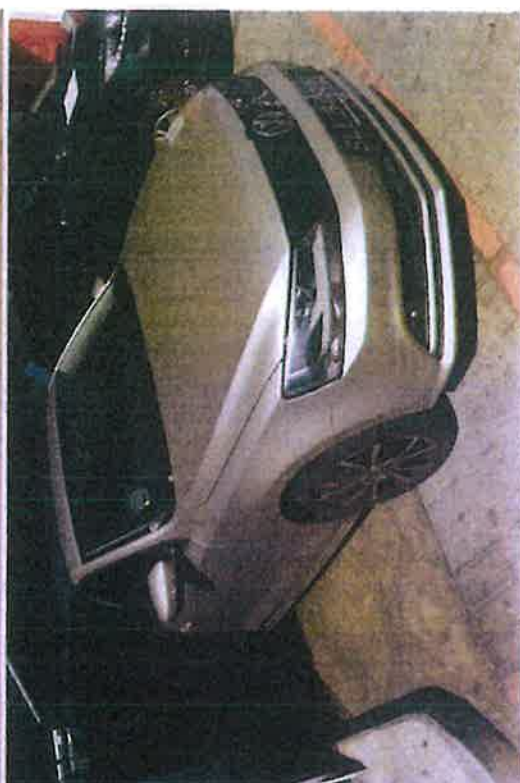
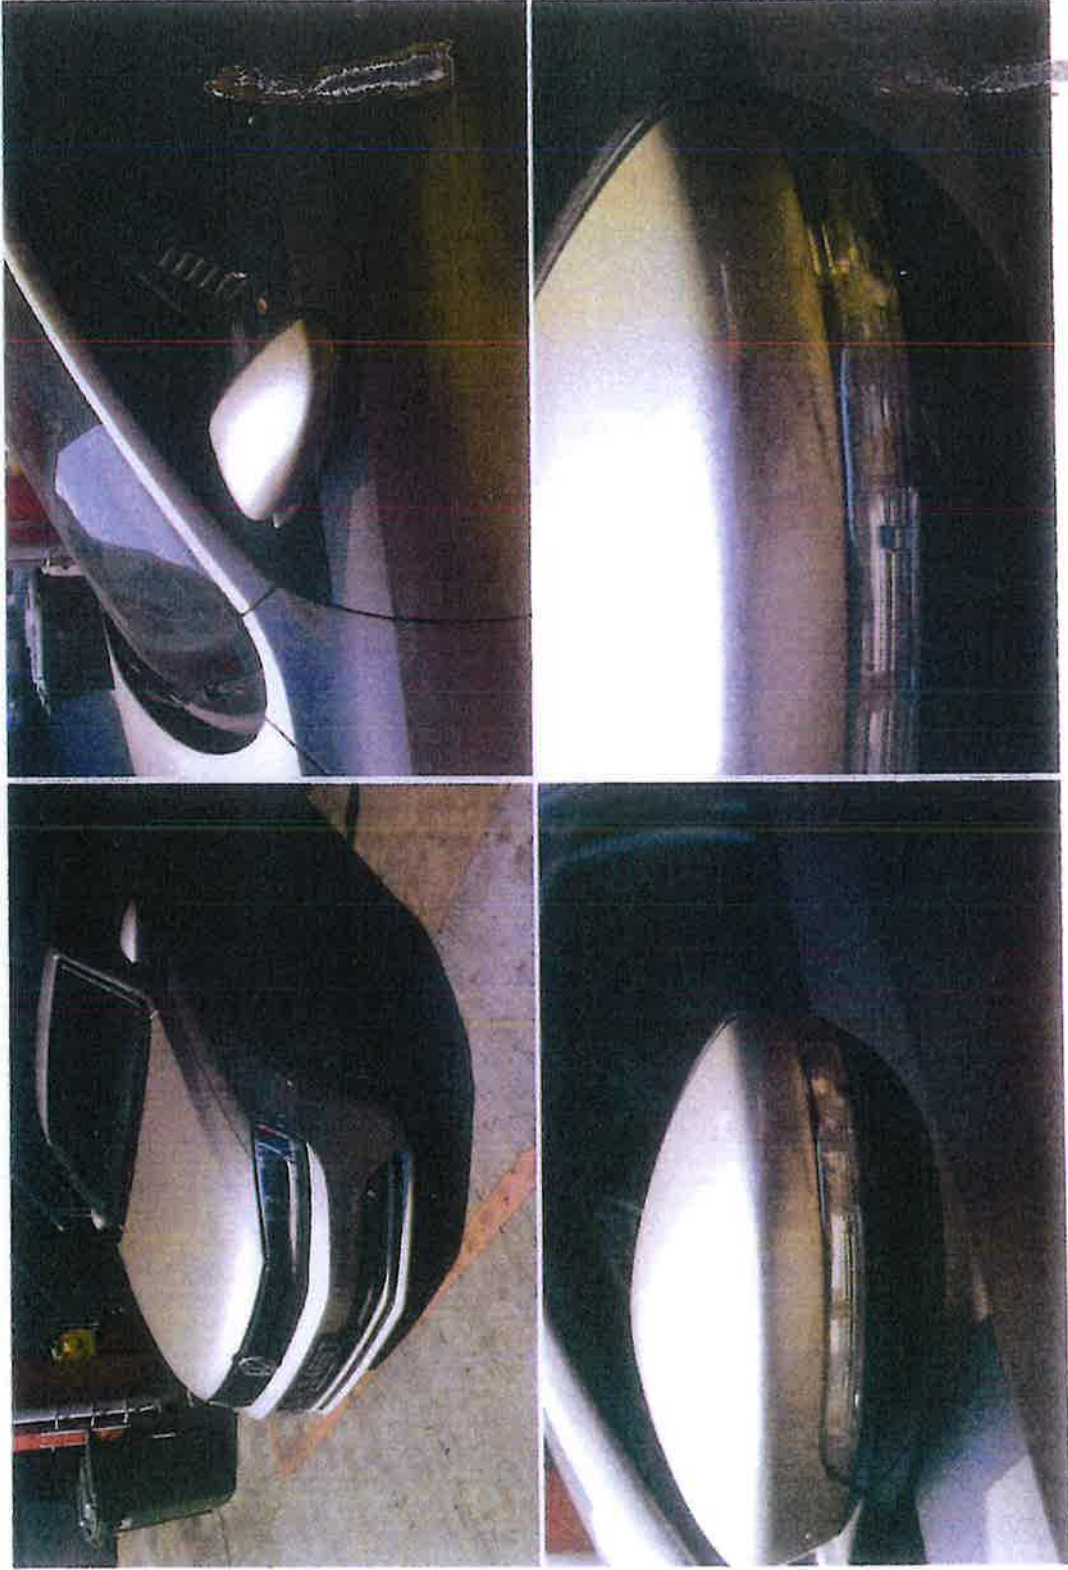
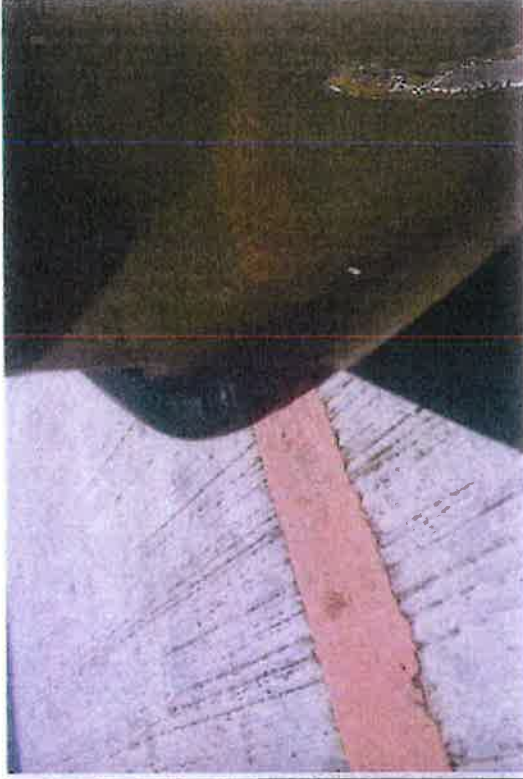
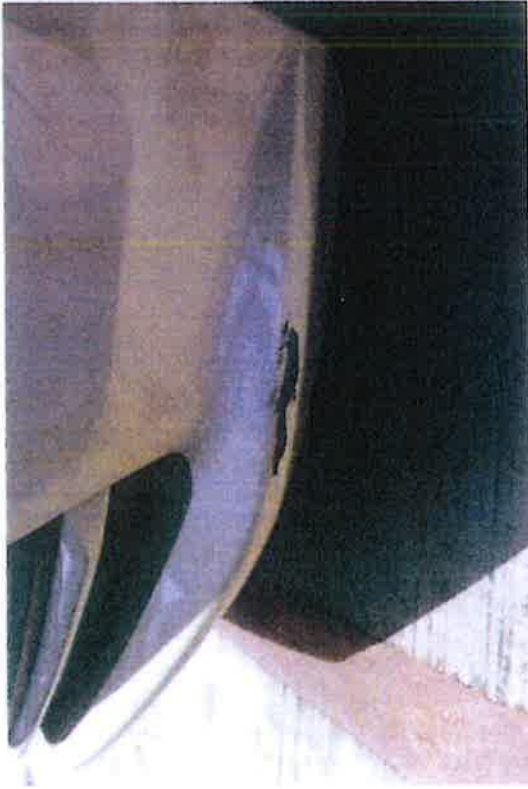
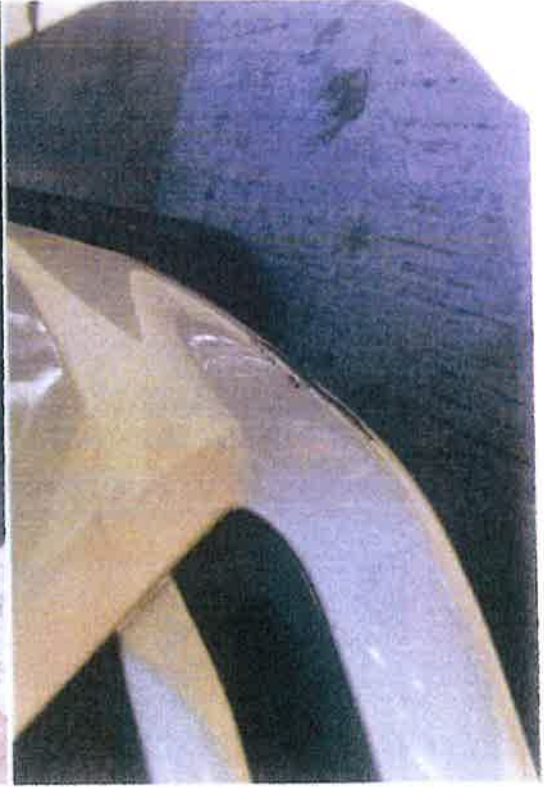
INSPECTION PHOTOS

The vehicle sustained damages to the front left portion.	 
--	--

Our visual inspection of the vehicle revealed that the damages noted are consistent with the accident as reported, please refer to ANNEX A & ANNEX B.

NO	QTY	PARTICULARS	CONDITIONS/ REMARKS	REPAIRER'S AMOUNT (\$)	ADJUSTER'S AMOUNT (\$)
<u>PARTS (LIST ITEMS)</u>					
1	1	L/H Wind Mirror	Cracked	752.40	752.40
2	1	L/H Headlamp	Cut	591.60	591.60
3	1	Front Bumper	Cracked	1,026.00	1,026.00
4	1	L/H Front Bumper Retainer	Necessary	45.60	45.60
5	1	L/H Sport Rim	Cut	570.00	570.00
6	1	L/H Shock Absorber	Serviceable	364.80	-
7	1	L/H Lower Arm	Serviceable	342.00	-
8	1	L/H Knuckle Arm	Serviceable	592.80	-
9	1	L/H Knuckle Bearing	Not Necessary	456.00	-
10	1	L/H Front Fender	Buckled	501.60	501.60
11	1	L/H Front Brake Motor	Not Necessary	205.20	-
				5,448.00	3,487.20
Less				10%	
				544.80	348.72
Sub-total:				4,903.20	3,138.48
<u>SPECIAL NETT ITEMS</u>					
1	1 set	Bumper Clips	Necessary	45.00	30.00
Sub-total:				45.00	30.00
Total Parts :				4,948.20	3,168.48

NO	PARTICULARS	REPAIRER'S AMOUNT (S\$)	ADJUSTER'S AMOUNT (S\$)
1	Fixing of wheel alignment.	100.00	60.00
2	Dismantle and refit undercarriage	250.00	80.00
3	Panel beating and straighten body for accident portion	800.00	500.00
4	Polish and spray painting for accident portion.	750.00	500.00
5	To apply undercoating on repaired and replaced panel.	180.00	60.00
Total labour :		2,080.00	1,200.00
