SINGAPORE ACCIDENT STATEMENT

REPAIR BILL FOR VEHICLE NO. YP 4083 D

AUTOMOBILE INSPECTION REPORT

VEHICLE REGISTRATION NO.: YP 4083 D

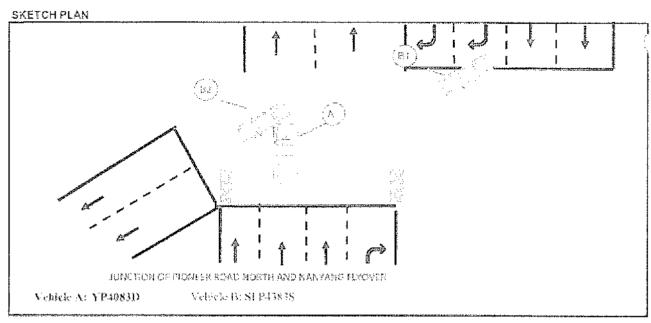
SKETCH PLAN

I was going straight along Pioneer Rood North under Nanyang Plyover on lane 3 and the traffic was green in tny favour. Suddenny s chuic B coming from apposite direction surving right to PH; and I didn't naturage to stop to stood collision resulted collision with vehicle B. After which both drivers allefined to assess the damage, took some photos and exchange particulars. No me was injured in chis accident.

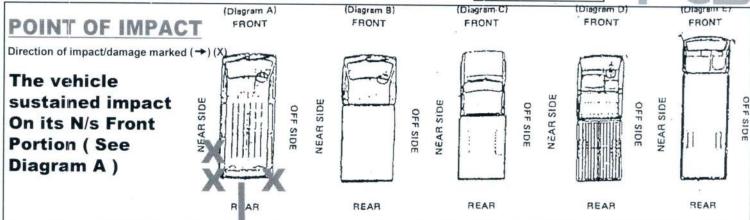
GENERAL DESCRIPTION OF DAMAGES

Parts damaged were: The front n/s door and pillar, front n/s corner panel and bumper were dented.

ADJUSTMENTS & RECOMMENDATIONS

A static inspection was carried out on 19/07/2021 & our report is here with enclosed for your perusal. The Repairs Estimate submitted by M/s New Pioneer Auto Pte. Ltd. as per attached Appraisement Schedule have been revised and scrutinised thoroughly by us & in our opinion, we consider it to be fair and reasonable. The repairer has agreed to effect repairs to the owners satisfaction & to roadworthy condition on an agreed Lump Sum Repair Basis of \$5,300.00 after deducting the Policy Excess Clause of \$NA.
