## SINGAPORE ACCIDENT STATEMENT

## AUTOMOBILE INSPECTION REPORT

Registration No. : YP 4083 D  
Make/Model : MITSUBISHI CANTER FEB21ER4SDEB  
Yr of Manuf/Regn : 09 Sep 2016  
Carrying Capacity : X  
Chassis No. : FEB21EA20975  
Engine No. : 4P10C35273  
Colour : Metallic White  
Class : Goods ( Lorry w Canopy)

APPENDIX A

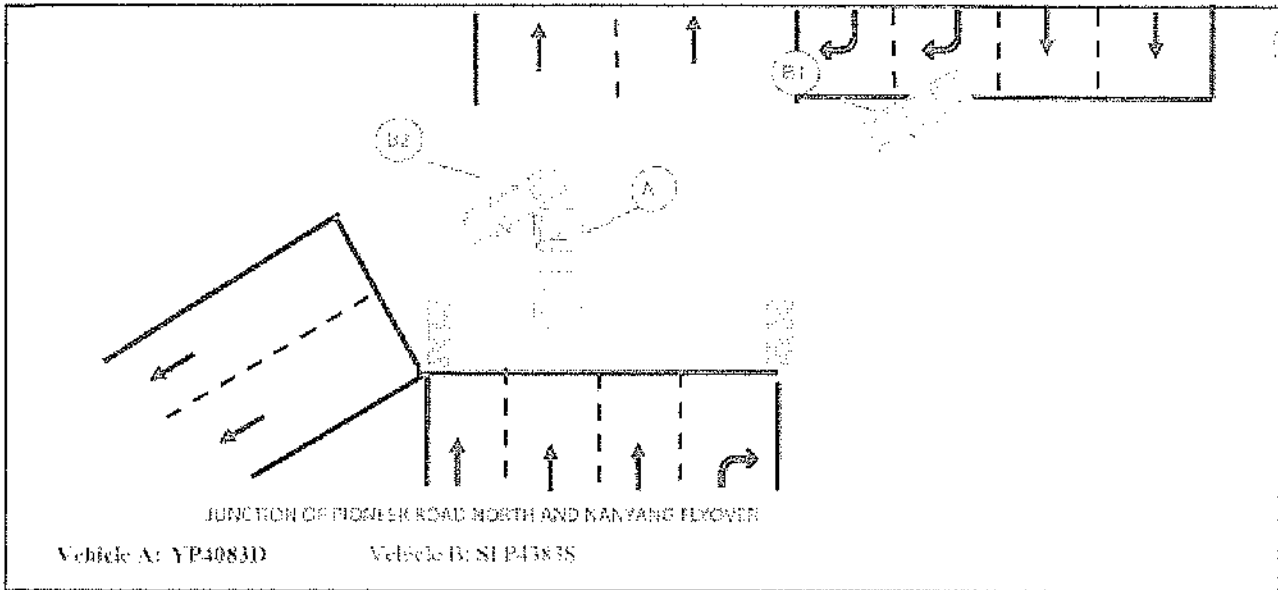
SKETCH PLAN

I was going straight along Pioneer Road North under Nanyang Flyover on lane 3 and the traffic was green in my favour. Suddenly vehicle B coming from opposite direction turning right to PHE and I didn't manage to stop to avoid collision resulted collision with vehicle B. After which both drivers aligned to assess the damage, took some photos and exchange particulars. No one was injured in this accident.

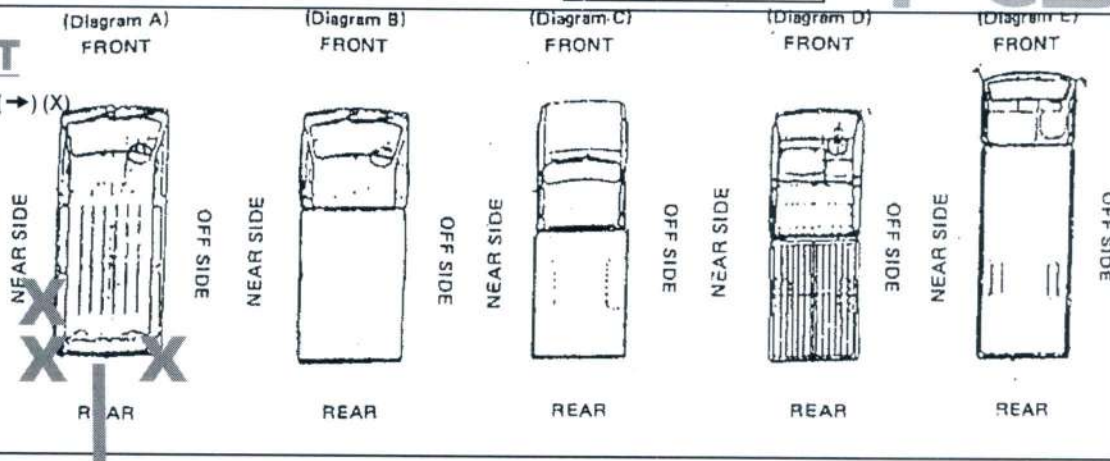
Direction of impact/damage marked (→) (X)

The vehicle sustained impact On its N/s Front Portion ( See Diagram A )

Parts damaged were : The front n/s door and pillar, front n/s corner panel and bumper were dented.

A static inspection was carried out on 19/07/2021 & our report is here with enclosed for your perusal. The Repairs Estimate submitted by M/s New Pioneer Auto Pte. Ltd. as per attached Appraisement Schedule have been revised and scrutinised thoroughly by us & in our opinion, we consider it to be fair and reasonable. The repairer has agreed to effect repairs to the owners satisfaction & to roadworthy condition on an agreed Lump Sum Repair Basis of \$ 5,300.00 after deducting the Policy Excess Clause of \$ NA. As instructed, we have not authorised any of the repairs on your behalf.
