Team AutoPro Pte Ltd 160 Sin Ming Dr, #02-12 Sin Ming AutoCity Singapore 575722

Vehicle Nos : **GBC 6181 G**
Made : Toyota Hiace
Year : 2013
Chassis No : 1KD2290097

SINGAPORE ACCIDENT STATEMENT

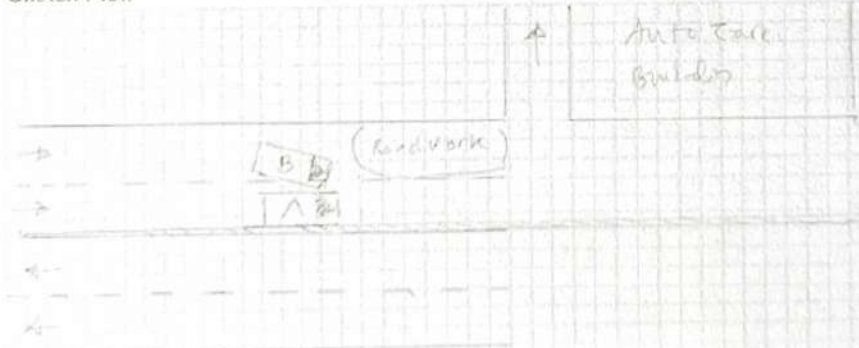
Sketch Plan

on the stated date and time, i vehicle X was traveling
 along my designated lane. There was road works on the
 left side of the road, hence i stayed in my lane on the right.
 As i was traveling along i suddenly felt an impact hitting me on
 left portion of my vehicle. I swerved slightly to the right and
 my front bumper hit the curb. That is all.
