ASSIGNMENT

To Inspect Vehicle No: GBC 30994

Make: Toyota Dyna 150M C.C. 2982

The U/C / Chassis frame / Body Structure affected due to collision.

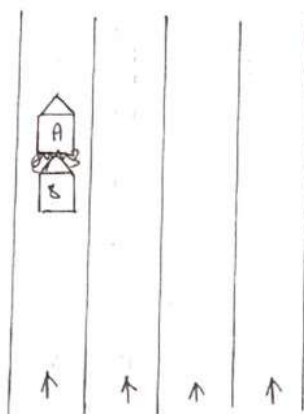
Sketch Plan

Vehicle A: GBL30996
Vehicle B: G18K8097L

I was travelling on PIE TOWARDS T4A BEFORE CTE SEE EXIT.
 The vehicle in front of me slowed down and came to a stop.
 I followed suit and did the same. Suddenly, I felt a
 huge impact on the rear of my vehicle. I got down and
 realised I was rear ended by vehicle B.
