1.		Policy Particulars :	- THIRD PARTY CLA	AIM
	Insured Veh.	SKE 8798Y	Veh. Inspected	GBB 4837S
	Policy No.	DMPPHQ21-002762	Coverage (\$)	0.00
	Claim No.	DM21HO01385/MT	Excess (\$)	0.00
	Assign From	MELODY TEOH	Assign Date	19/09/2021

4.		Description	n of Damages	
	THE VEHICLE SUS	STAINED DAMAGES AT THE REA	AR N/S PORTION.	
	DAMAGES SEE DE	ETAILS.		
5.		General	Information	
	Accident Date	16/09/2021	Inspection Date	20/09/2021
	Survey held at	Blk 15 Kaki Bukit Road 4, Bartley	Biz #01-53	
	Repairer	ZOOM AUTOWERKS PTE LTD		
5a.		Re	emarks	
	A)THE INSPECTION WAS CONDUCTED ON A"WITHOUT PREJUDICE" BASIS. B)IN ACCORDANCE TO YOUR INSTRUCTIONS, WE HAVE NOT AUTHORISED REPAIRS.			
5b.	b. Estimate Days of Repair			
	ESTIMATED NORM	MAL PERIOD FOR REPAIR:	4 Wo	orking Days

ADJUSTMENT ON REPAIR COST FOR VEHICLE NO. GBB 4837S

PHOTOGRAPHS FOR VEHICLE NO. GBB 4837S

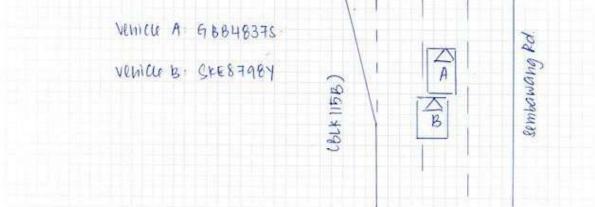
Policyholder's Signature / Date 8 Driver's Signature (# driver is not the policyholder) / Date 8 Time Sketch Plan

Describe Circumstances of the Accident the stated date time vehicu 96646375 was stationary alona true Stated vehille due light red the traffic hight turns green before could MOVE vehille SKE 87984 collided onto my vehicle's rear povien.
