**ACCIDENT INVOLVING SJK 6462J AND XE 4566Y ON 18.08.2021
AT/ALONG HARBOUR DRIVE
INJURED DRIVER: QUEK SOO MENG**

GENERAL DESCRIPTION OF DAMAGES :

Inspection Photos

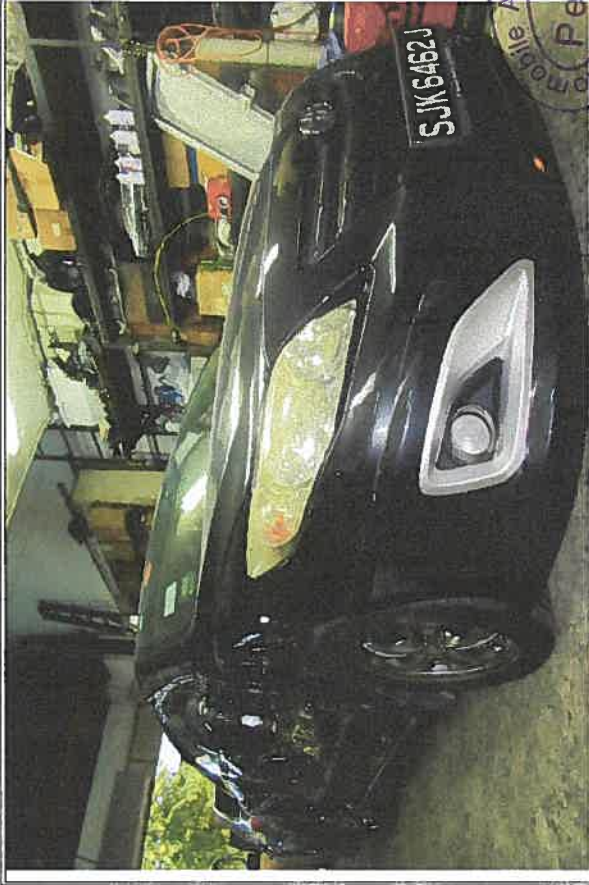
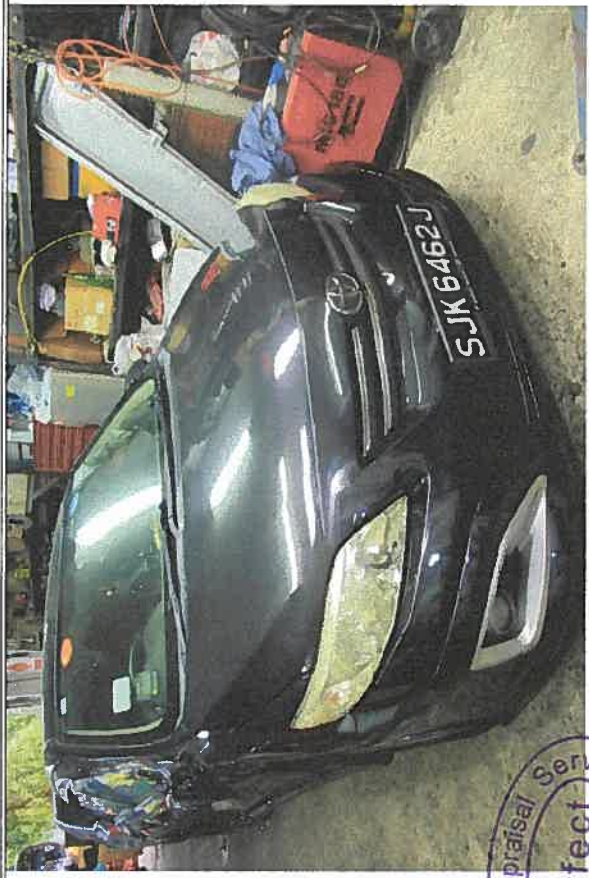
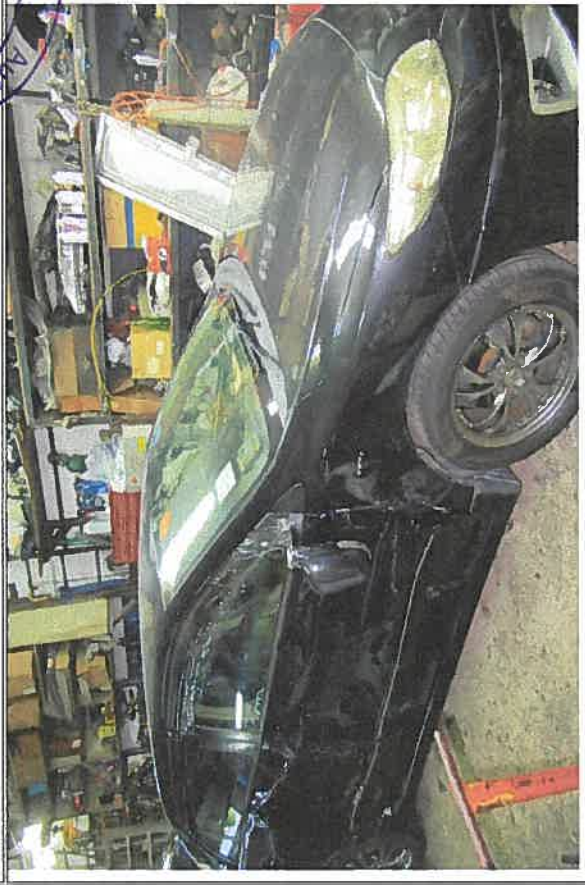
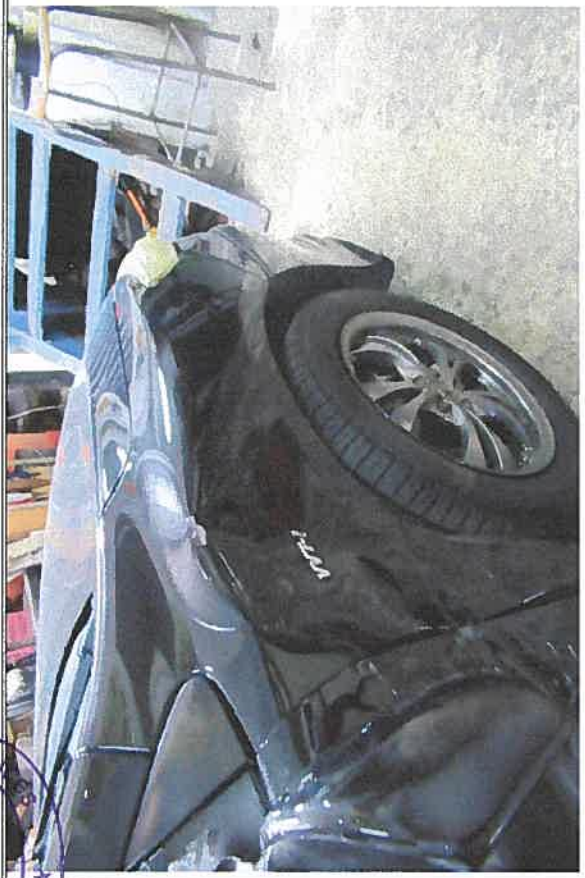
At the time of inspection, we noted that this vehicle sustained damages along the o/s body length.

For more details of the damages, please see schedule and photographs attached.

To remove and replace damaged parts as listed above including reinstatement of the necessary attachments and fittings to facilitate repairs. Jack up, straighten, panel beat and reshape the affected parts and components. To correct and realign the necessary parts.

To putty and spray painting on damaged portion including touch up paint on accident affected areas.
