Report No. T/20210729/2084

REPORT OF A TRAFFIC ACCIDENT

Type of Accident:	Injury Attended by Police	Drink Drive: No	Date/Time of Accident: 21/07/2021 20:30	Type of Location: Straight Road
Location: LIM CHU KANG ROAD				
Lamp Post Number: 29				
Weather: Clear		Road Surface: Dry	Road Speed Limit:	
Traffic Flow: Two Way		Traffic Control:	Traffic Volume: Light	
Type of Collision: Between Moving Vehicles - Head To Rear			Anyone conveyed by ambulance: Yes

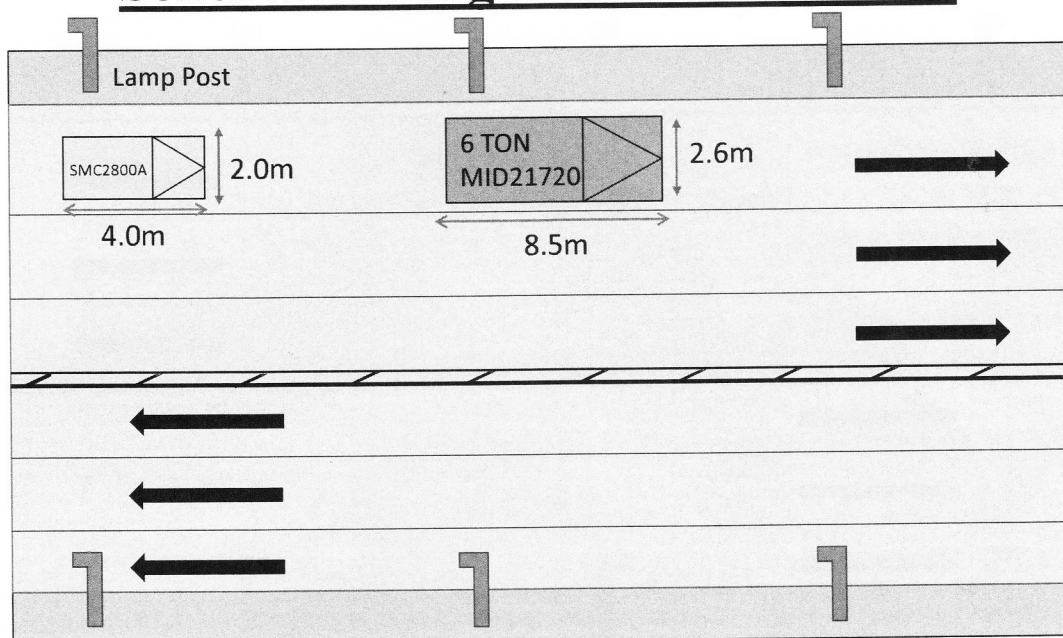
Schematic Diagram of the incident

MID21720 : 6 TON travelling along Lim Chu Kang Road

SMC2800A : Civilian Yellow Honda Fit travelling along Lim Chu Kang Road

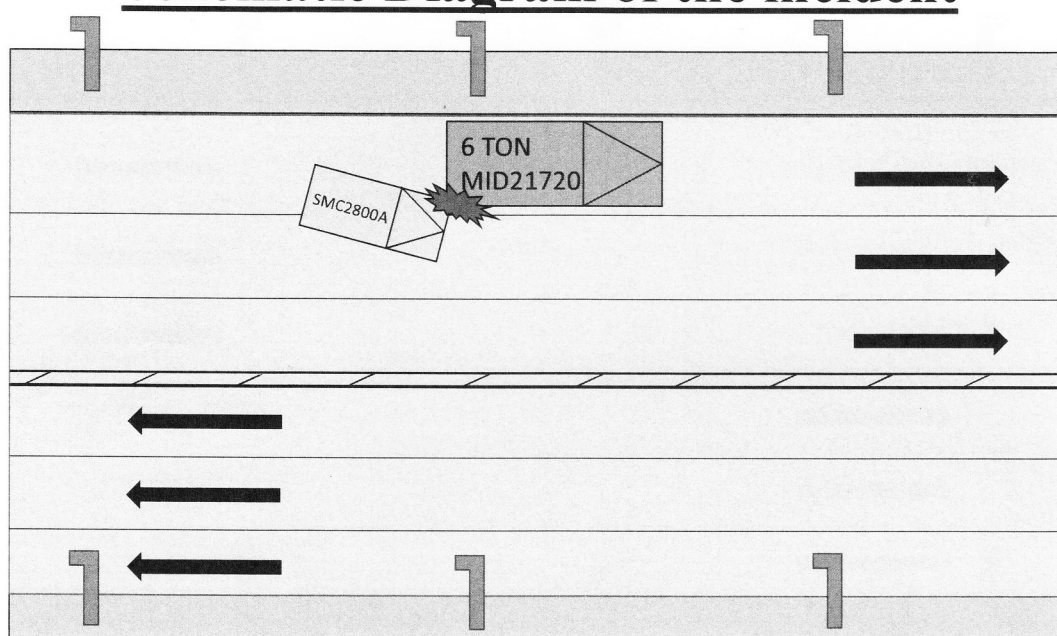
Schematic Diagram of the incident

MID21720 : 6 TON travelling along Lim Chu Kang Road

SMC2800A : Honda Fit collided into 6 TON while trying to overtake it

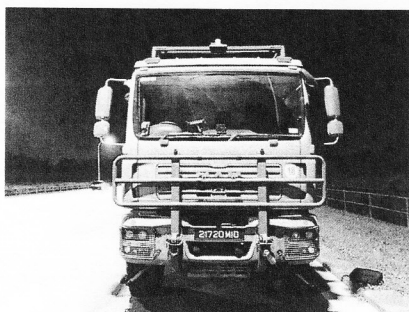
Front View of MID 21720

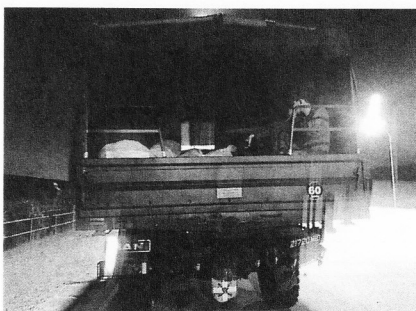
Rear View of MID 21720

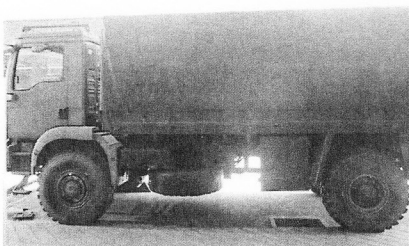
Left Side View of MID 21720

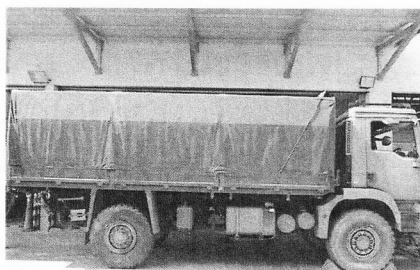
Right Side View of MID 21720

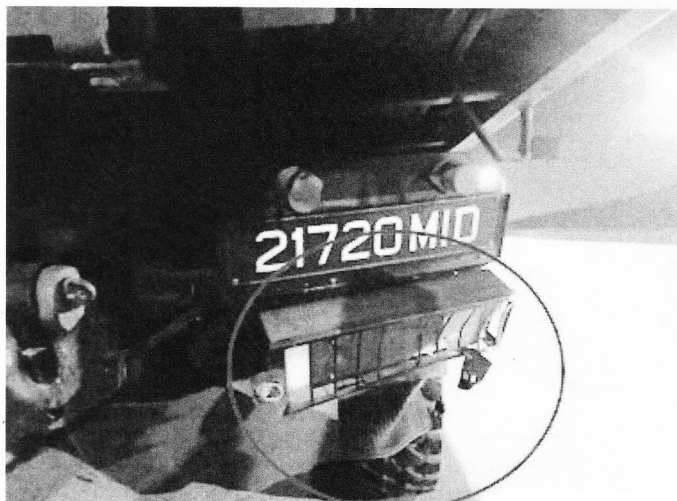
Zoom-in damage

- RHS rear brake light cover was dented.

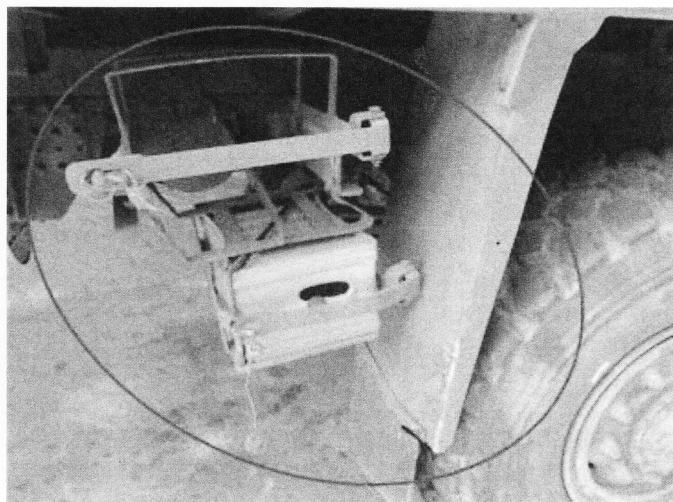
Zoom-in damage

- RHS rear wheel chock cage was dented.
- RHS rear mud guard sustained scratches.

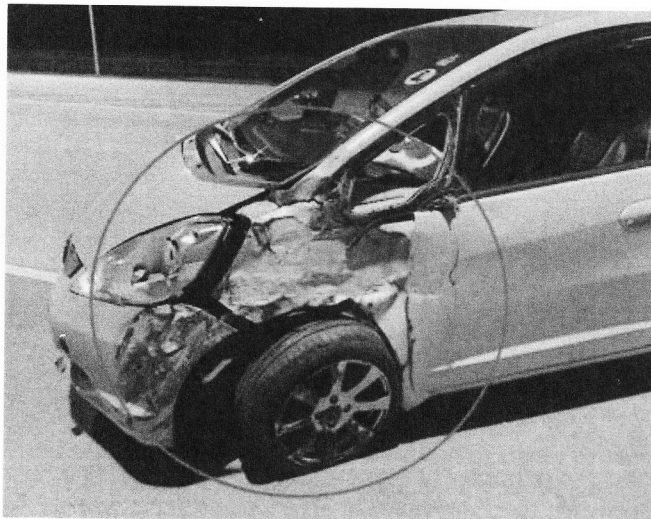
Zoom-in damage

On 21/07/2021 at about 2045hrs, I was driving back to Pasir Lebar Camp along Lim Chu Kang Road at 55km/hr. Behind me is a yellow car SMC2800A. The driver of SMC2800A was following behind me when I felt that my vehicle was hit by something. Hence I stopped my vehicle. My lorry sustained right rear and right rear light was heavily damaged. I alighted and checked on the driver of SMC2800A however she was not very responsive. Soon after, my passenger called for ambulance and she was conveyed by ambulance. The front left part of SMC2800A was severely crushed and the windscreen cracked.

- LHS of the civilian car was dented.
- LHS Front tyre was deflated.
- LHS mirror was dislodged.
- LHS passenger door was dented.
