Your Ref: Triumph Spitfire 1500
(chassis number FH89762L)
Our Ref : CI/TP22000529/D

13 January 2022

INSPECTION REPORT OF A TRIUMPH SPITFIRE 1500 MOTOR CAR WITH CHASSIS NUMBER FH89762L

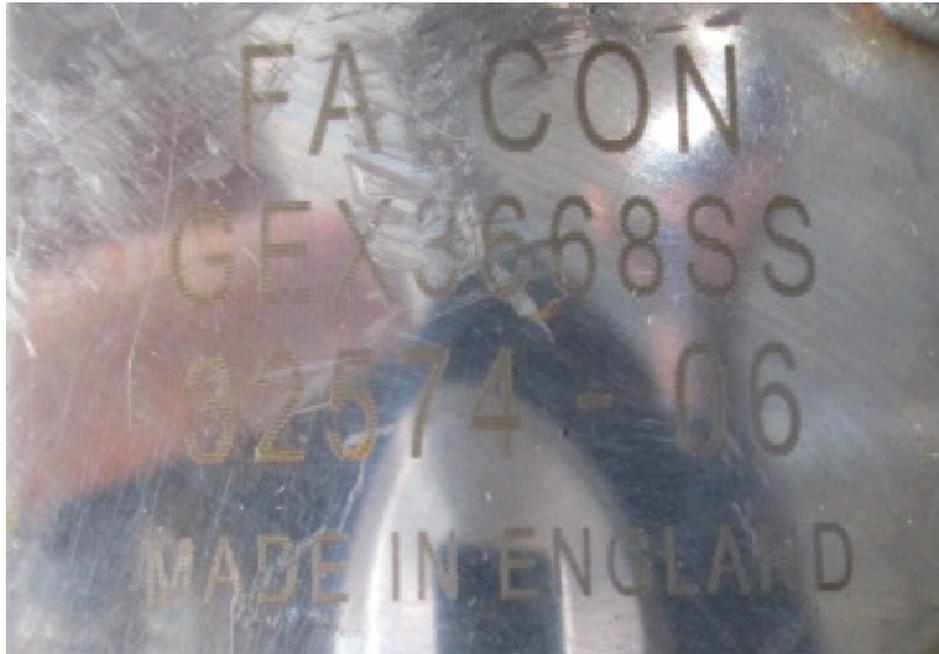
Photo 1 shows the tag that was riveted on the bottom surface area of the Motor Car's rear exhaust muffler. Engraved on the tag were: Falcon, GEX3668SS, 32574-06 and Made In England.

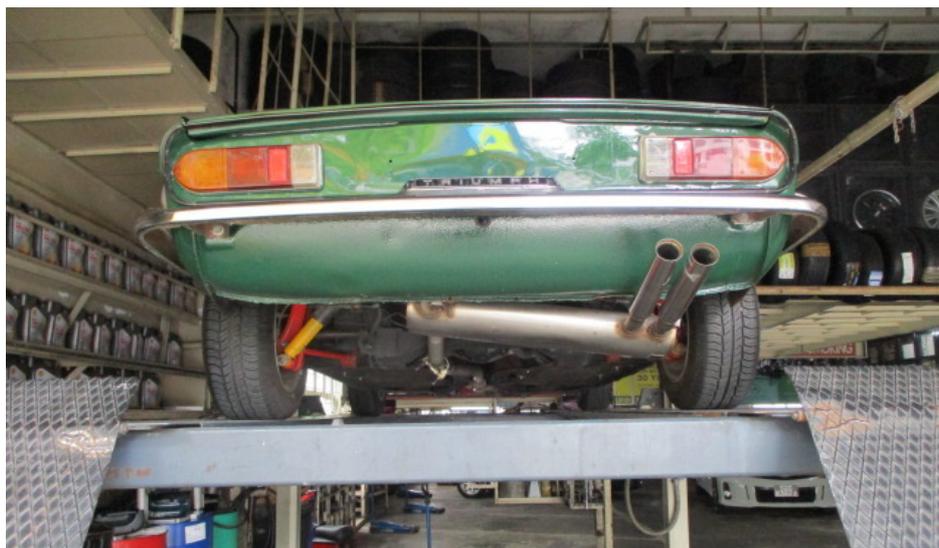
Photo 2 shows the Motor Car hoisted up at the time of my inspection. The inspection carried out had primarily focussed on the rear exhaust muffler that was fitted on the Motor Car.

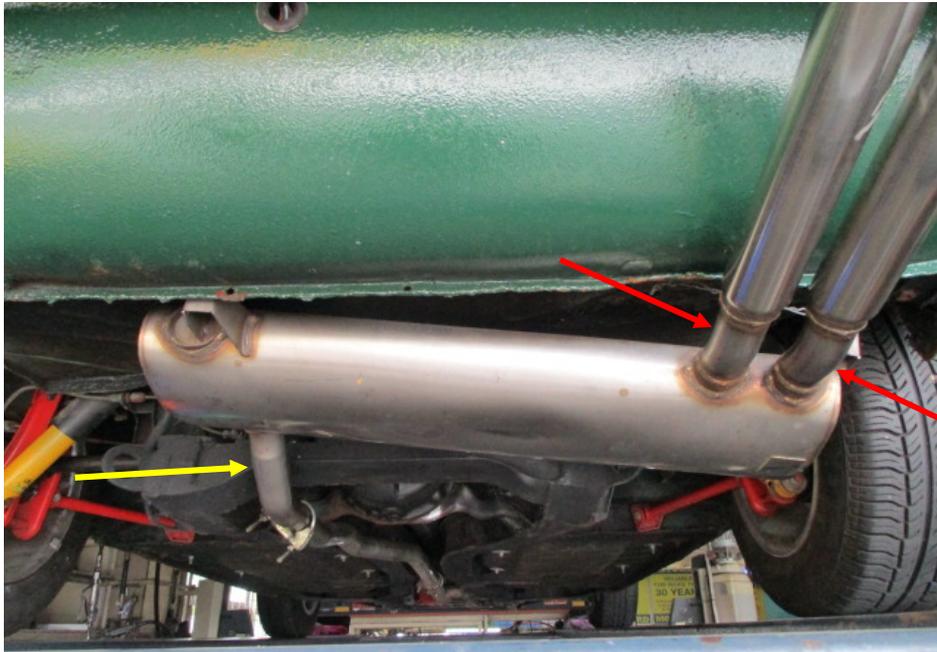
6. The Motor Car's rear exhaust muffler was fitted with 2 exhaust end pipes and a single exhaust pipe that connects to the centre exhaust pipe. Welding marks were seen surrounding the area where these pipes join the rear exhaust muffler.

Photo 3 shows a general view of the rear exhaust muffler that was fitted on the Motor Car. The Motor Car's rear exhaust muffler was fitted with 2 exhaust end pipes (red arrow) and a single exhaust pipe (yellow arrow) that connects to the centre exhaust pipe. Welding marks were seen surrounding the area where these pipes join the rear exhaust muffler.

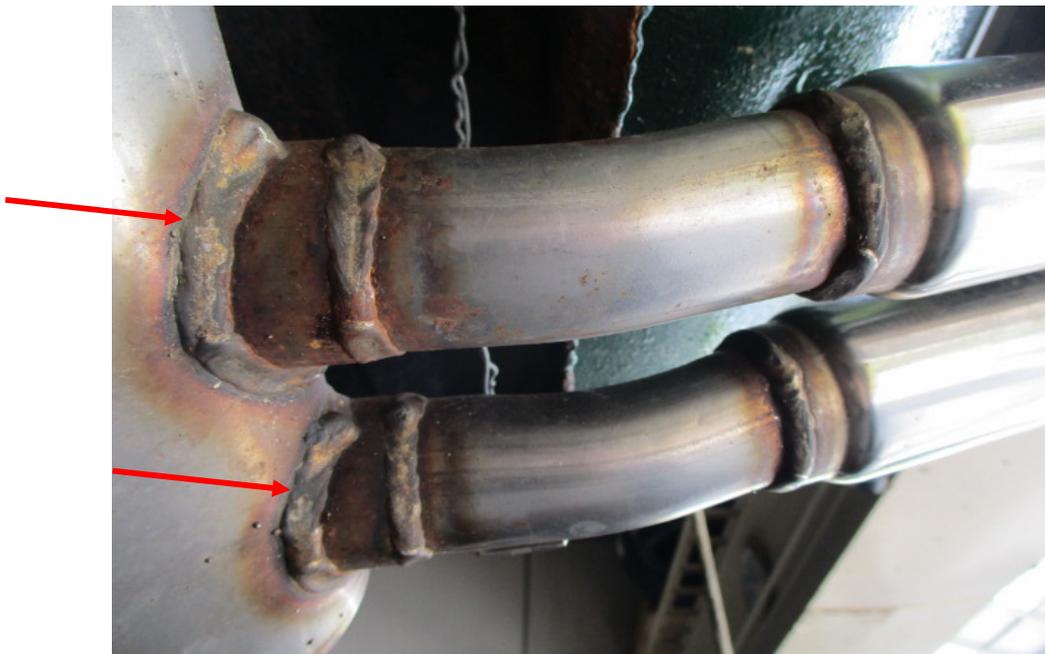
Photo 4 shows a close up view of the welding marks (arrowed) that were seen surrounding the area where the exhaust end pipes join the rear exhaust muffler.

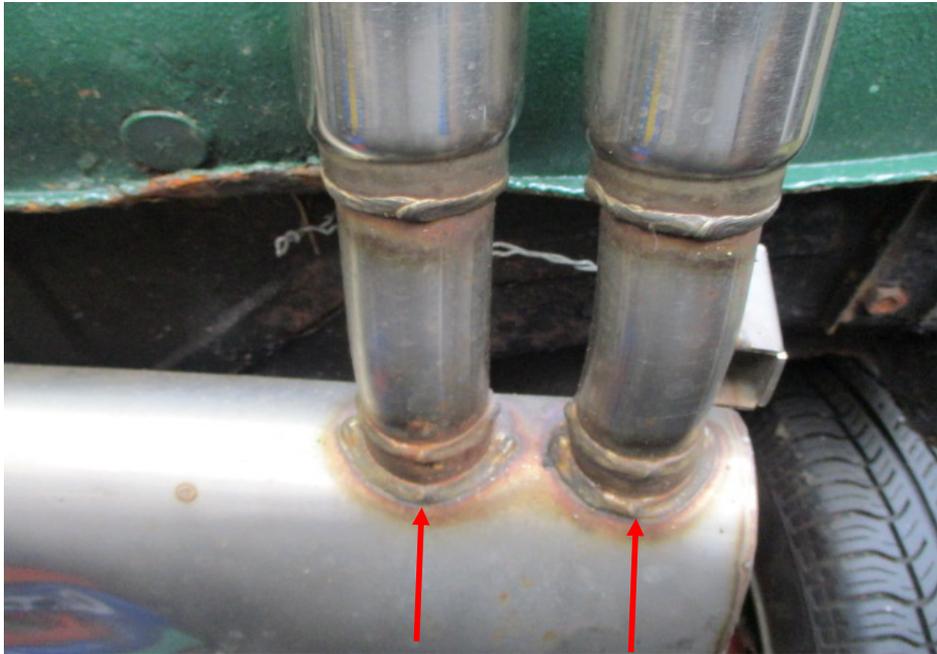
Photo 5 shows another view of the welding marks (arrowed) that were seen surrounding the area where the exhaust end pipes join the rear exhaust muffler.

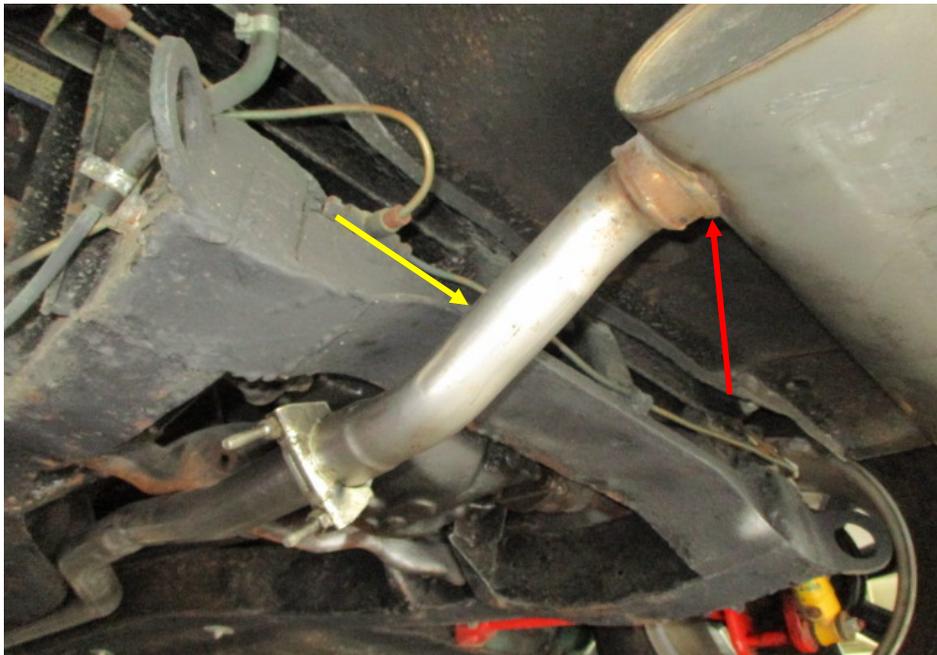
Photo 6 shows a general view of the single exhaust pipe (yellow arrow) that connects between the rear exhaust muffler and the centre exhaust pipe. Welding marks (red arrow) were seen surrounding the area where this single pipe joins the rear exhaust muffler.

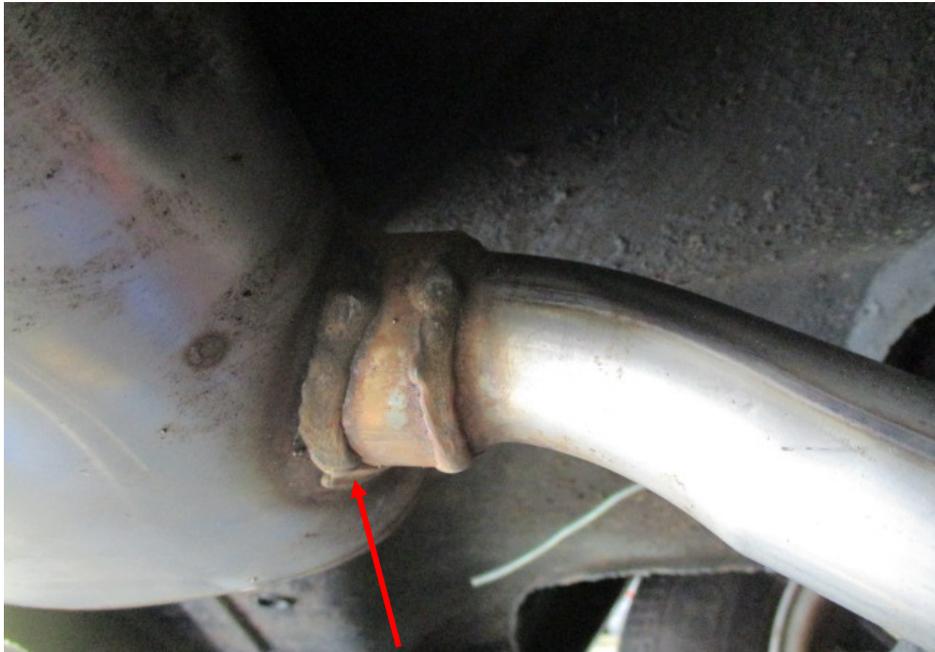
Photo 7 shows a close up view of the welding marks (arrowed) that were seen surrounding the area where the single exhaust pipe joins the rear exhaust muffler.

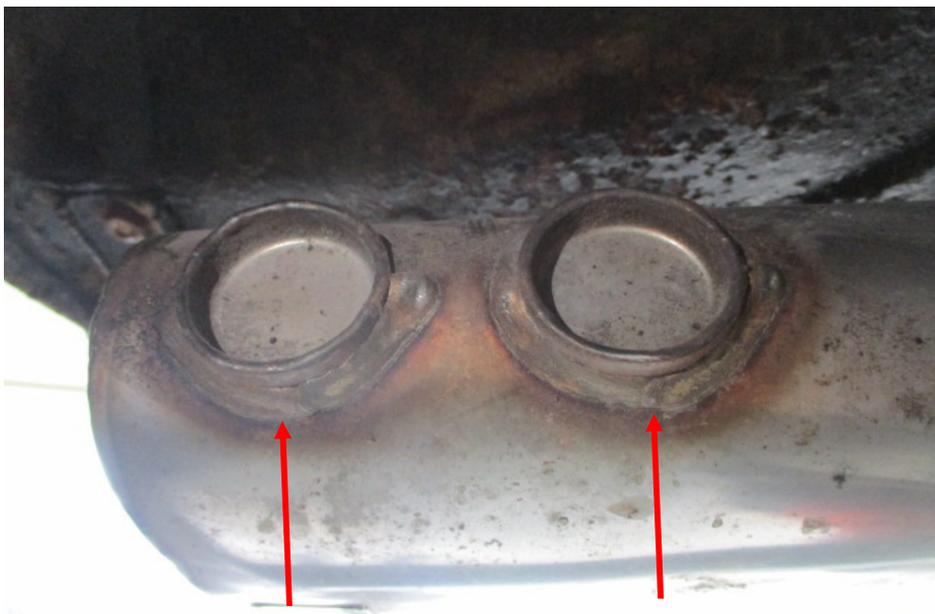
7. I had also observed 3 sealed openings on the rear exhaust muffler with welding marks surrounding all 3 openings. There were 2 openings on the side surface of the rear exhaust muffler facing the front of the Motor Car and 1 opening on the side surface facing the rear of the Motor Car. See photo 1 – 9 below.

Photo 8 shows the 2 openings on the side surface of the rear exhaust muffler, facing the front of the Motor Car. The 2 openings were observed to be sealed with welding marks (arrowed) surrounding the 2 openings.

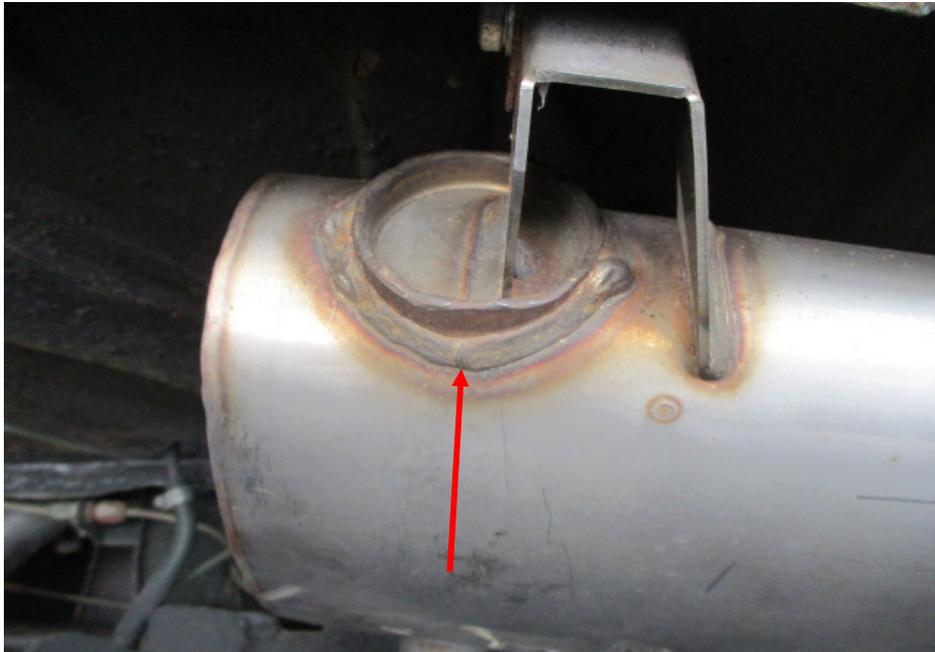
Photo 9 shows the opening on the side surface of the rear exhaust muffler, facing the rear of the Motor Car. The opening was observed to be sealed with welding marks (arrowed) surrounding the opening.

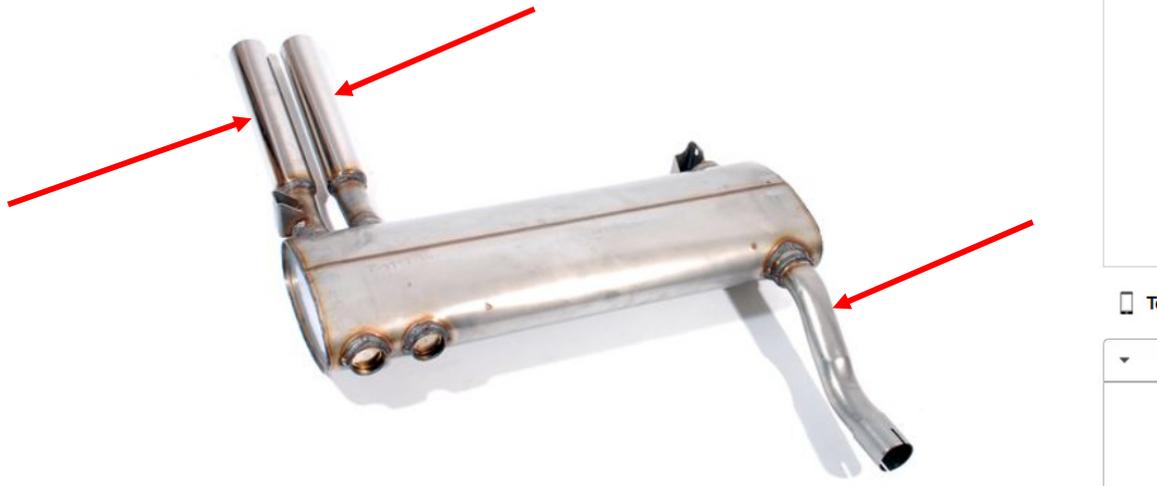
Stainless Steel Sports Rear Silencer - Spitfire MkIV/1500 - GEX3668SSSPORT

8. My research on the information engraved on the tag that was riveted on the bottom surface area of the Motor Car's rear exhaust muffler revealed that the "**GEX3668SS**" engraved on the tag is the model number of a rear exhaust muffler that can be fitted on a Triumph Spitfire 1500 model motor car, which is the same make and model as the Motor Car.
9. Upon my closer examination of the photograph shown for the "**GEX3668SS**" model rear exhaust muffler, I note that the "**GEX3668SS**" model rear exhaust muffler was identical to the rear exhaust muffler that was fitted on the Motor Car. The shape of both rear exhaust mufflers, the number of exhaust pipes fitted to both rear exhaust mufflers, sealed openings and welding mark areas on both rear exhaust mufflers were all similar. See photo 10 – 14 below for comparison.

Photo 10 shows the photograph for the “**GEX3668SS**” rear exhaust muffler (extracted from web research). The “**GEX3668SS**” engraved on the tag on the bottom surface area of the Motor Car’s rear exhaust muffler (refer to photograph 1 above) is the model number of a rear exhaust muffler that can be fitted on a Triumph Spitfire 1500 model motor car (circled), which is the same make and model as the Motor Car. As seen from the photograph shown, the “**GEX3668SS**” model rear exhaust muffler is identical to the rear exhaust muffler that was fitted on the Motor Car. The shape of both rear exhaust mufflers, the number of exhaust pipes fitted to both rear exhaust mufflers (arrowed), sealed openings and welding mark areas on both rear exhaust mufflers were all similar. Refer to photograph 3 above for comparison.

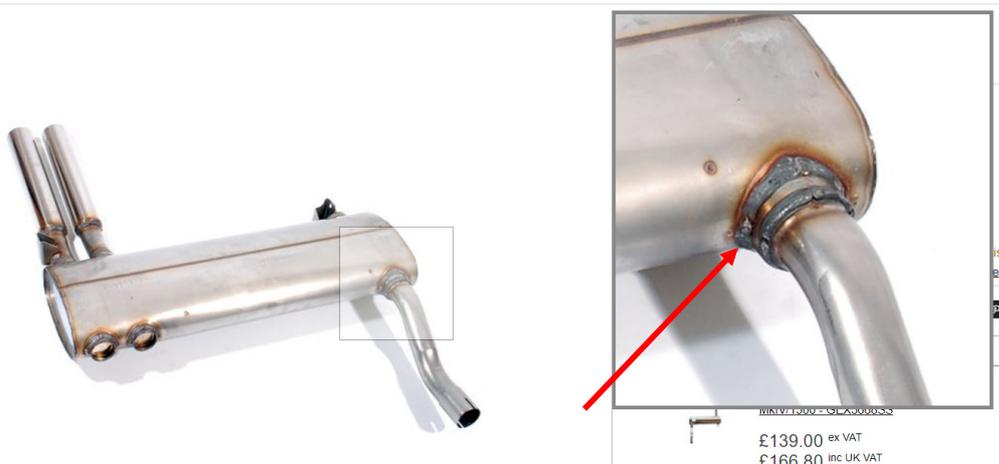
Stainless Steel Sports Rear Silencer - Spitfire MkIV/1500 - GEX3668SSSPORT

Photo 11 shows a zoomed in view of the **GEX3668SS**” model rear exhaust muffler, at the area where the single exhaust pipe connects to the centre exhaust pipe (photograph extracted from web research). Welding marks were seen surrounding the area where the single exhaust pipe joins the rear exhaust muffler (arrowed). Welding marks were also found at the same area on the rear exhaust muffler that was fitted on the Motor Car. Refer to photograph 6 & 7 above for comparison.

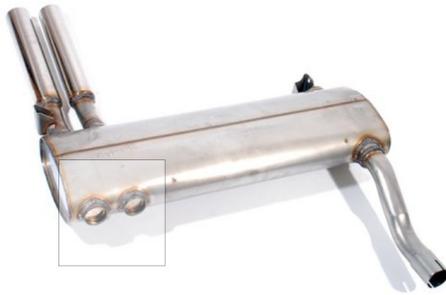
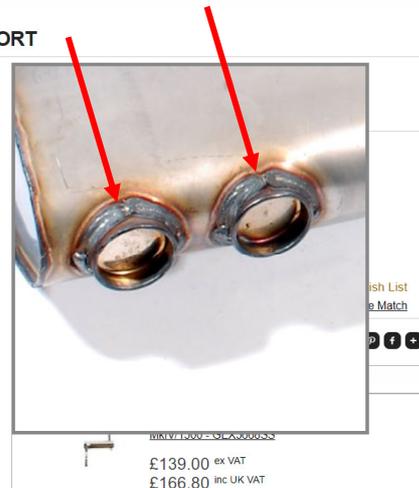
Stainless Steel Sports Rear Silencer - Spitfire MkIV/1500 - GEX3668SSSPORT

Photo 12 shows a zoomed in view of the **GEX3668SS** model rear exhaust muffler, at the 2 sealed openings on the side surface area (photograph extracted from web research). Welding marks were seen surrounding the 2 openings (arrowed). Welding marks were also found at the same area on the rear exhaust muffler that was fitted on the Motor Car. Refer to photograph 8 above for comparison.

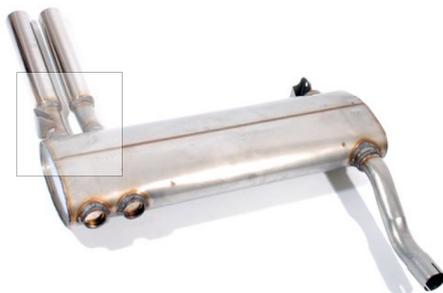
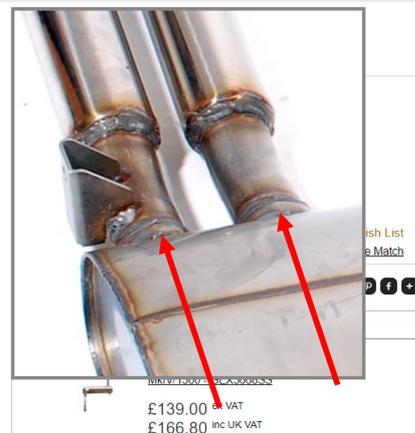
Stainless Steel Sports Rear Silencer - Spitfire MkIV/1500 - GEX3668SSSPORT

Photo 13 shows a zoomed in view of the **GEX3668SS** model rear exhaust muffler, at the area where the 2 exhaust end pipes join the rear exhaust muffler (photograph extracted from web research). Welding marks were seen surrounding the area where the 2 exhaust end pipes join the rear exhaust muffler (arrowed). Welding marks were also found at the same area on the rear exhaust muffler that was fitted on the Motor Car. Refer to photograph 4 & 5 above for comparison

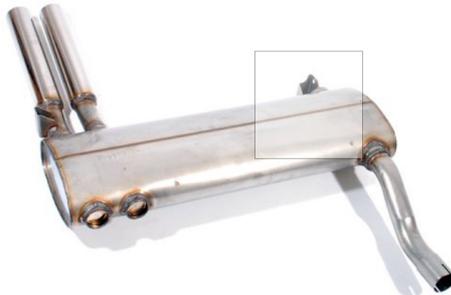
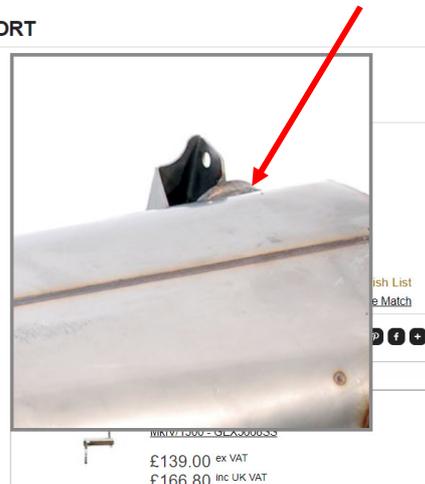
Stainless Steel Sports Rear Silencer - Spitfire MkIV/1500 - GEX3668SSSPORT

Photo 14 shows a zoomed in view of the **GEX3668SS**” model rear exhaust muffler, at the sealed opening on the side surface area (photograph extracted from web research). Welding marks were seen surrounding the opening (arrowed). Welding marks were also found at the same area on the rear exhaust muffler that was fitted on the Motor Car. Refer to photograph 9 above for comparison.
