## ASSIGNMENT

To Inspect Vehicle No: SKN 9573A

The U/C / Chassis frame / Body Structure affected due to collision.

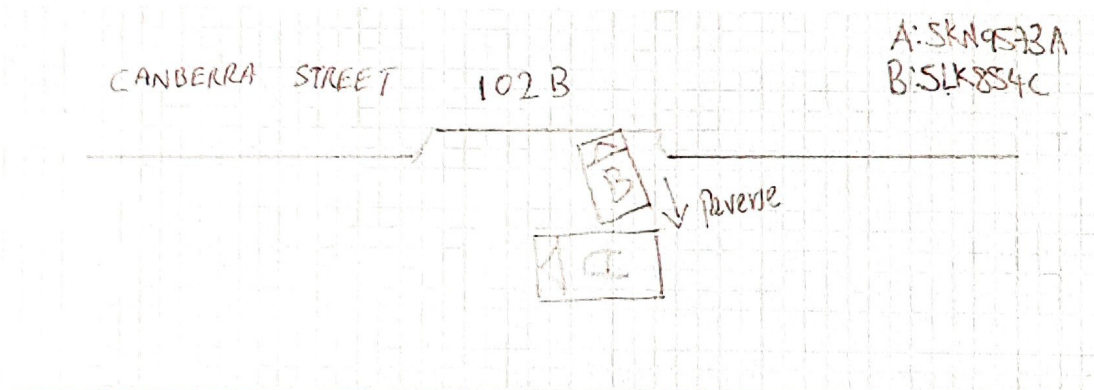
**Sketch Plan**

On the stated date and time, I (SKN 9573A) was travelling towards the drop-off point of 102 Canberra Street. Suddenly, I felt an impact at my right passenger door. I alighted and found out that (SLK 854G) had reversed and collided onto my vehicle.
