## ASSIGNMENT

Remark: The veh had commenced its  
repair at the time of inspection.

The U/C / Chassis frame / Body Structure affected due to collision.

ESTIMATED COST OF REPAIR FOR TOYOTA FORTUNER 2WD (2694CC)(2013) SML9008C

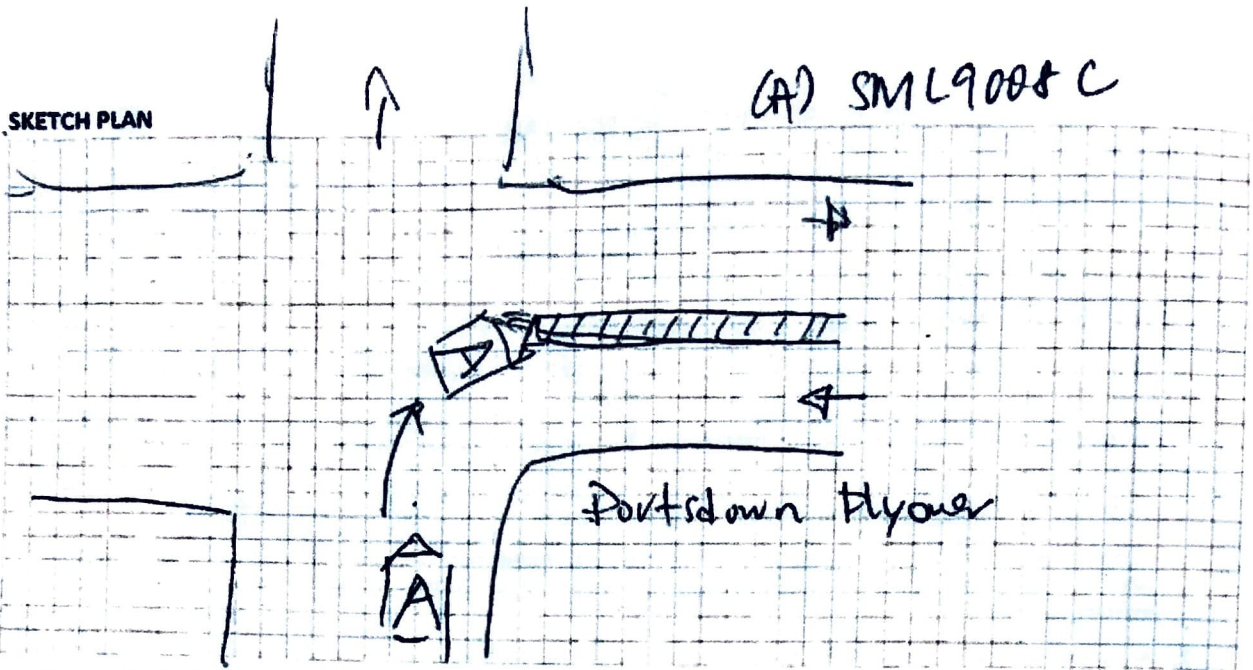
SKETCH PLAN

On 16/2/22 at 11:15 am. I was driving my vehicle (A) SML9008C at Portsdown Flyover towards Alexandra. When I turn right, suddenly my vehicle hit onto the curve/kerb and traffic light. No damage to Traffic Light. My car is damaged.
