ASSIGNMENT

☒ OD / TP / WS / TP RES / OD RES / EVA / INV / MVTo Inspect Vehicle No: SKR 80884at Workshop m/s TTS EUROKARSof 383, SIN MINH PR

Veh No: SKR 80884 Yr Regn: 2017 / OCTType: ☒ M. Car / M. Cycle / Bus / Van / Lorry / Taxi / Prime Mover /

Make: MERCEDES BENZ E200DSE A.C.C. 1950Colour: BLACK A/C: Insured / Std / NI / NASp. Reading: 114136 T/Radio: Insured / Std / NI / NA

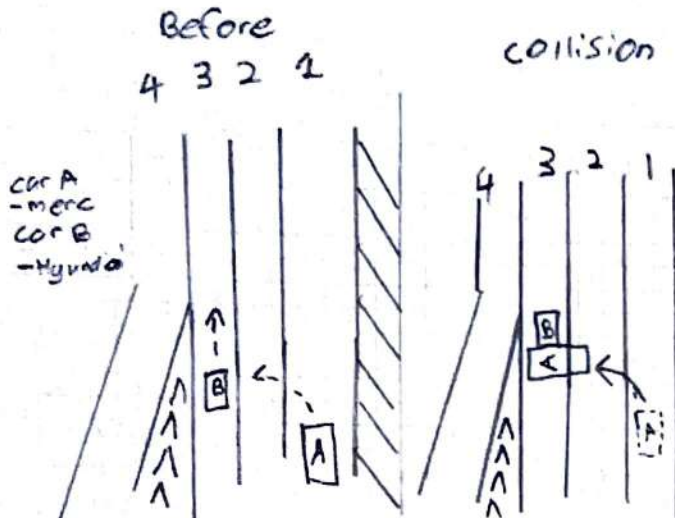
SKETCH PLAN

Around 1850 on the 3rd March 2022, the merc was driving along the TPE just before the merge from Pasir Ris Drive 12 but after the overhead bridge. The incident began when the front right tire skid as the merc was along the Lane 1. The front nose of the car swerved to the right and was heading for the metal barrier. I then avoided and turned left, and the car went into a skid drifting into lane 2 and into lane 3 while being perpendicular to the road. This is where the right driver side door collided with the rear of a Hyundai and we ended up along the chevrons at the merger where our cars came to a stop. No other cars or environment was damaged. There were 2 people in the Hyundai, the driver and 1 front passenger.
