**AUTOMOBILE ASSESSMENT REPORT**

Assessed Vehicle No : **SLQ9184L**  
Car Make and Model : **~~VOLKSWAGEN~~ *SEEP.* TOURAN 1.6 TDI AT 1T332Z**  
Date of Accident : **11-Mar-22**  
Date of Assessment : **11-Mar-22**

We have carried out a physical assessment of SLQ9184L at our workshop Auto Insure Pte Ltd sustained damages to the RH SIDE portion of the vehicle.

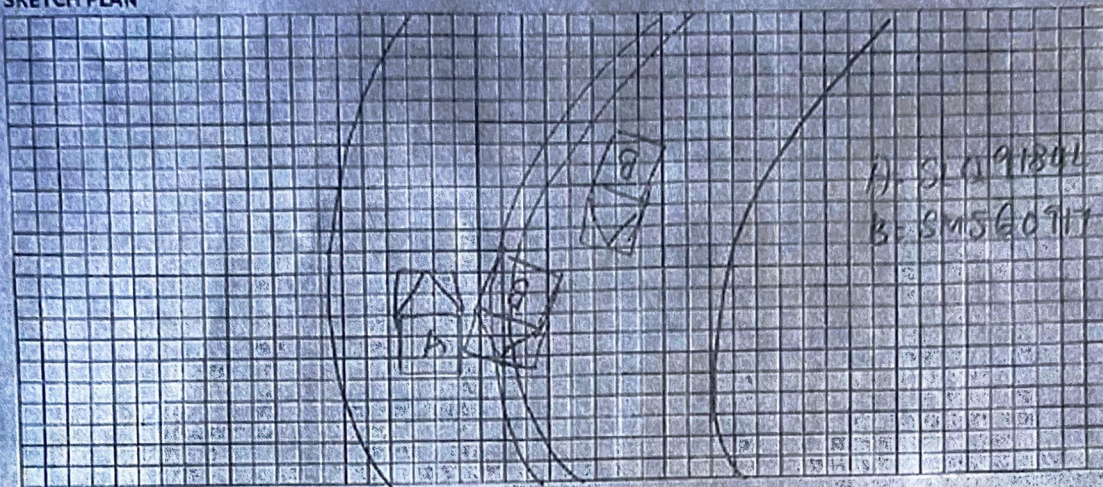
# SKETCH PLAN

On 11/3/2022 at about 2330hrs I was travelling Along South Buona Vista Road. As I was driving Along vehicle B: SMS60911 came from the other lane at a very fast speed & collide to my right hand side door.
