Your Ref: Toyota Engine
(number 2AZB143526)
Our Ref : CI/TP22002752/D

INSPECTION REPORT OF A TOYOTA ENGINE WITH NUMBER 2AZB143526

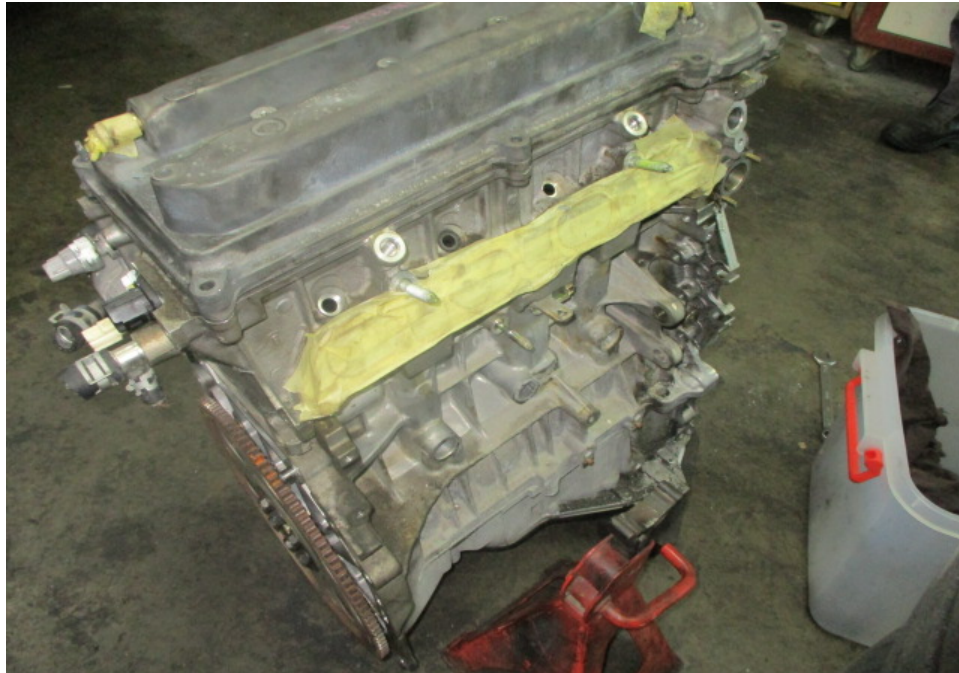
Photo 1 shows a general view of the Toyota engine that I had inspected. The Toyota engine was observed to be a used engine and was not fitted on any motor car. It was also observed to be a complete assembly with all mechanical parts still intact, within the engine housing.

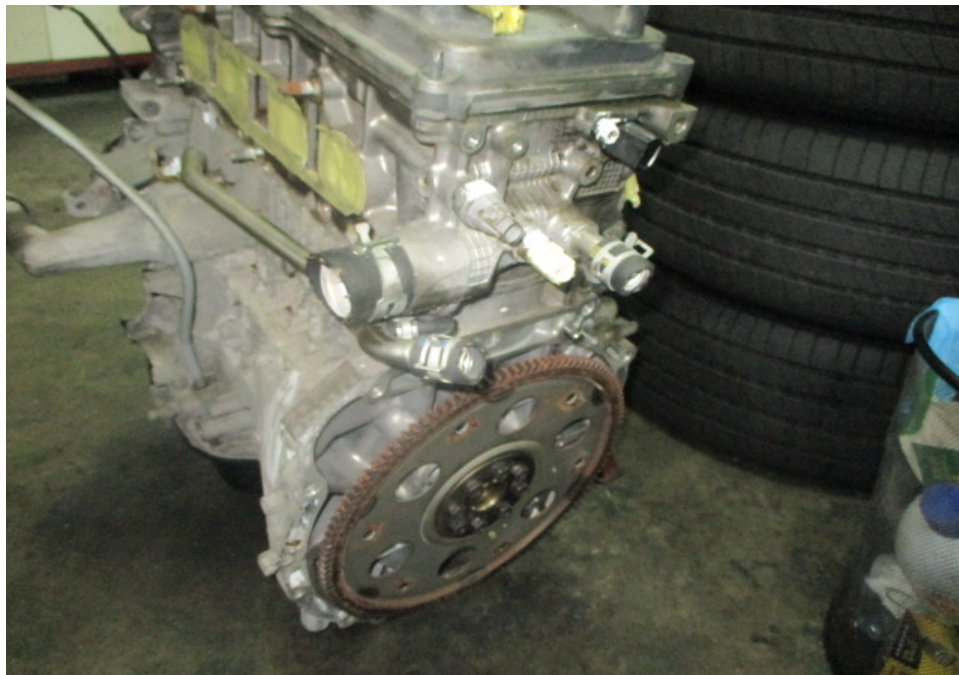
Photo 2 shows a general view of the Toyota engine that I had inspected. My visual examination of the engine housing revealed the housing to be of serviceable/satisfactory condition. There was no crack and/or hole observed on the engine housing.

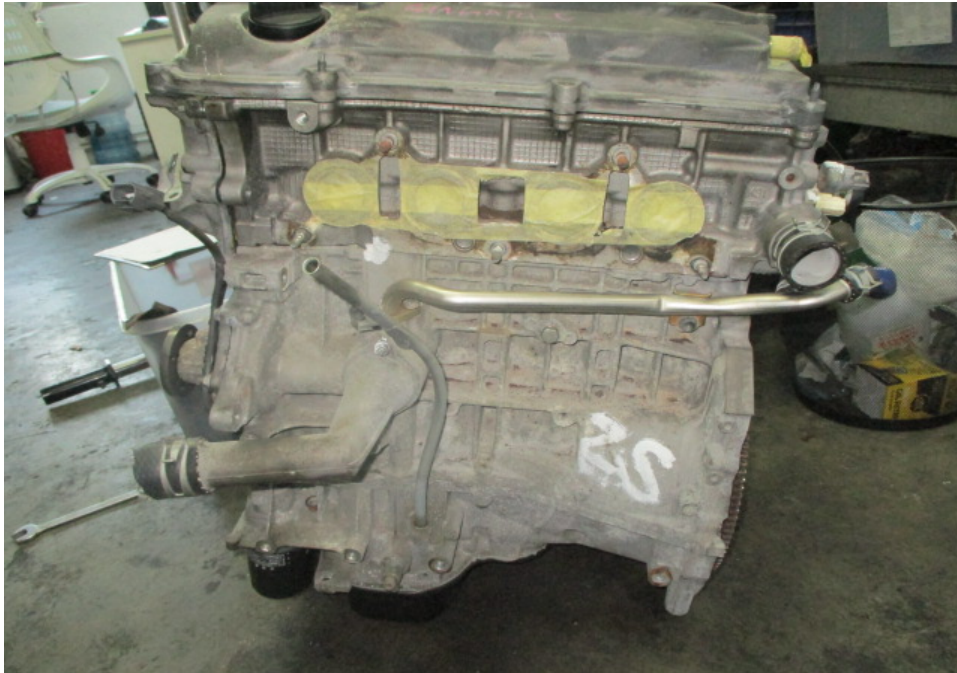
Photo 3 shows a general view of the Toyota engine that I had inspected. My visual examination of the engine housing revealed the housing to be of serviceable/satisfactory condition. There was no crack and/or hole observed on the engine housing.

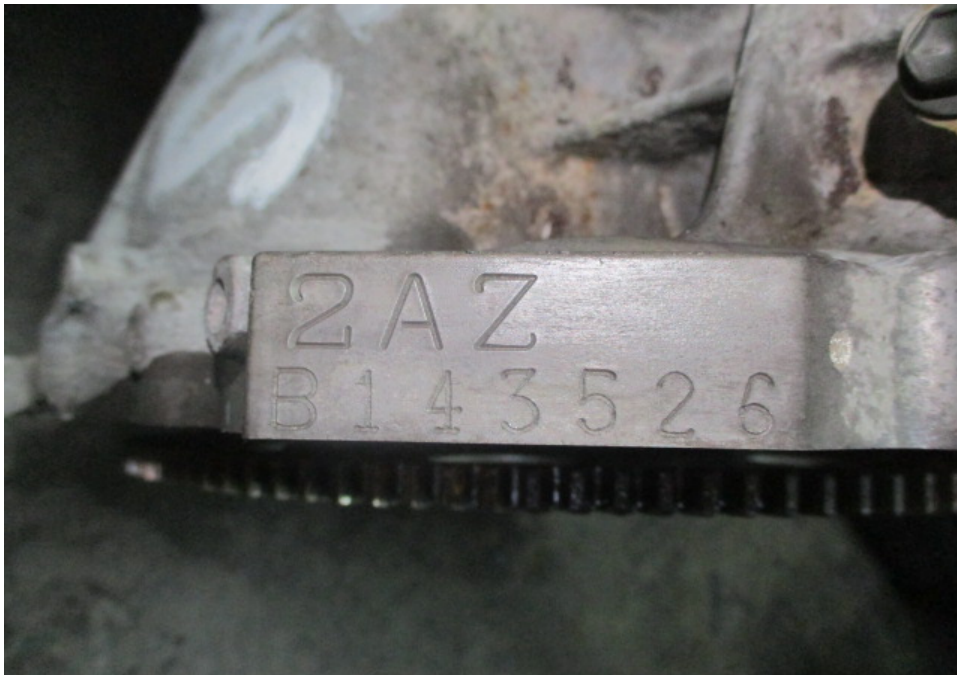
Photo 4 shows the engine number engraved on the housing of the Toyota engine that I had inspected. The engine number was 2AZB143526.

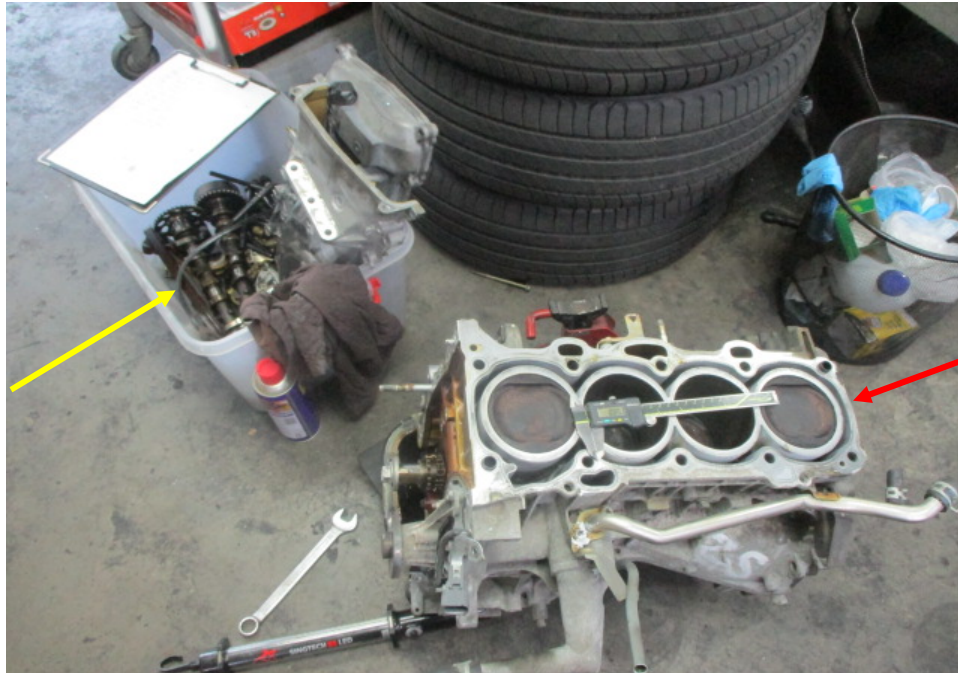
Photo 5 shows the top block (yellow arrow) of the Toyota engine separated from its bottom block (red arrow). This was to enable me to carry out measurements of its cylinders, in particular the bore and stroke measurements of each cylinder, which typically can be used to determine the engine displacement or more commonly referred to as engine cc.

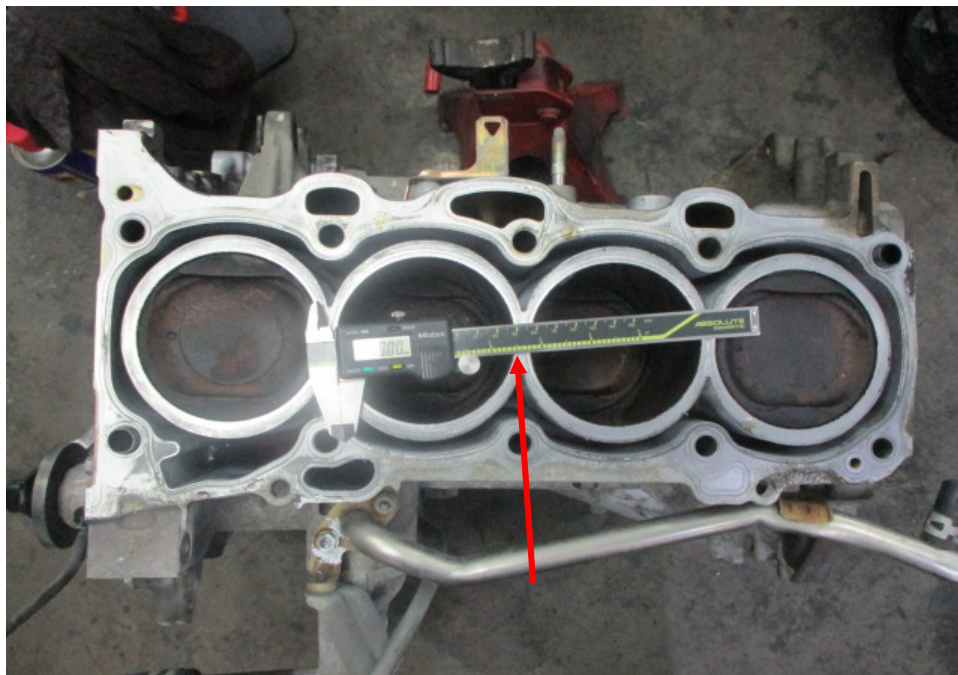
Photo 6 shows the bottom block of the Toyota engine and the digital Vernier Caliper (arrowed) that was used to measure the bore and stroke measurements of each cylinder. The digital Vernier Caliper was calibrated before the start of the measurements.

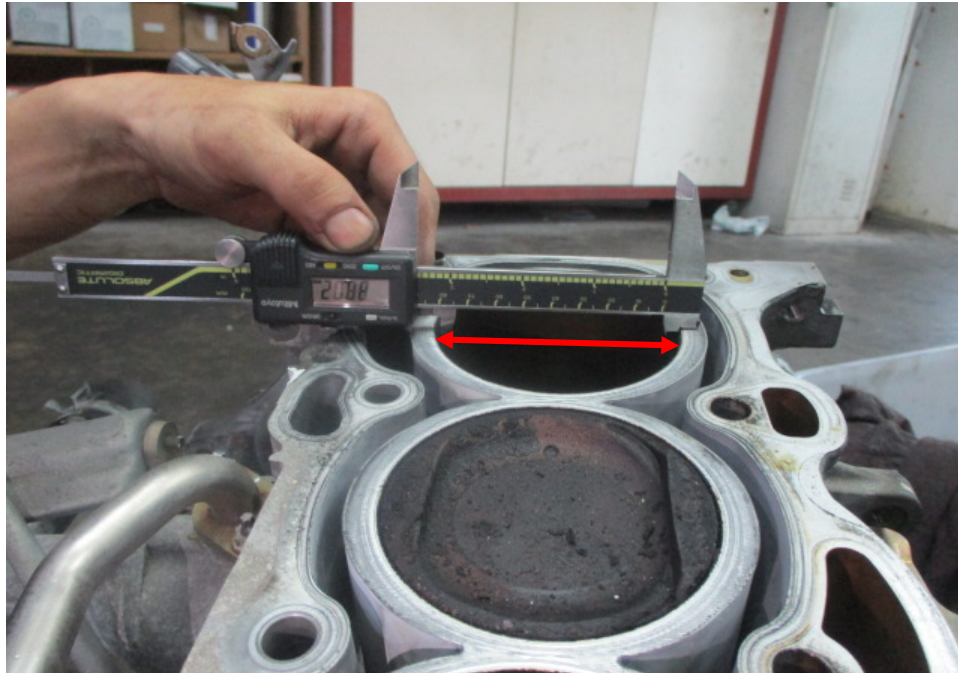
Photo 7 shows measurement being carried out to the bore (arrowed) of cylinder 1 of the Toyota engine. The measurements were carried out using a digital Vernier Caliper that was calibrated before the start of the measurements.

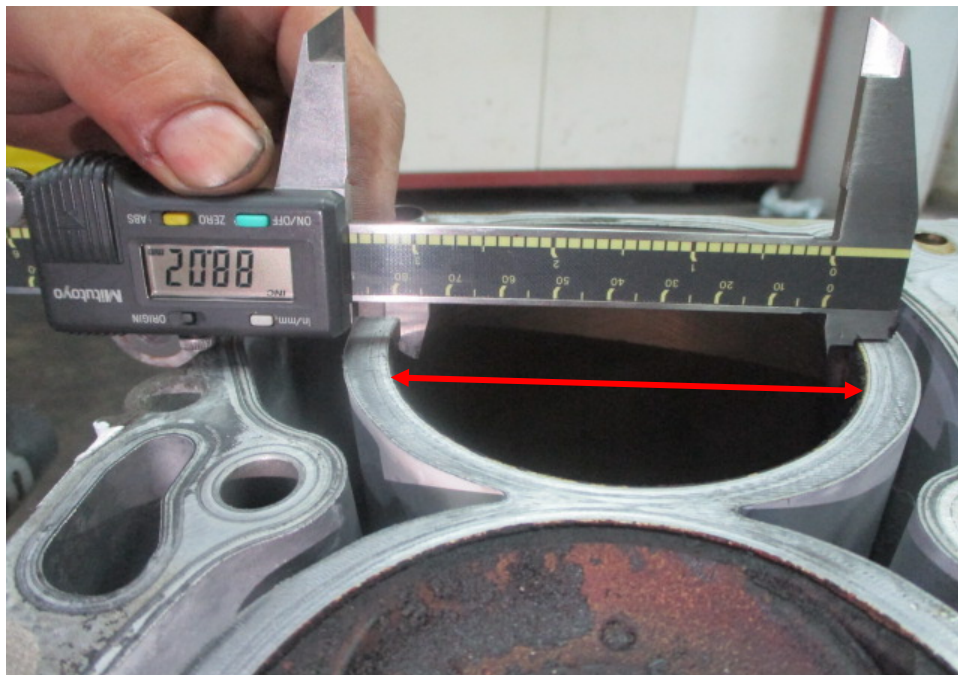
Photo 8 shows measurement being carried out to the bore (arrowed) of cylinder 1 of the Toyota engine, which was recorded to be 88.02mm.

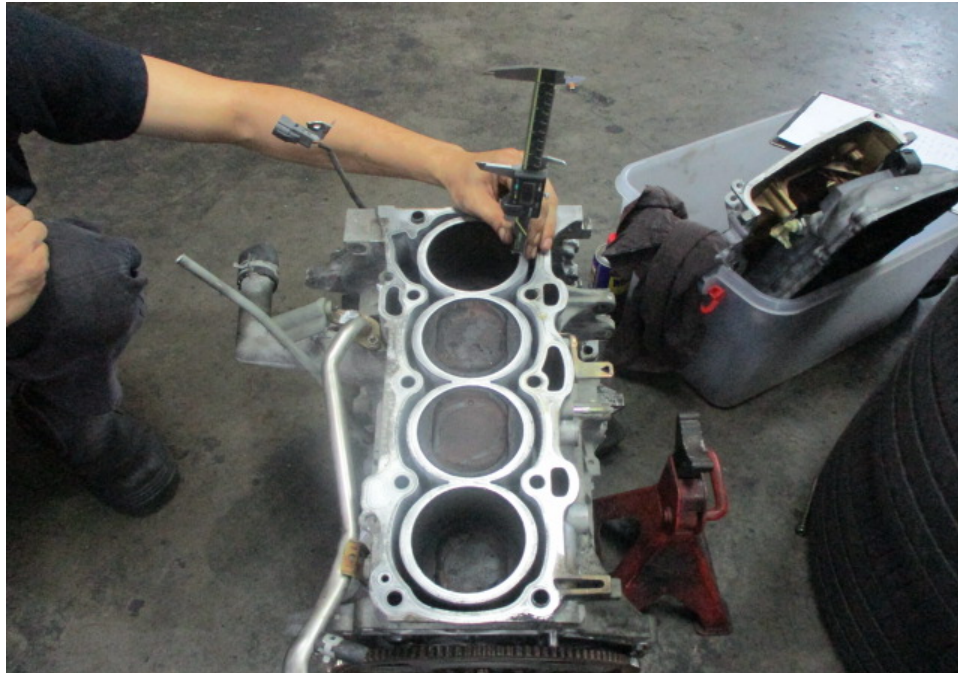
Photo 9 shows measurement being carried out to the stroke of cylinder 1 of the Toyota engine. The bore and stroke measurements of the Toyota engine were carried out using a digital Vernier Caliper that was calibrated before the start of the measurements.

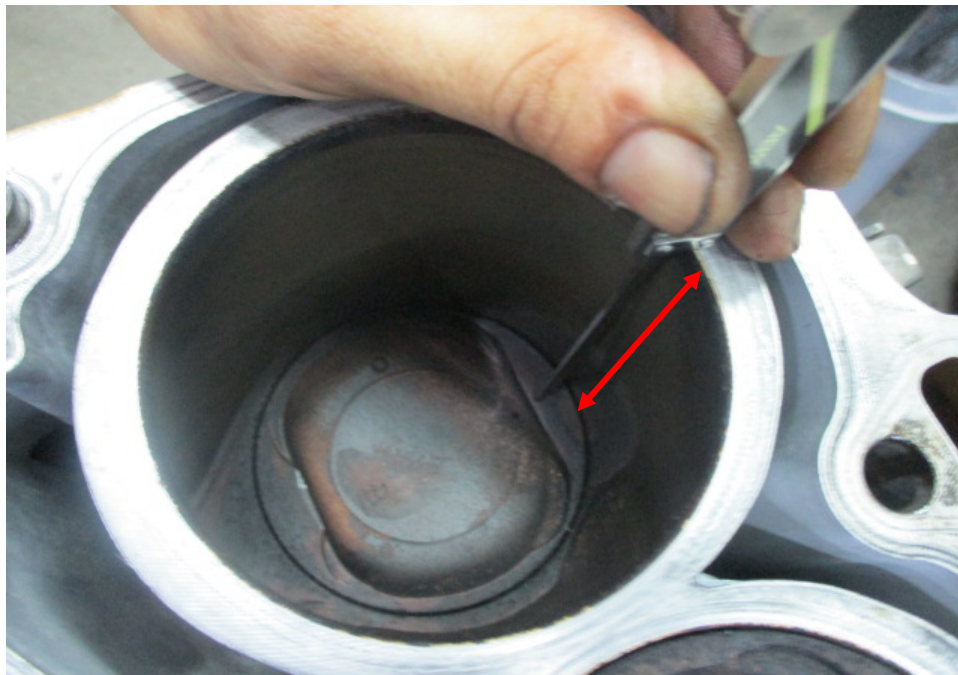
Photo 10 shows measurement of the stroke (arrowed) for cylinder 1 of the Toyota engine that I had inspected. The bore and stroke measurements of the Toyota engine were carried out using a digital Vernier Caliper that was calibrated before the start of measurements.

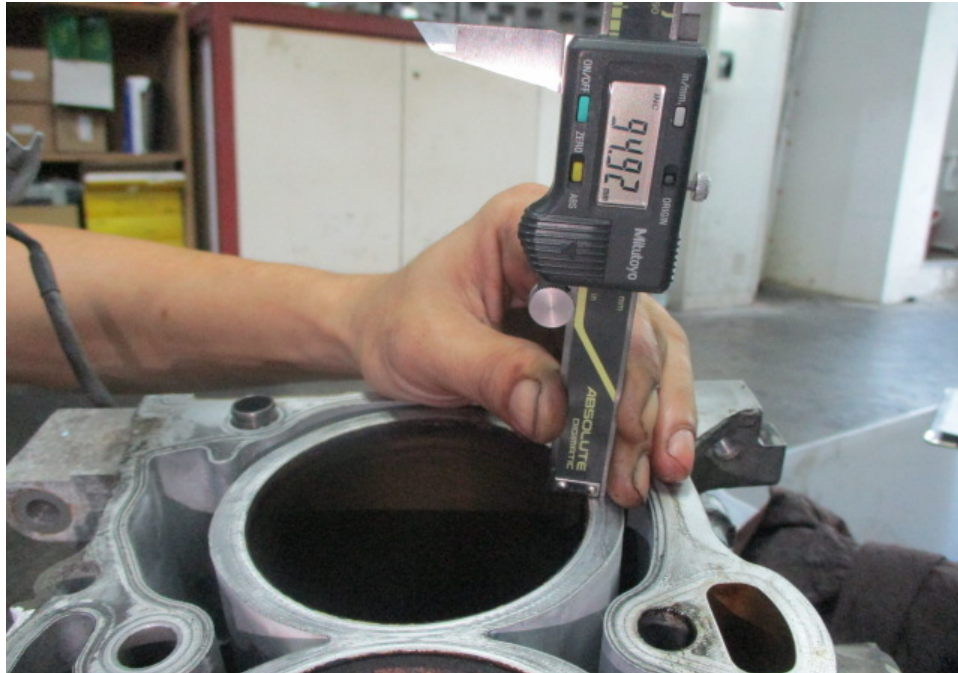
Photo 11 shows the stroke measurement of cylinder 1, which was recorded to be 94.92mm.

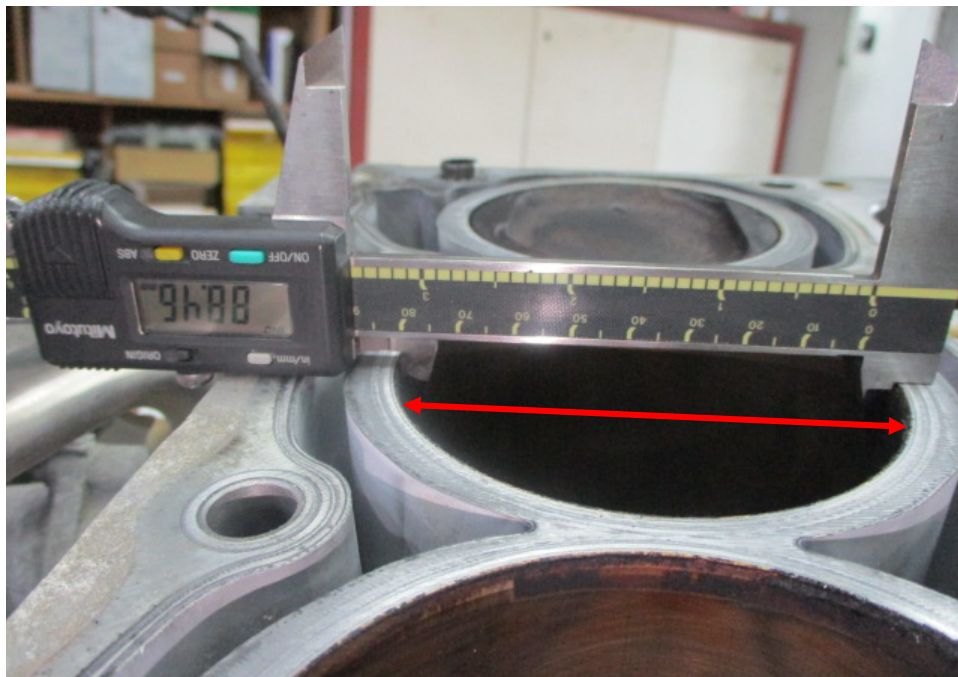
Photo 12 shows measurement being carried out to the bore (arrowed) of cylinder 2 of the Toyota engine. The bore measurement of cylinder 2 was recorded to be 88.46mm.

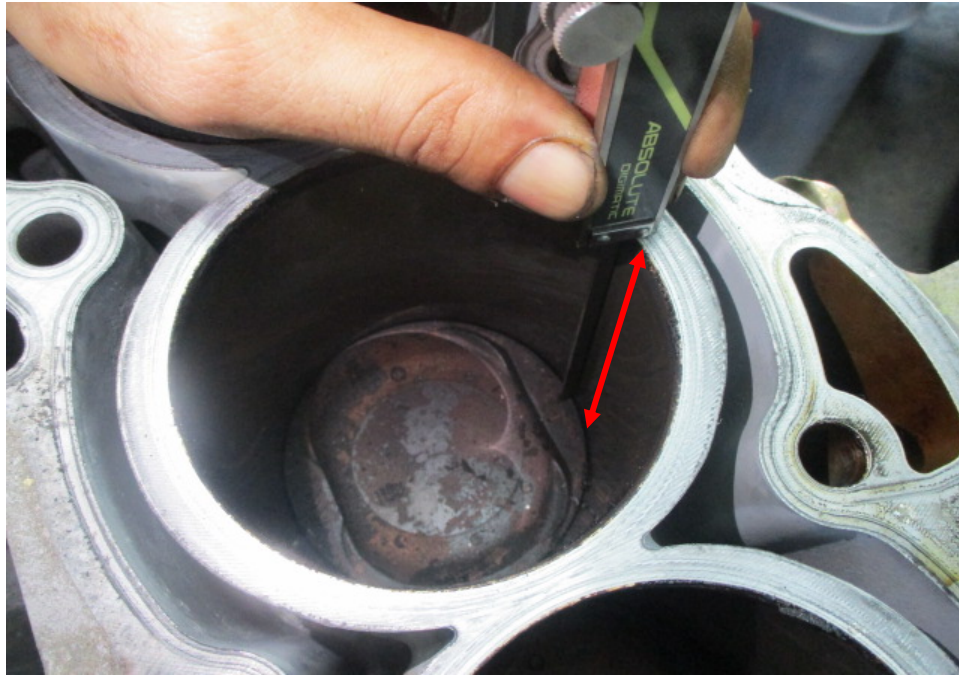
Photo 13 shows measurement of the stroke (arrowed) for cylinder 2 of the Toyota engine that I had inspected. The bore and stroke measurements of the Toyota engine were carried out using a digital Vernier Caliper that was calibrated before the start of the measurements.

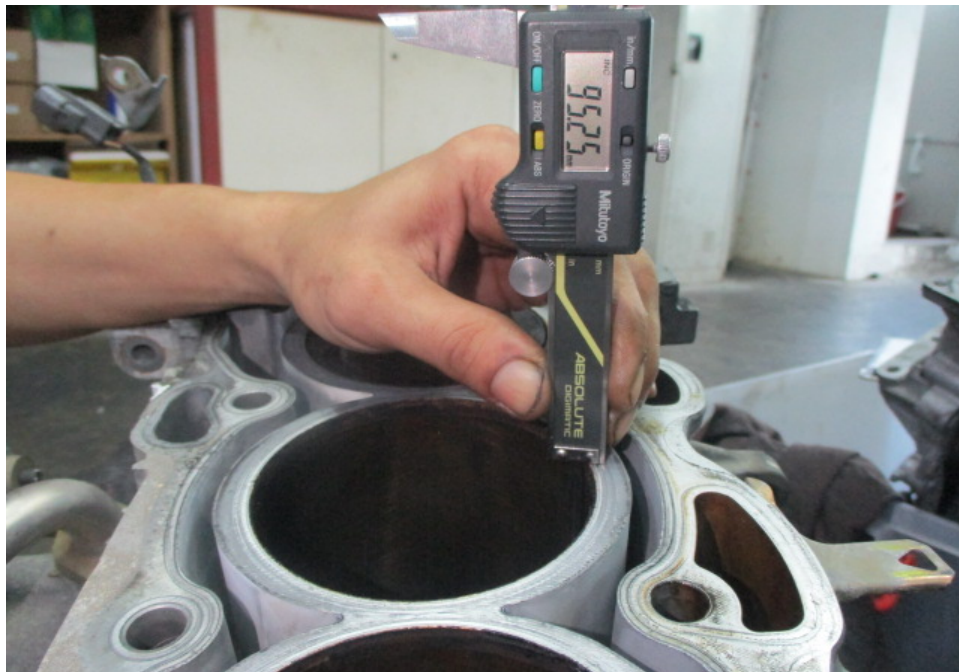
Photo 14 shows the stroke measurement of cylinder 2, which was recorded to be 95.25mm.

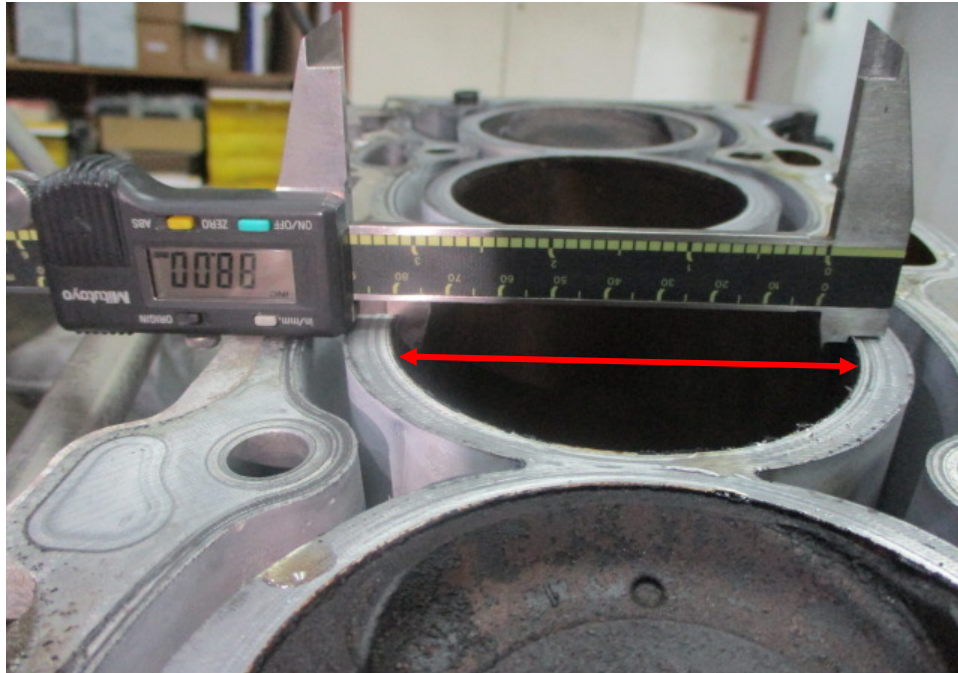
Photo 15 shows measurement being carried out to the bore (arrowed) of cylinder 3 of the Toyota engine. The bore and stroke measurements of the Toyota engine were carried out using a digital Vernier Caliper that was calibrated before the start of measurements. The bore measurement of cylinder 3 was recorded to be 88.00mm.

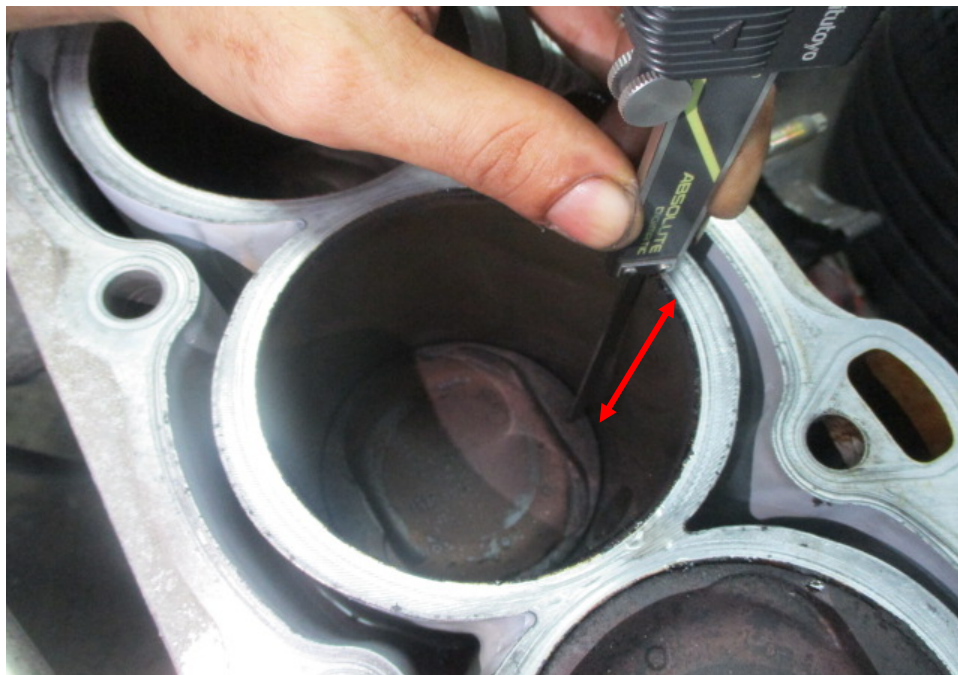
Photo 16 shows measurement of the stroke (arrowed) for cylinder 3 of the Toyota engine that I had inspected. The bore and stroke measurements of the Toyota engine were carried out using a digital Vernier Caliper that was calibrated before the start of measurements.

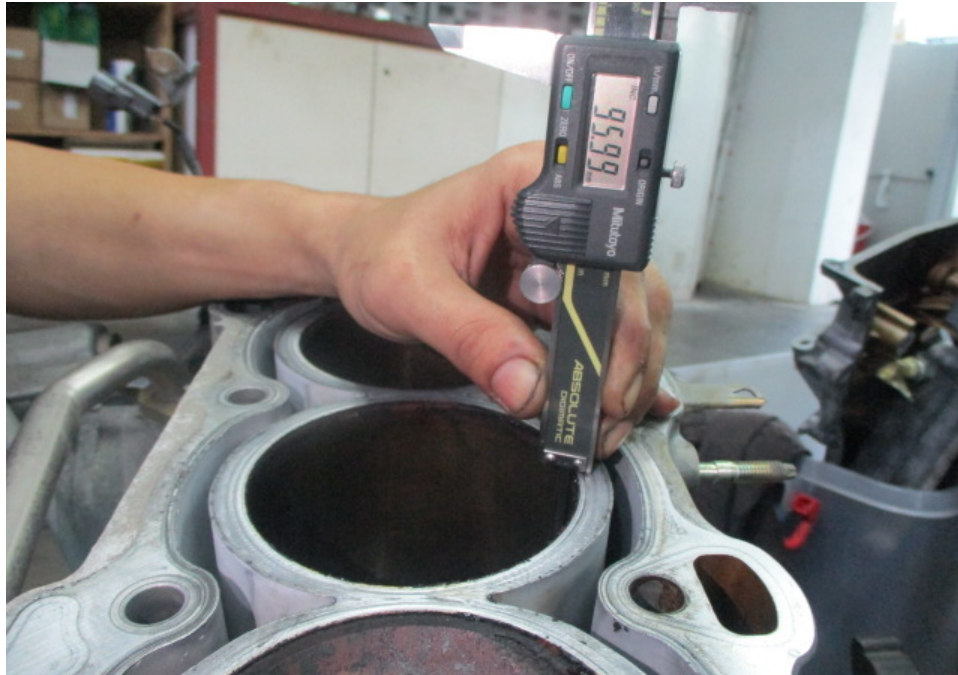
Photo 17 shows the stroke measurement of cylinder 3, which was recorded to be 95.99mm.

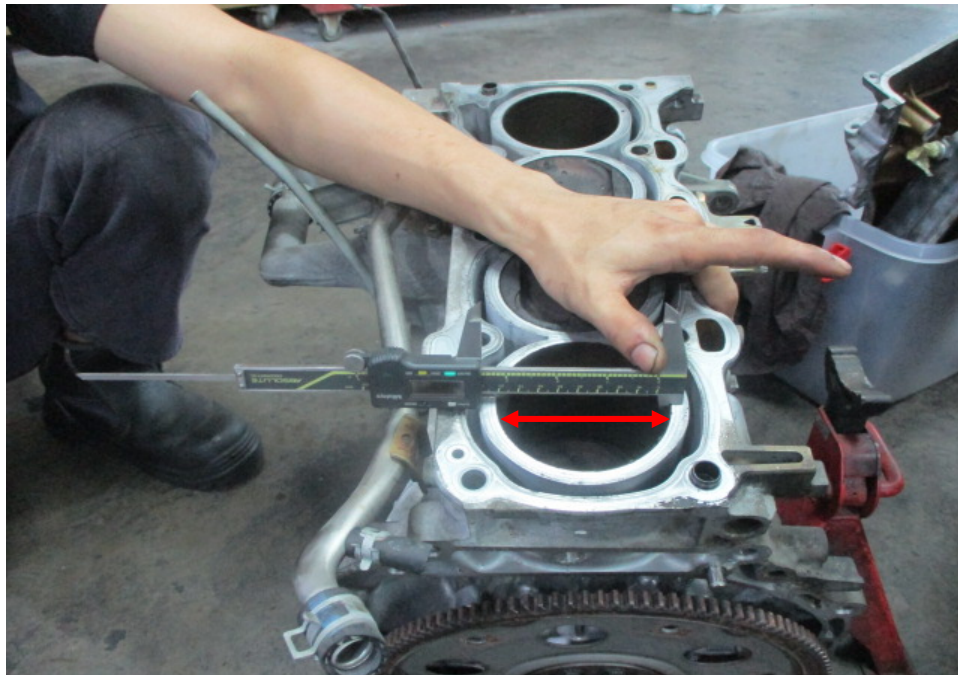
Photo 18 shows measurement being carried out to the bore (arrowed) of cylinder 4 of the Toyota engine. The bore and stroke measurements of the Toyota engine were carried out using a digital Vernier Caliper that was calibrated before the start of measurements.

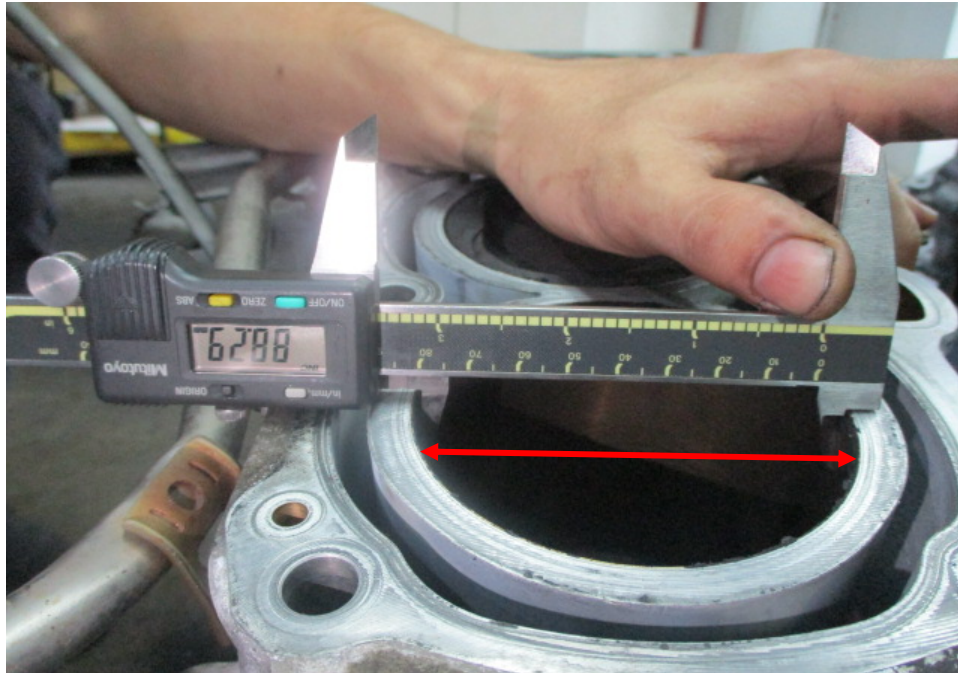
Photo 19 shows measurement being carried out to the bore (arrowed) of cylinder 4 of the Toyota engine. The bore measurement of cylinder 2 was recorded to be 88.29mm.

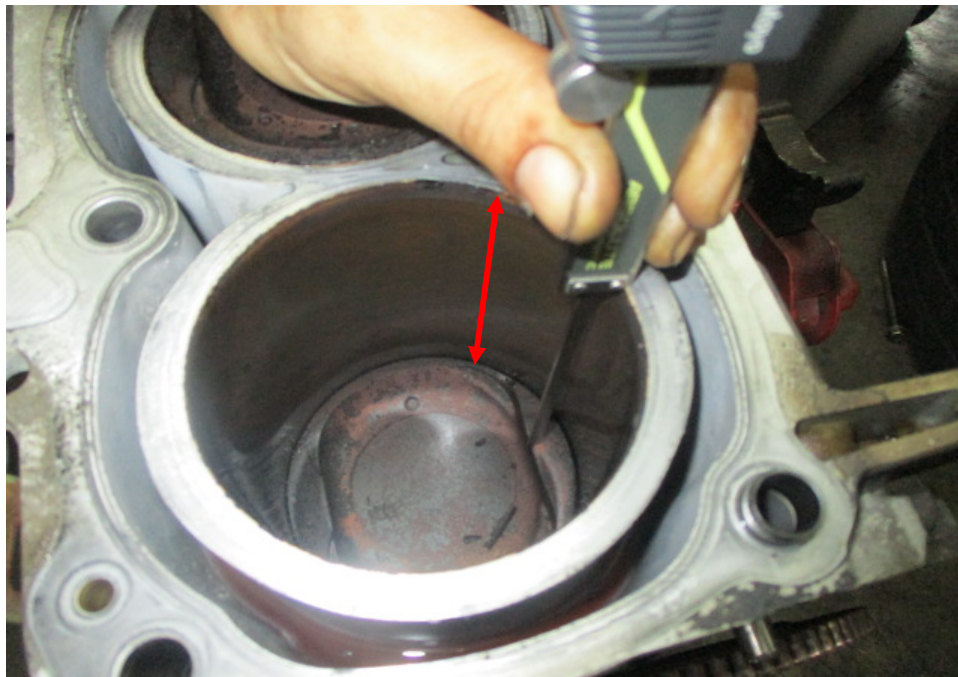
Photo 20 shows measurement being carried out to the stroke (arrowed) of cylinder 4 of the Toyota engine. The bore and stroke measurements of the Toyota engine were carried out using a digital Vernier Caliper that was calibrated prior to the start of measurements.

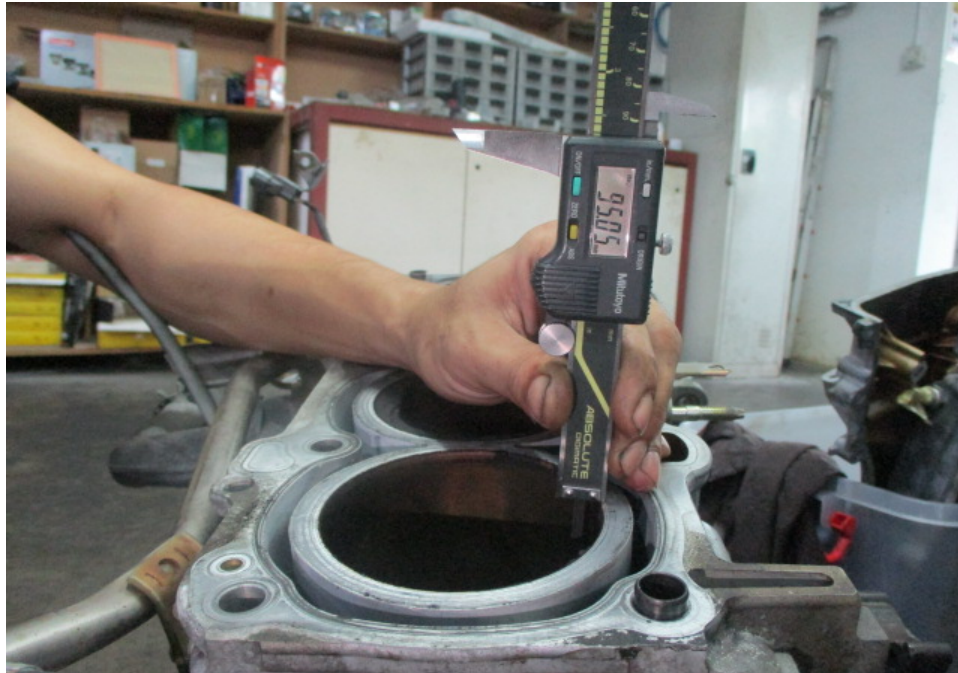
Photo 21 shows the stroke measurement of cylinder 4, which was recorded to be 95.05mm.
