Vehicle No. YL 3879C

4.		Description	on of Damages		
	THE VEHICLE SU	STAINED DAMAGES AT THE REA	AR PORTION.		
	DAMAGES SEE D	ETAILS.			
5.		General	Information		
	Accident Date	10/04/2022	Inspection Date		14/04/2022
	Survey held at	14 TAMPINES IND DRIVE, CTM	BUILDING, S (52853	80)	
	Repairer	COMPLETE VMS PTE LTD			
5a.		Re	emarks		
		ON WAS CONDUCTED ON A"WIT CE TO YOUR INSTRUCTIONS, W			
5b.		Estimate l	Days of Repair		
	ESTIMATED NORI	MAL PERIOD FOR REPAIR:	3 \	Worki	ng Days

ADJUSTMENT ON REPAIR COST FOR VEHICLE NO. YL 3879C

PHOTOGRAPHS FOR VEHICLE NO. YL 3879C

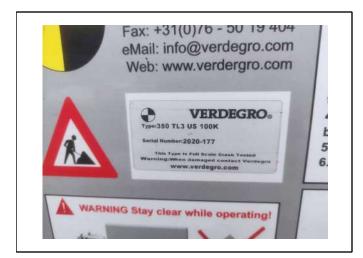
All of a sudden, I felt an impact from the rear (near to lamp post 621). I then stopped my vehicle and went down to make a check. I realized that a vehicle (SND681Y) had collided onto my company vehicle. My rear Truck Mounted Attenuator (TMA) suffered some damages while the vehicle suffered some damages on his front bumper. The driver was bleeding on his left side of the face.

Qty	Description of Parts	Condition	Estimate By Workshop (\$))	Our Adjusted (\$)
	REPLACEMENT OF PARTS			
1	VERDEGRO US-100K (TMA'S) TRUCK MOUNTED ATTENUATORS (PASS NCHRP350 STS LEVER 3) C/W HYDRAULIC LIFT UP	DENTED	58,000.00	58,000.00
	LESS 10% DISCOUNT		-	-5,800.00
			58,000.00	52,200.00
	<u>LABOUR</u>			
	LABOUR CHARGE.		2,800.00	1,000.00
			2,800.00	1,000.00
	GRAND TOTAL		60,800.00	53,200.00
