Accident/Incident Investigation Report

Reported By:	Sulaiman Ahmad	Report No:	05(R3)
Designation:	WSHC	wshc	21-03-2022

Description of Incident: Public cars parked below the expo Foyer 1 was stained by paint.

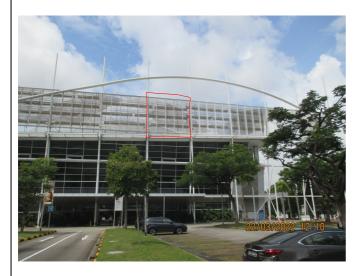
On 21st March 2022, at 1:00pm ISO TEAM C & P PTE LTD was carrying out spray painting work to steel trusses at Foyer 1 roof. Spray paint particle was blown away onto vehicles parked in public carpark below the Expo foyer 1. Thus, stained vehicles that were parked there.

Location of painting works being carry out.

- 4. Also, unauthorized works was carried out without any canvas protection at the opposite side of the spray paint direction.
- 5. Change of wind direction during the spray paint work was carried out on top of foyer 1 roof. Spray paint particle was blown to direction of car park where vehicle parks.

- 6. Worker had adjusted the spray pressure at 8-10 psi, resulted residue to paint being blown away due to change of wind direction.

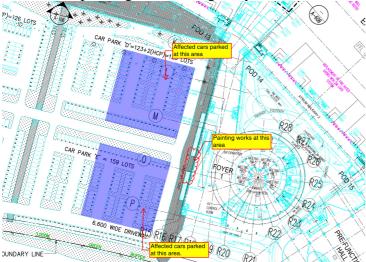
Site plan shows the affected car parking area.

See Appendix 1 for list of affected cars.
