VEHICLE DAMAGE ASSESSMENT REPORT

Ref No : 2022/05046 Date of Report
Claim Type : Third Party Date of Request
Third party vehicle : SLB9138A Date of Accident
Insured Vehicle : Date of Inspection

Registration Plate No SLB9138A Engine Modification NIL Model / Make : Toyota Altis Pre-accident damage NIL Colour Grey **General Condition** Good 2019 Manufacturing Year General Paint Work Good **Engine No** : 1ZRY293183 Serviceable Steering **Engine Capacity** 1600 cc Handbrake Serviceable **Chassis No** : MR053REH104551178 Footbrake Serviceable

At the time of inspection, this vehicle sustained damages to the Front Lh Portion.

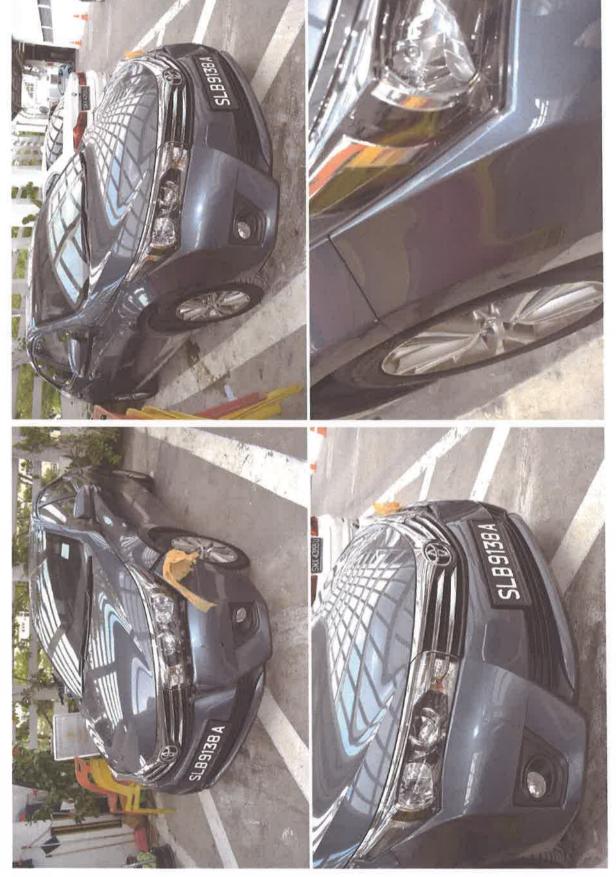
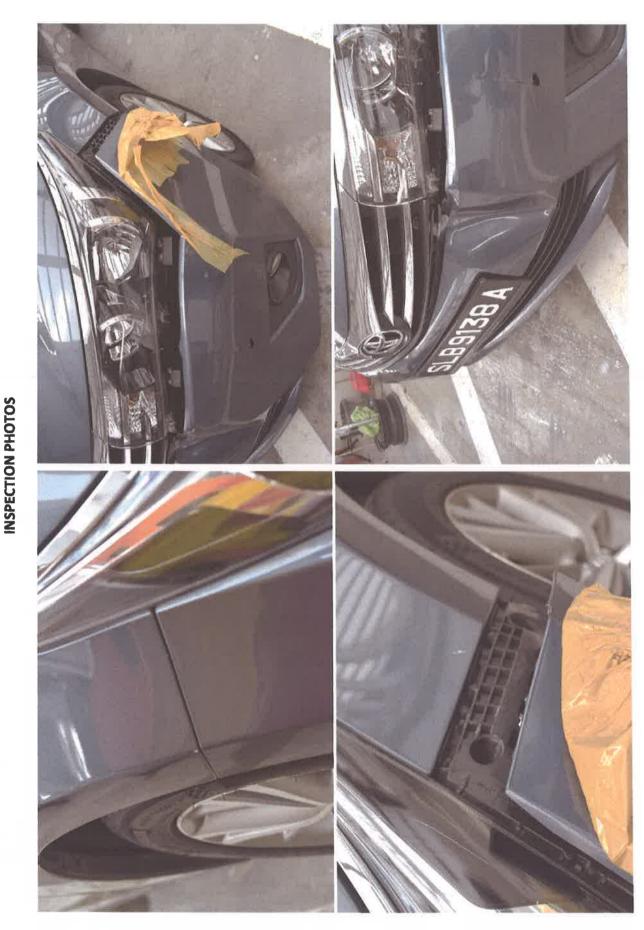
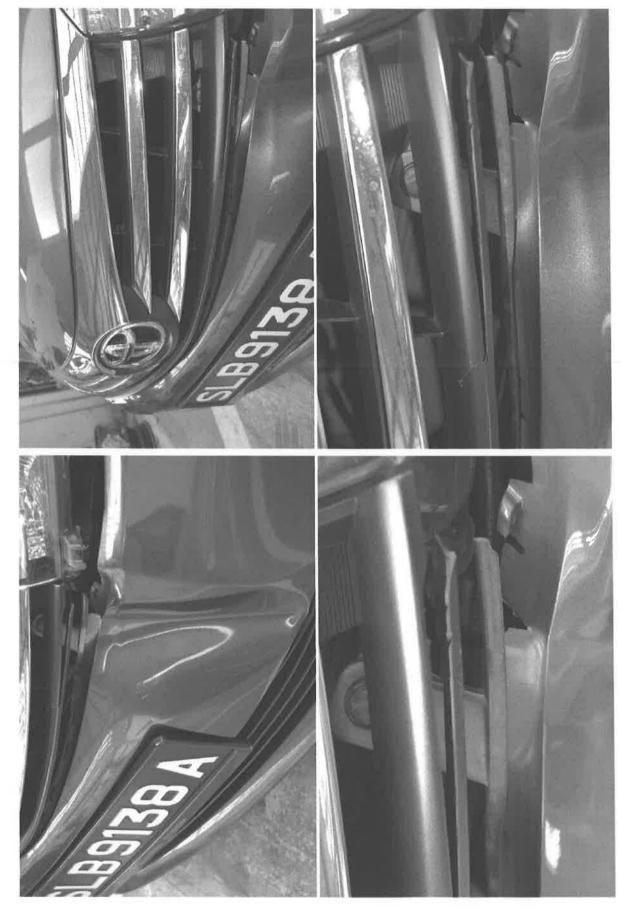
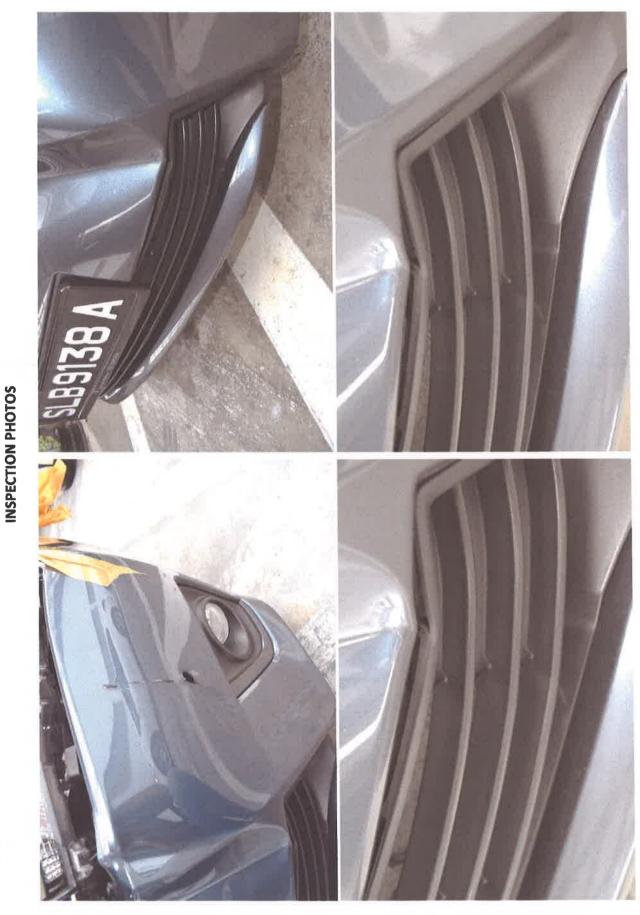
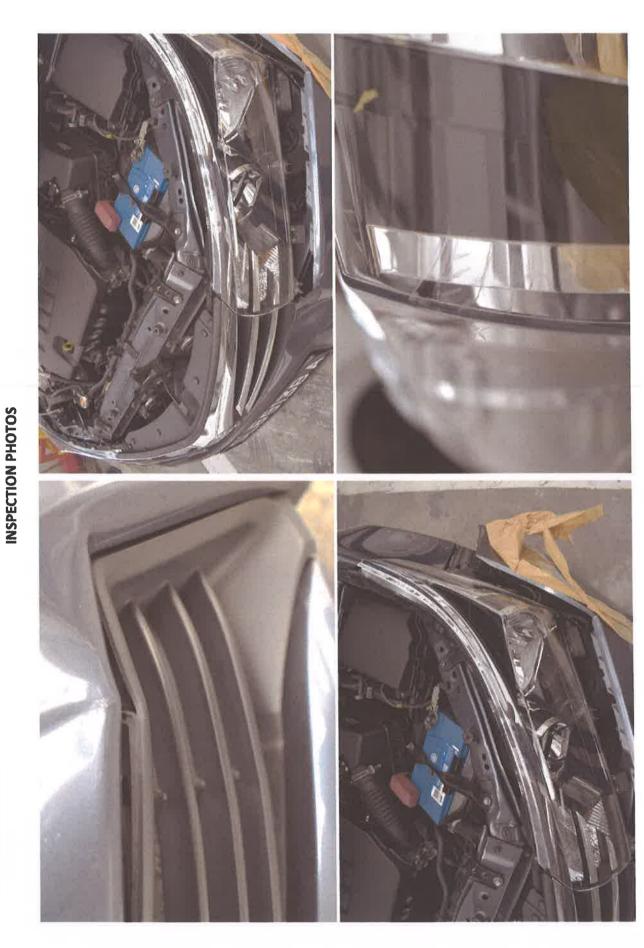
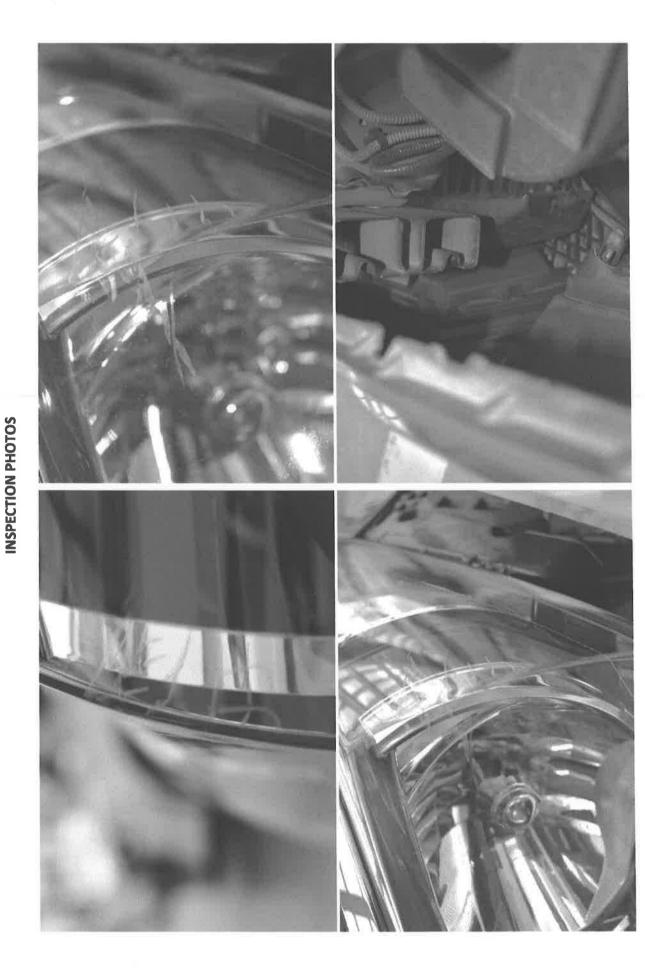
INSPECTION PHOTOS

Front bumper, front lh fender dented, lh headlamp grazed, support panel push in etc.

The workshop has agreed to undertake the repair on a Lump Sum Basis, and/or use of ex-stock/reconditioned parts whichever is possible (having taken into consideration to repair instead of replacements).

The final adjusted Lump Sum contract amount is \$\$3,700.

Under normal circumstances, the repair period would be about 5 working days.
