**ASSIGNMENT**

Veh No: SHA 6064 B Yr Regn: Jan / 2020  
 Type: M/Car / M/Cycle / Bus / Van / Lorry / Taxi / Prime Mover /  
 Truck / Trailer or  
 Make: Hyundai Ioniq c.c. 1580  
 Colour: Blue A/C: Insured / Std / NI / NA  
 Sp. Reading: 277495 T/Radio: Insured / Std / NI / NA  
 Eng/No: G4LEKU 404652  
 C/No: KMHC851CVLW188089  
 Gen. Cond: Good / Fair / Poor / Burnt  
 Steering: Inorder / Jammed / Leaked / Burnt or  
 Brake: Inorder / Jammed / Leaked / Burnt or  
 Mod: Nil / S/Rim / STD A/Rim or  
 Tyre Size: F: 195/65R15  
 R: 11  
 BS / DUN / EXNOVA / GY / FS / LIZA / MIC / OHTSU / PIR / SUMI /  
 TOYO / YOKO or Westlake  
 Front S mm Rear S mm  
 R/Bal. S mm L/Bal. S mm  
 D.O.A. 23/05/2022 D.O.I. 31/05/2022  
 Survey held at Berut Sin Ming  
 Des. of Damages: Frt / Rear / O/S / N/S / U/C / Rooftop or  
H/S Runt  
 The U/C / Chassis frame / Body Structure affected due to collision.

**VEHICLE ALIGNMENT REPORT**  
HYUNDAI, IONIQ (AE HEV) Hybrid, 17-17 (Customized)

## REPAIR ESTIMATE

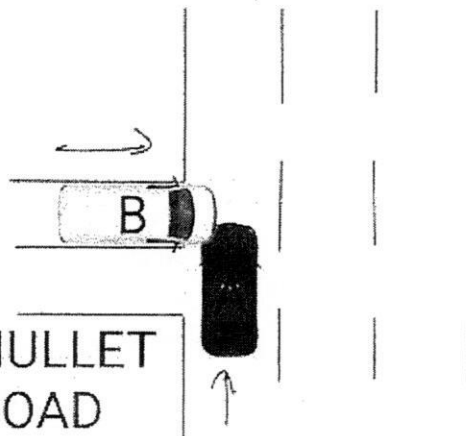
Sketch Plan

A.SHA6064B  
B.GBG5479J

HULLET  
ROAD

CAIRHILL  
ROAD

I was driving my comfort taxi (SHA6064B) on the most left lane of Cairnhill Road towards Orchard at approximately 1040pm on 23/5/2022 when a silver van (GBG5479J) suddenly came out of the minor road (near the T junction of Hullet road) without stopping as required. The van hit the front left side of my taxi and caused me to swerve across 2 lanes to the right.
