## VEHICLE INSPECTION REPORT

Report No. : PAS/TP/0160522

| Vehicle Registration No. | : SKT318Z | Engine Capacity (cc) | : 1984cc |
| Make & Model | : Audi Q5 Sport 2.0 TFSI Quattro S Tror | Mileage (km) | : 73911km |

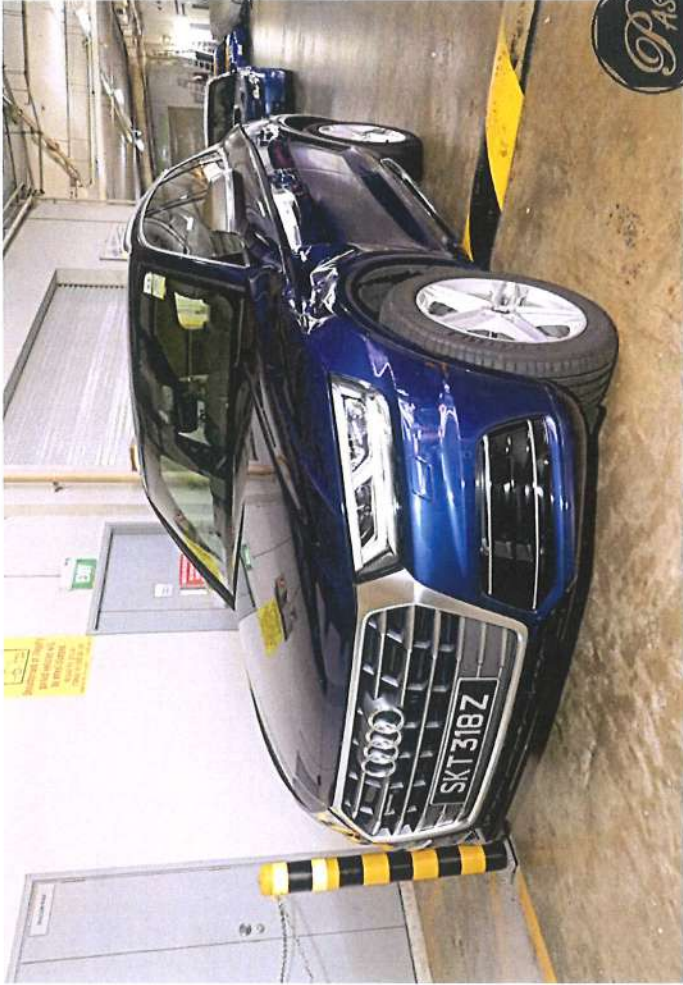
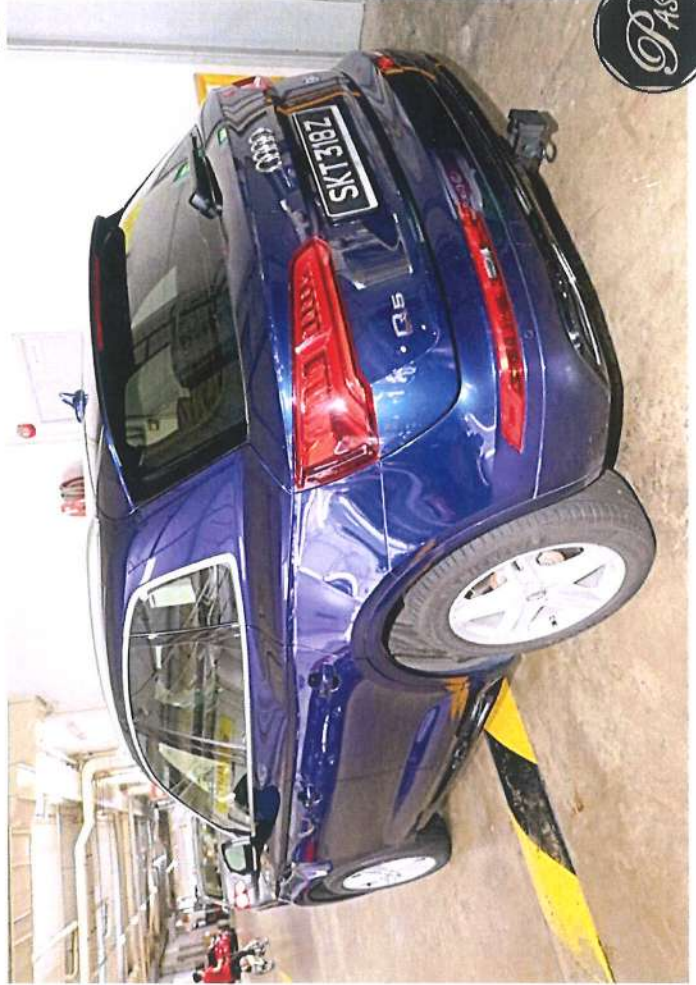
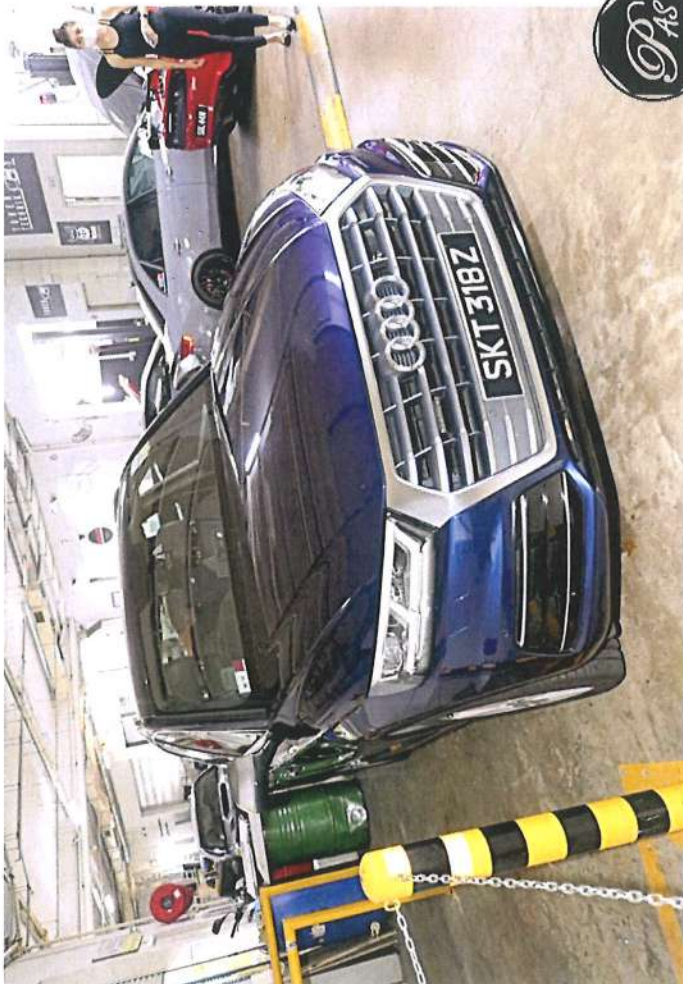
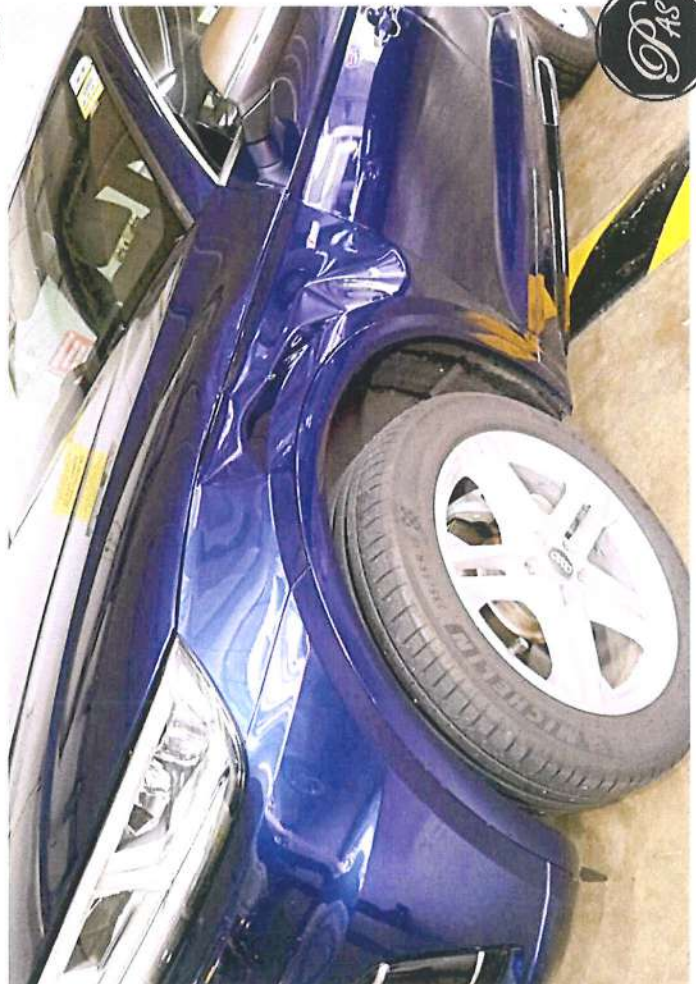
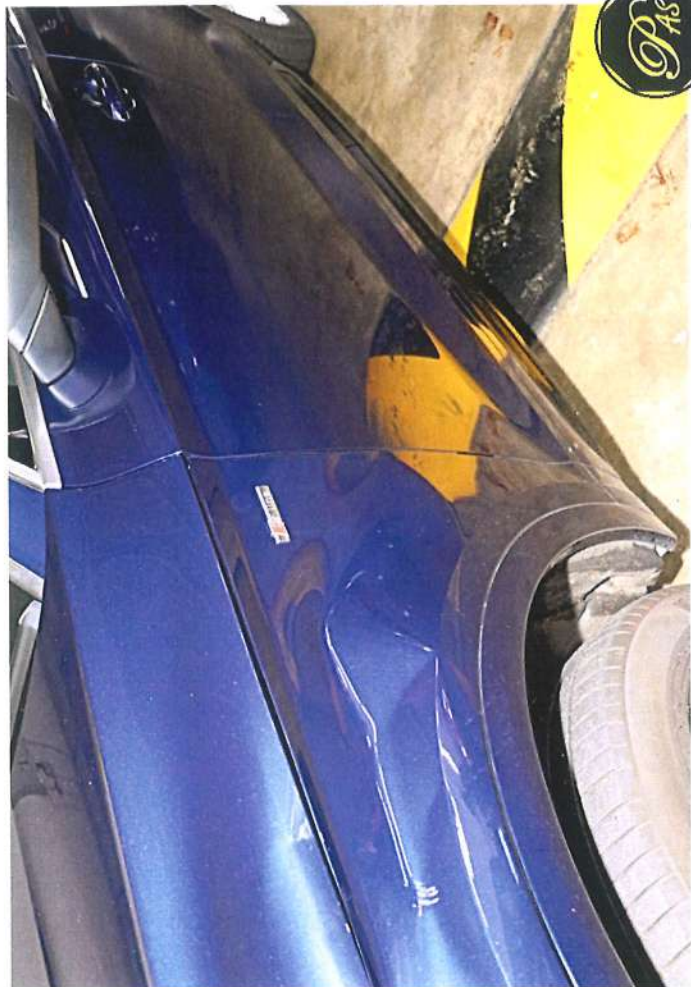
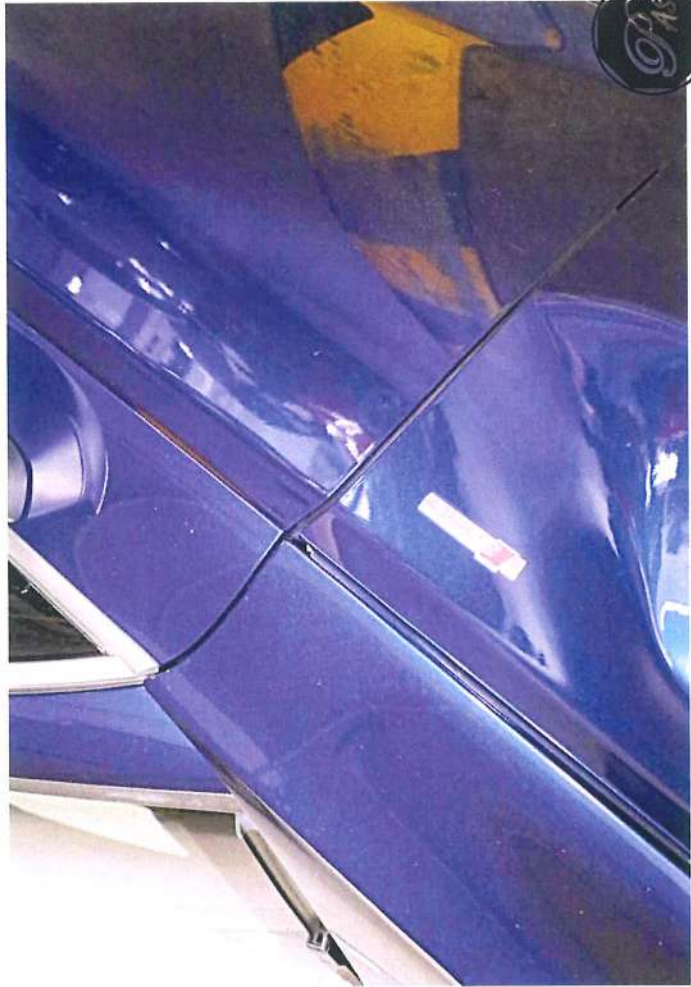
28 Photographs were taken at the time of inspection.

The bonnet, LHF fender, LHF fender top fledge cover and LHF aluminium rim were Dented / Distorted / Defaced.

Note: The bonnet and LHF wheel rim were made by aluminium material. Aluminium is unlike metal steel in that it doesn't have a "Memory Metal". It cannot be reshaped back to its undamaged state as easily as steel even though trying to perform welding and panel beating. Especially the surface are badly Dented/Distorted and/or brushed chrome surface was Defaced. Therefore, we recommended to be replace.

The used parts for this model were not available. Beside, the vehicle is only about 2 years and 10 months old. And it is still under warranty by Agent of Premium Automobiles. In our opinion, it is fair and reasonable for Part-by-Part Repairs Basis to re-instate/revert the vehicle back to its road-worthy / pre-accident condition.
