## VEHICLE INSPECTION REPORT

Report No. : PAS/TP/0160522

| Vehicle Registration No. | : SKT318Z | Engine Capacity (cc) | : 1984cc |
| Make & Model | : Audi Q5 Sport 2.0 TFSI Quattro S Tror | Mileage (km) | : 73911km |

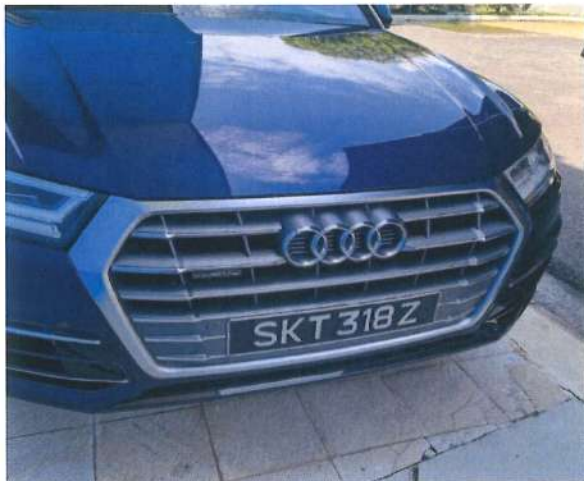
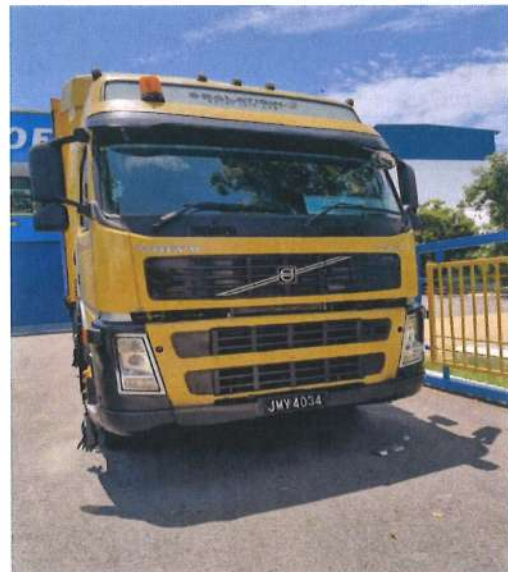
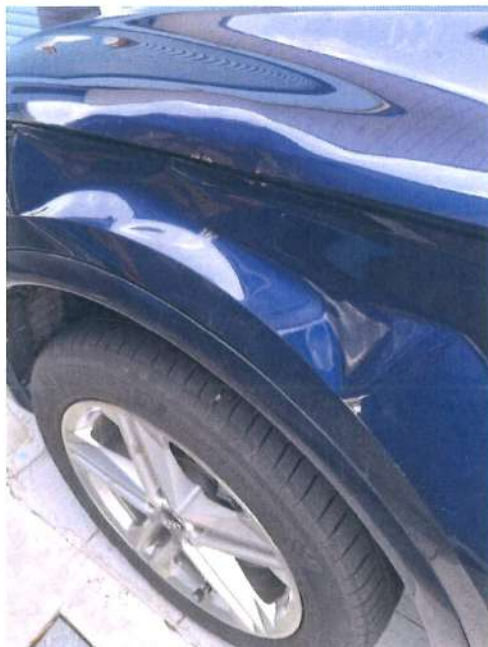
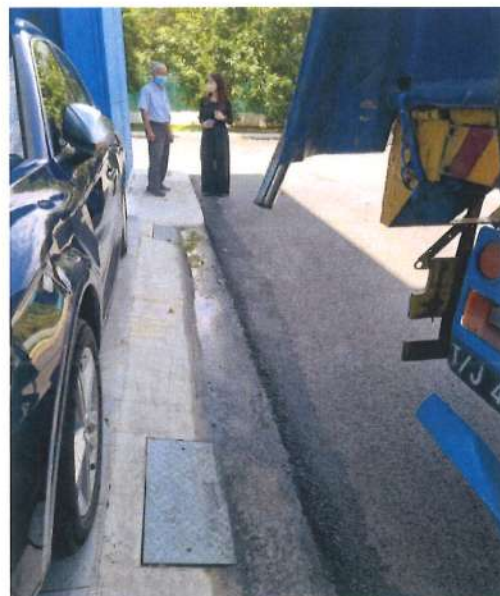
The vehicle sustained Left Hand Front portion damages during the accident on 18/04/2022. The Left Hand Front roadwheel was also affected.

It was report that the vehicle has been parked and subsequently hit by a lorry while reversing.

From the evidence of 9 pieces accident scene photographs and 4 pieces photos of video footage captured from the vehicle SKT318Z dashcam (*provided by the owner*), damages appeared consistent with the Police Report made.

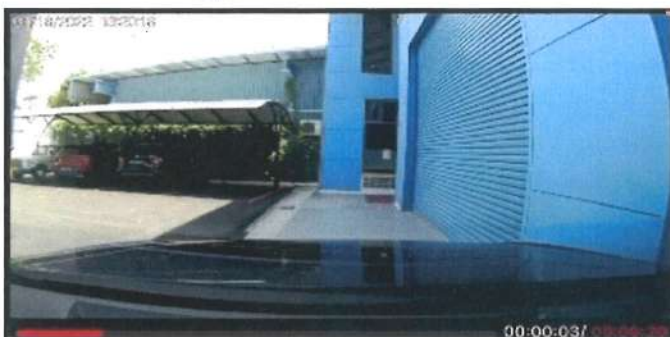
Footage Captured No.1

## POINT OF IMPACT / VIDEO FOOTAGE CAPTURED FROM VEHICLE SKT318Z
