Your Ref: Mitsubishi Engine  
(number 4B11BC0151)  
Our Ref : CI/TP22006781/D

### **INSPECTION REPORT OF A MITSUBISHI ENGINE WITH NUMBER 4B11BC0151**

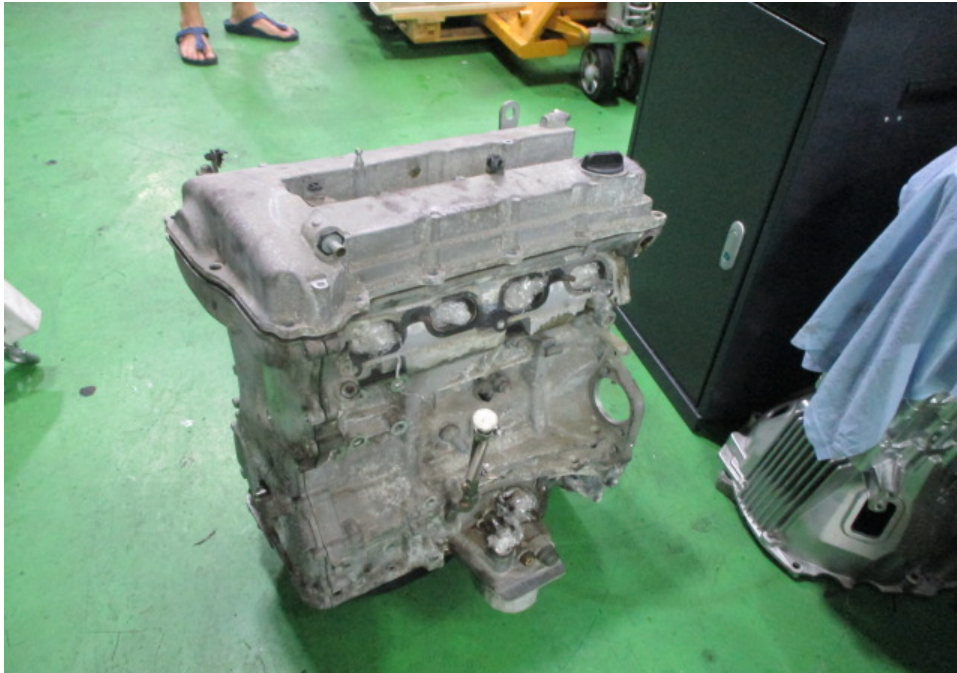
**Photo 1** shows a general view of the Mitsubishi engine that I had inspected. The Mitsubishi engine was observed to be a used engine and was not fitted on any motor car. It was also observed to be a complete assembly with all mechanical parts still intact, within the engine housing.

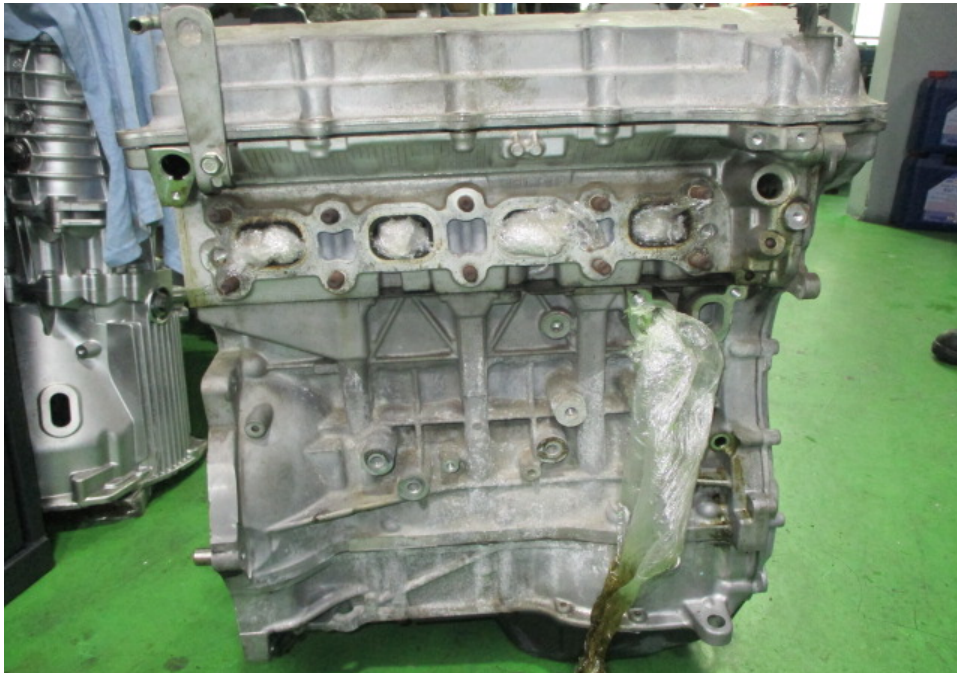
**Photo 2** shows a closer view of the Mitsubishi engine that I had inspected. My visual examination of the engine housing revealed the housing to be of serviceable/satisfactory condition. There was no crack and/or hole observed on the engine housing.

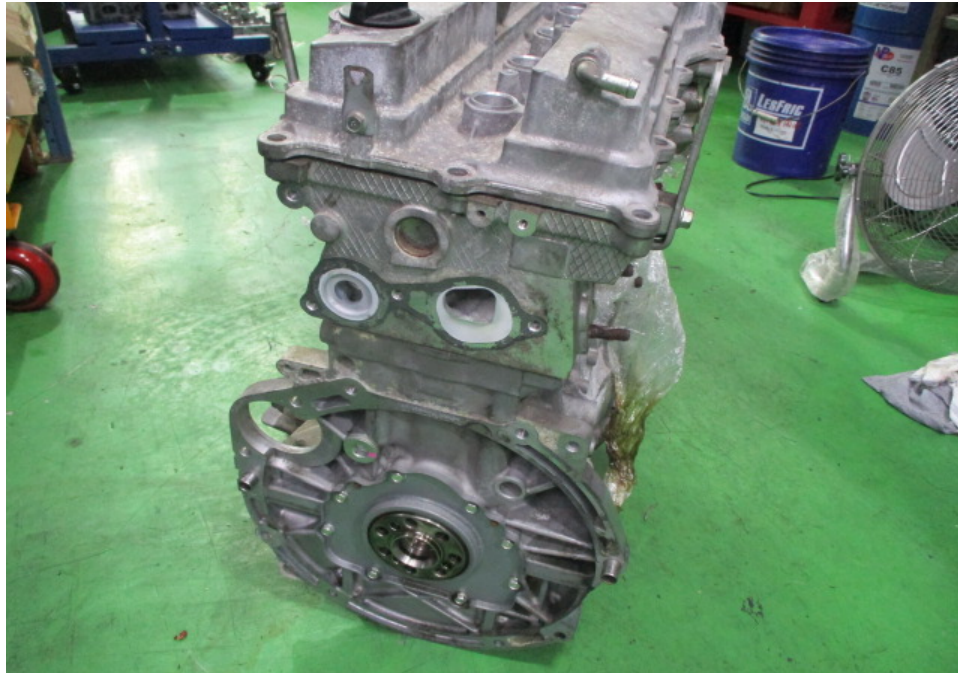
**Photo 3** shows another view of the Mitsubishi engine that I had inspected. My visual examination of the engine housing revealed the housing to be of serviceable/satisfactory condition. There was no crack and/or hole observed on the engine housing.

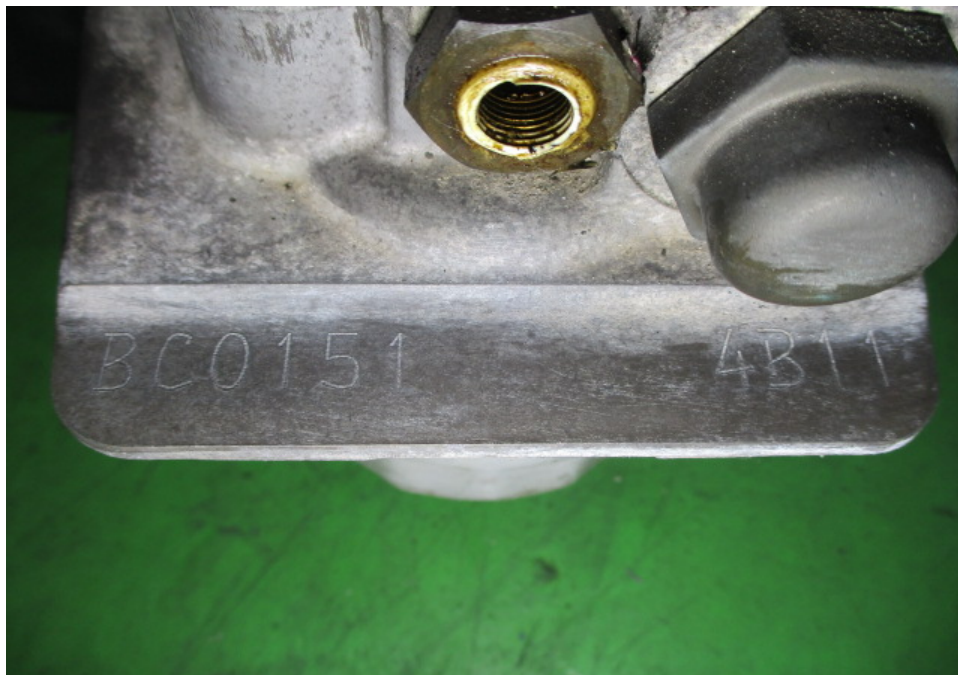
**Photo 4** shows the engine number engraved on the housing of the Mitsubishi engine that I had inspected. The engine number was 4B11BC0151.

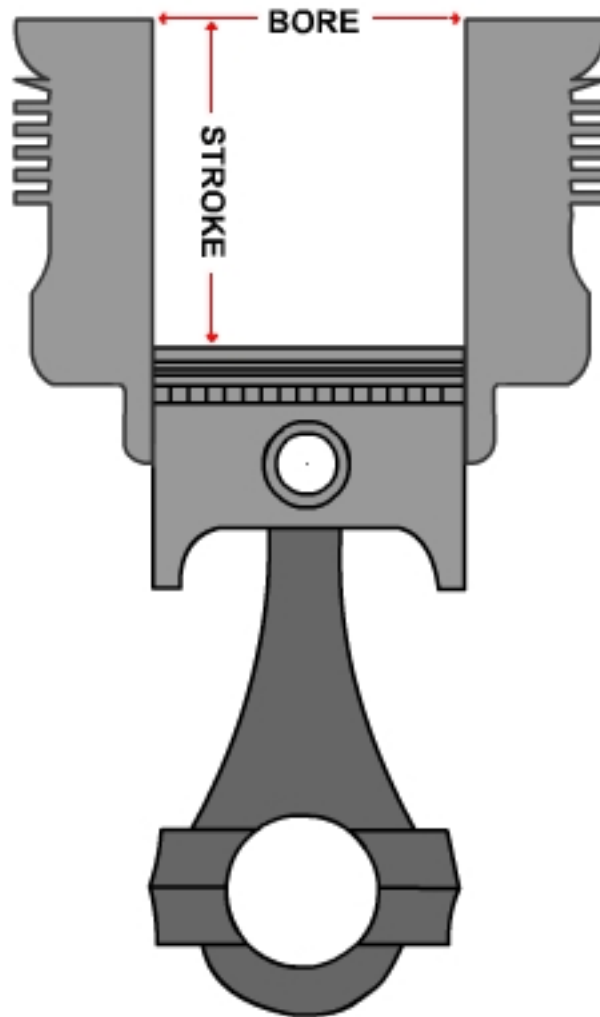
9. The bore refers to the measurement of the inside diameter of the cylinder while the stroke refers to the distance the piston moves in one direction of upward or downward movement in the cylinder. See diagram below for illustration purposes.

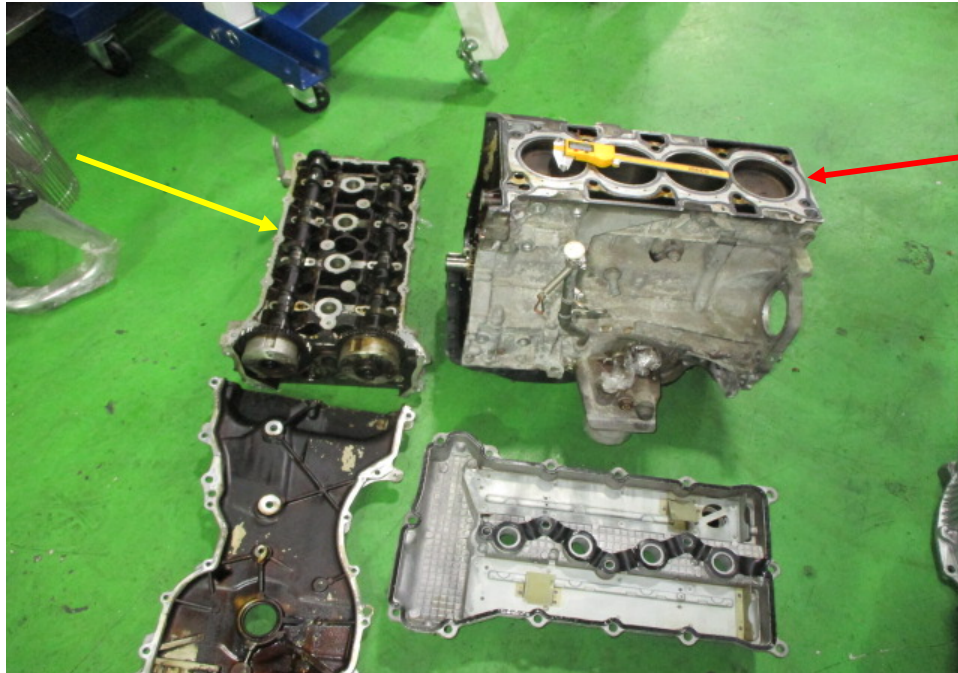
**Photo 5** shows the top block (yellow arrow) of the Mitsubishi engine separated from its bottom block (red arrow). This was to enable me to carry out measurements of its cylinders, in particular the bore and stroke measurements of each cylinder, which typically can be used to determine the engine displacement or more commonly referred to as engine cc.

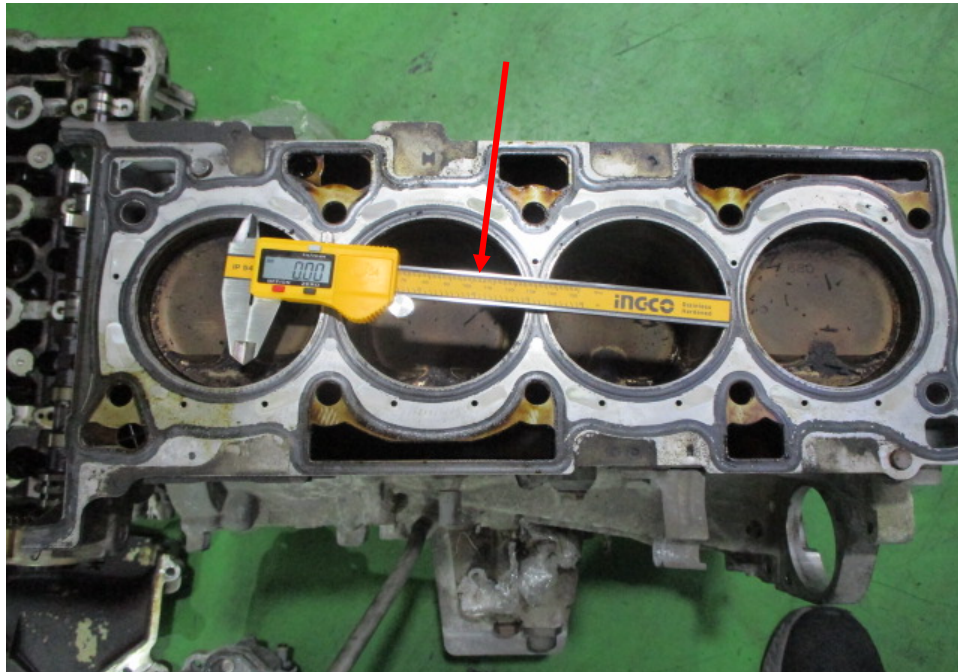
**Photo 6** shows the bottom block of the Mitsubishi engine and the digital Vernier Caliper (arrowed) that was used to measure the bore and stroke measurements of each cylinder. The digital Vernier Caliper was calibrated before the start of the measurements.

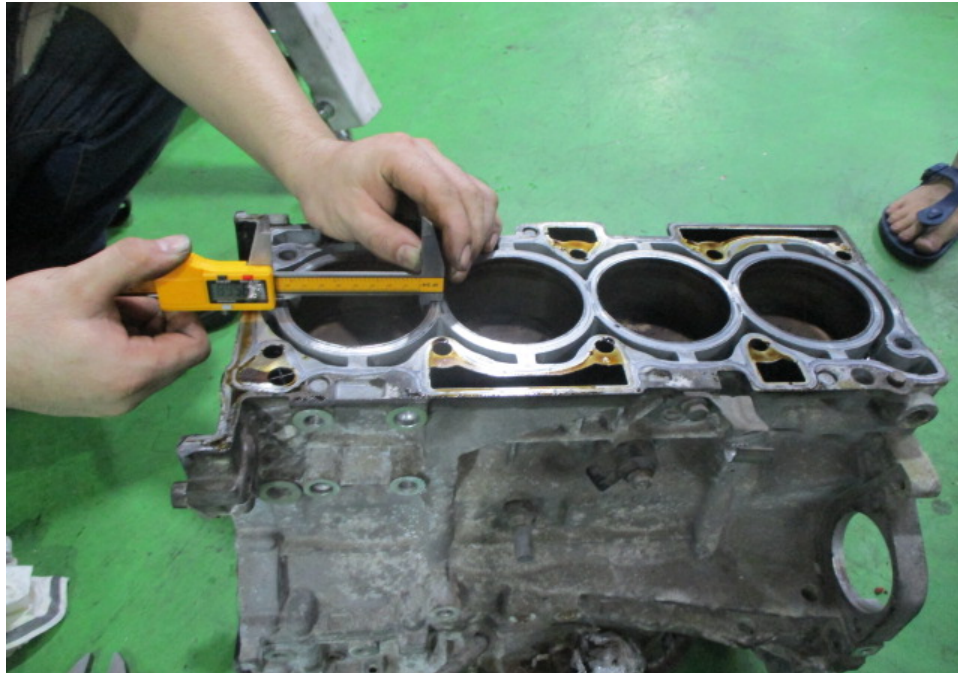
**Photo 7** shows measurement being carried out to the bore of cylinder 1 of the Mitsubishi engine. The measurements were carried out using a digital Vernier Caliper that was calibrated before the start of the measurements.

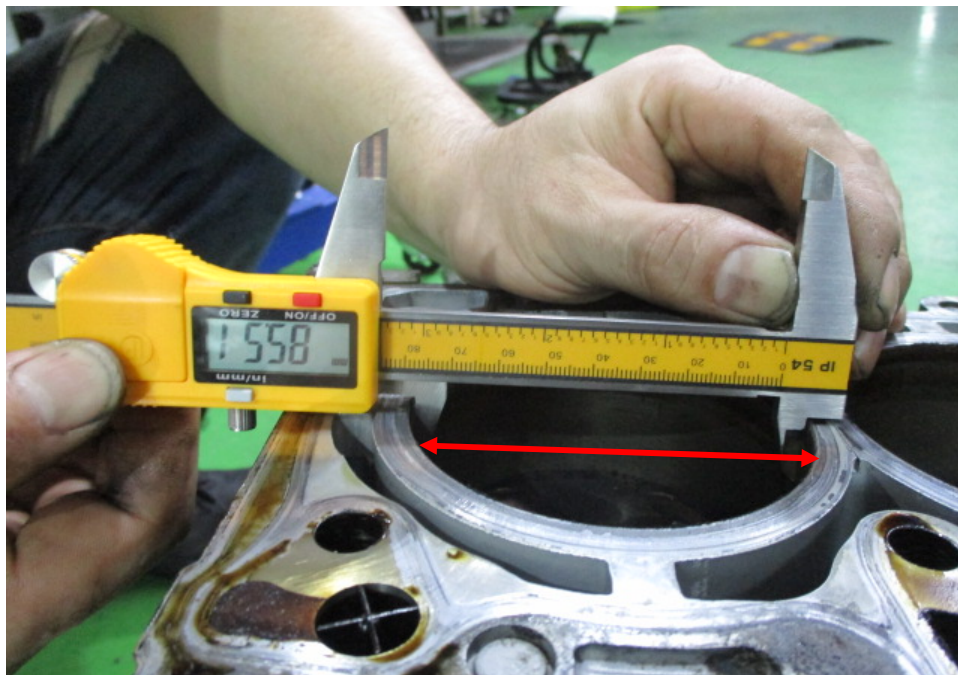
**Photo 8** shows measurement being carried out to the bore (arrowed) of cylinder 1 of the Mitsubishi engine. The bore measurement of cylinder 1 was recorded to be 85.51mm.

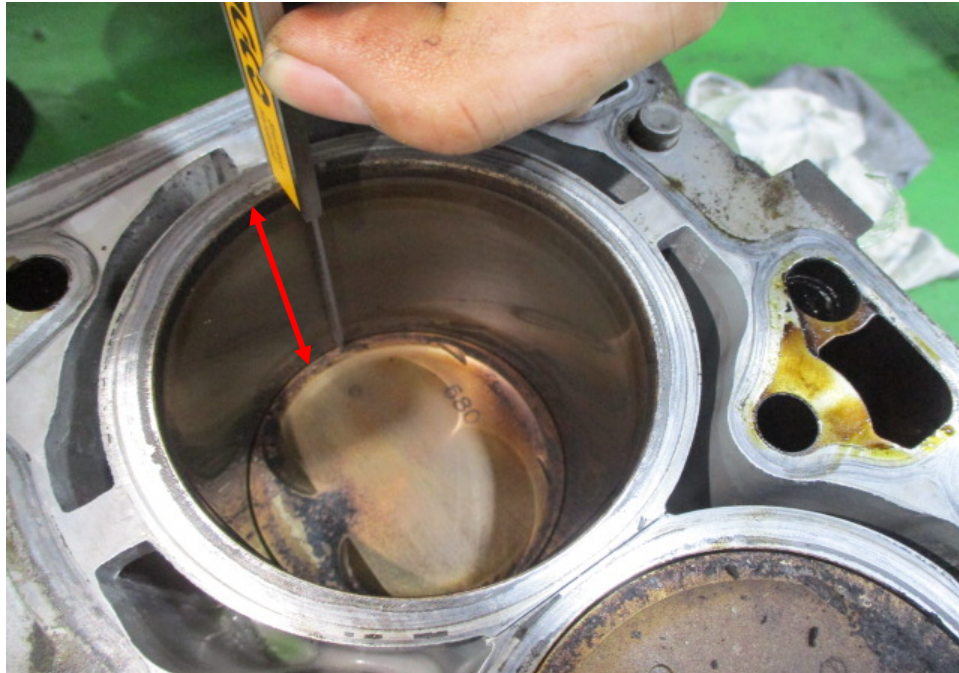
**Photo 9** shows measurement being carried out to the stroke (arrowed) of cylinder 1 of the Mitsubishi engine. The bore and stroke measurements of the Mitsubishi engine were carried out using a digital Vernier Caliper that was calibrated before the start of the measurements.

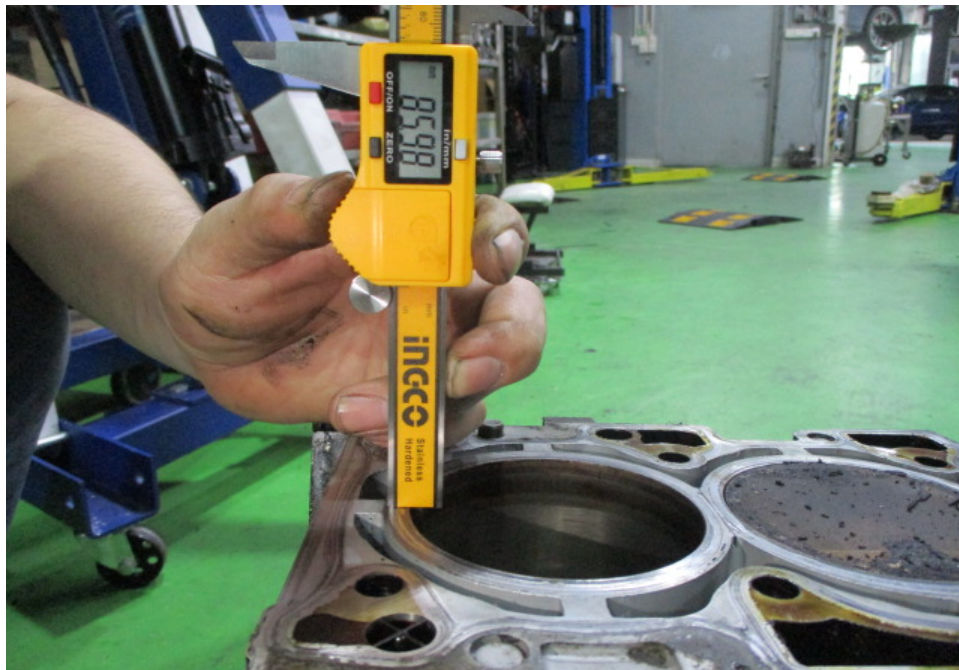
**Photo 10** shows the stroke measurement of cylinder 1, which was recorded to be 85.98mm.

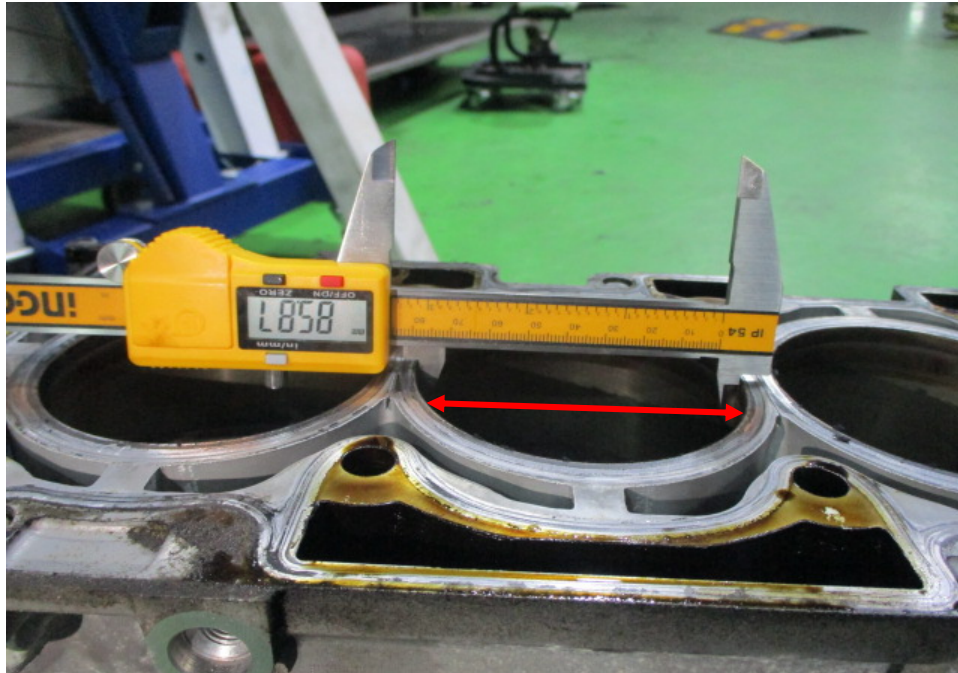
**Photo 11** shows measurement being carried out to the bore (arrowed) of cylinder 2 of the Mitsubishi engine. The bore measurement of cylinder 2 was recorded to be 85.87mm.

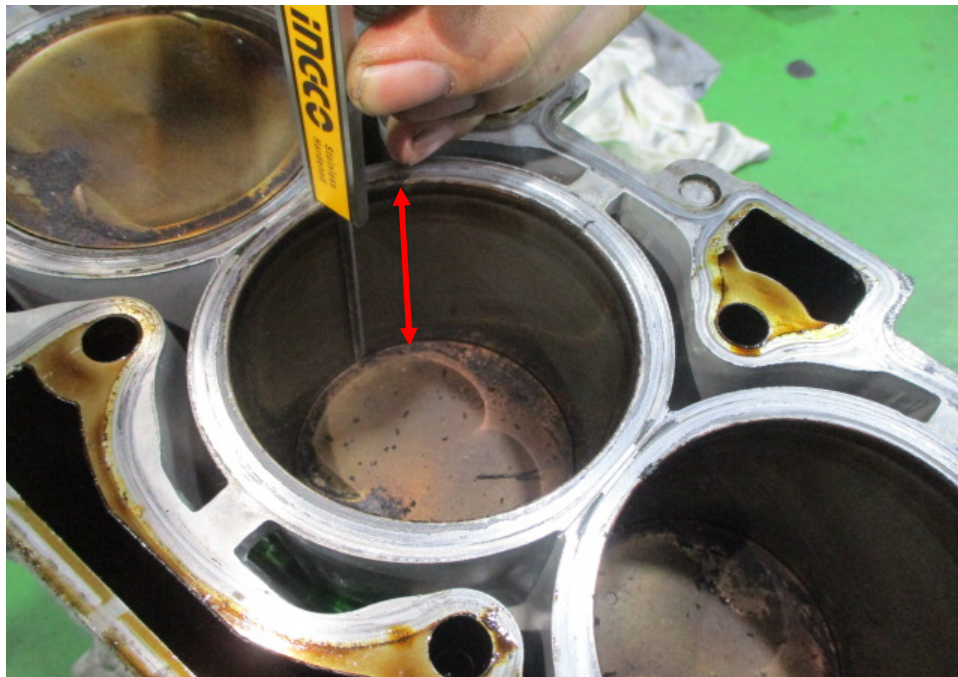
**Photo 12** shows measurement of the stroke (arrowed) for cylinder 2 of the Mitsubishi engine that I had inspected. The bore and stroke measurements of the Mitsubishi engine were carried out using a digital Vernier Caliper that was calibrated before the start of measurements.

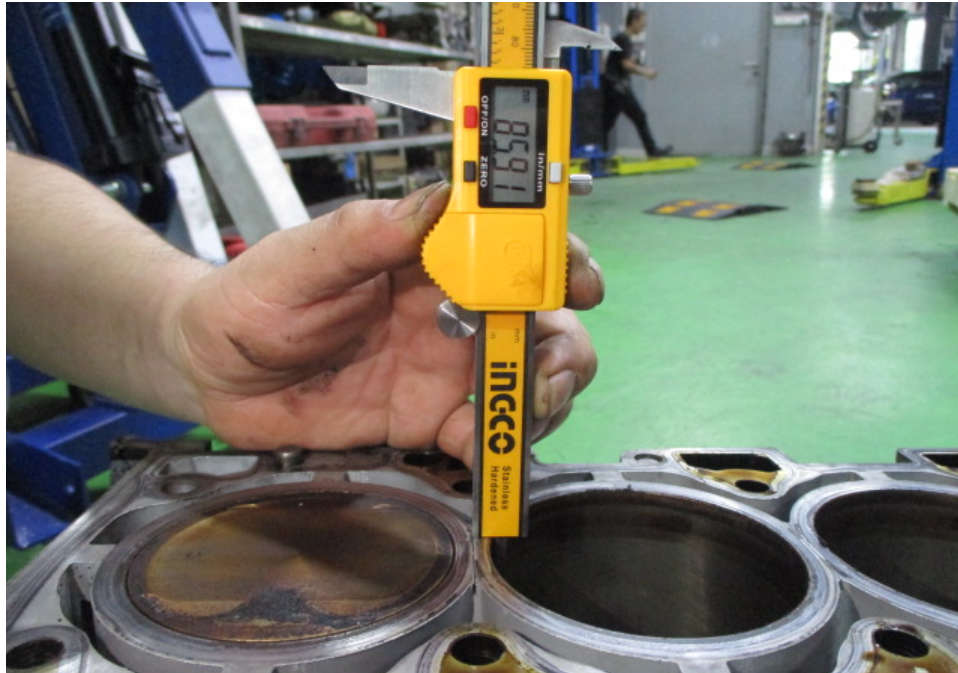
**Photo 13** shows the stroke measurement of cylinder 2, which was recorded to be 85.91mm.

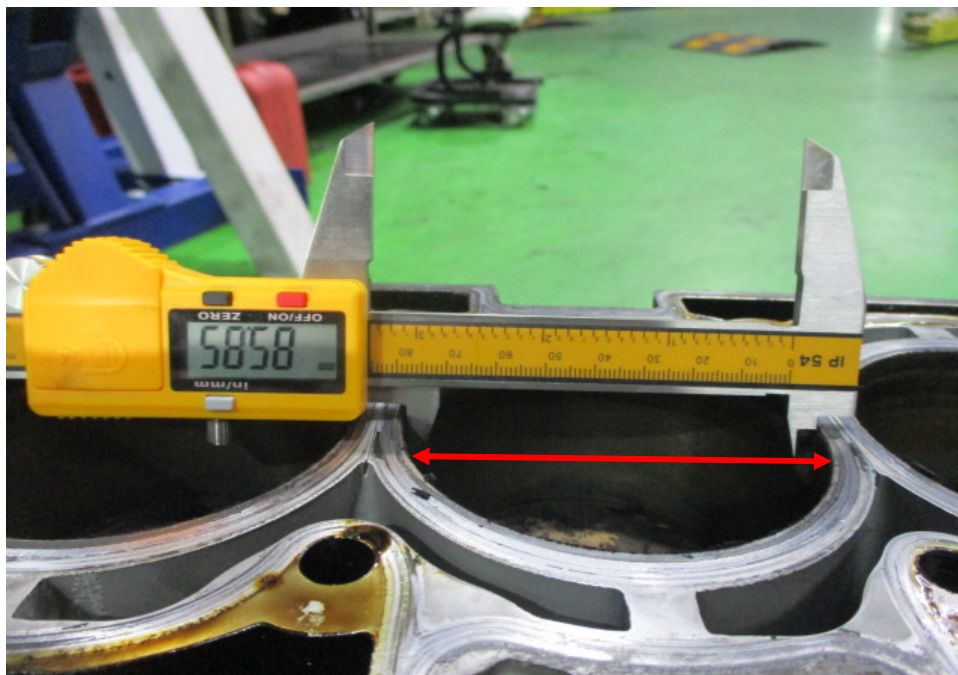
**Photo 14** shows measurement being carried out to the bore (arrowed) of cylinder 3 of the Mitsubishi engine. The bore and stroke measurements of the Mitsubishi engine were carried out using a digital Vernier Caliper that was calibrated before the start of measurements. The bore measurement of cylinder 3 was recorded to be 85.85mm.

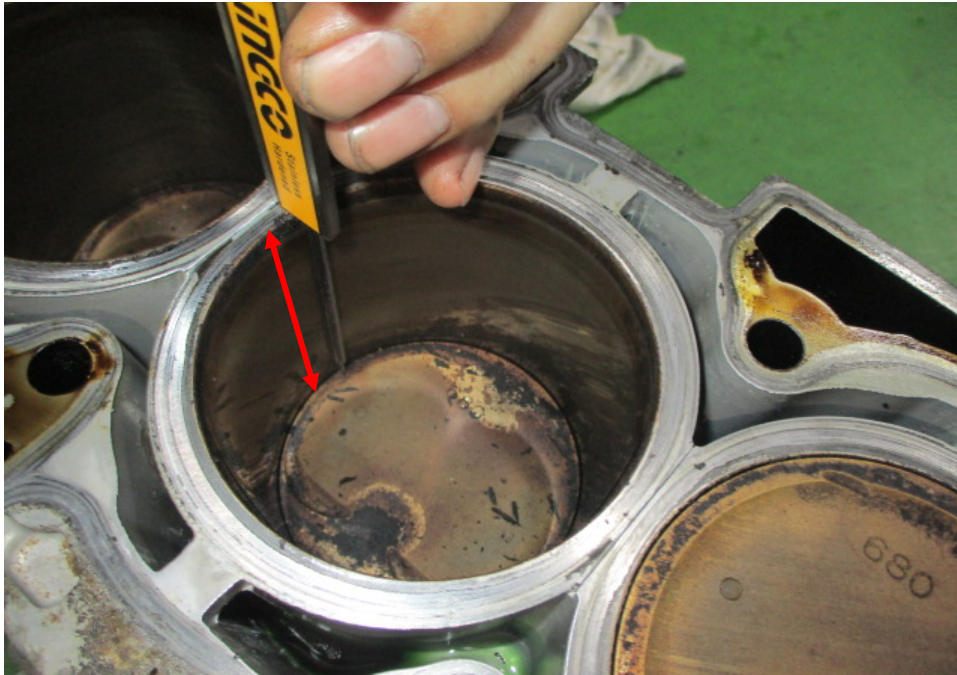
**Photo 15** shows measurement of the stroke (arrowed) for cylinder 3 of the Mitsubishi engine that I had inspected. The bore and stroke measurements of the Mitsubishi engine were carried out using a digital Vernier Caliper that was calibrated before the start of measurements.

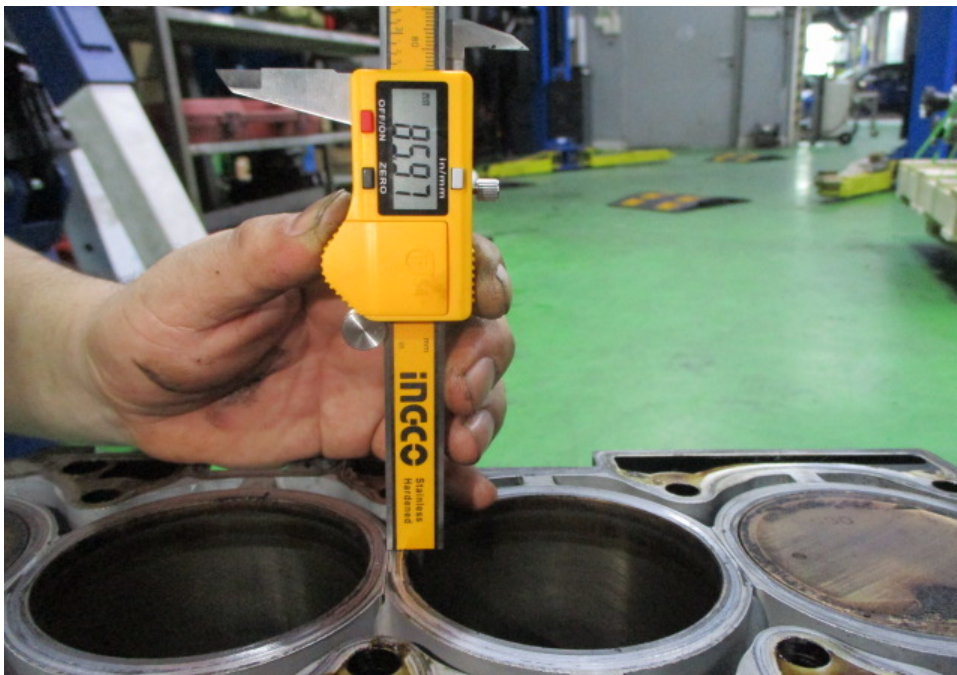
**Photo 16** shows the stroke measurement of cylinder 3, which was recorded to be 85.97mm.

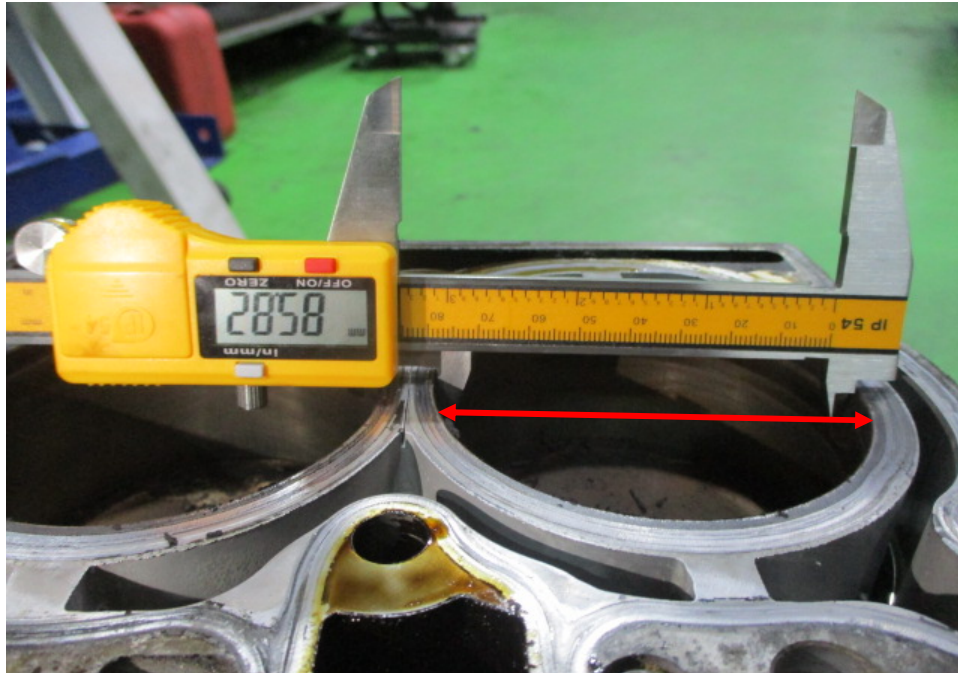
**Photo 17** shows measurement being carried out to the bore (arrowed) of cylinder 4 of the Mitsubishi engine. The bore measurement of cylinder 4 was recorded to be 85.82mm.

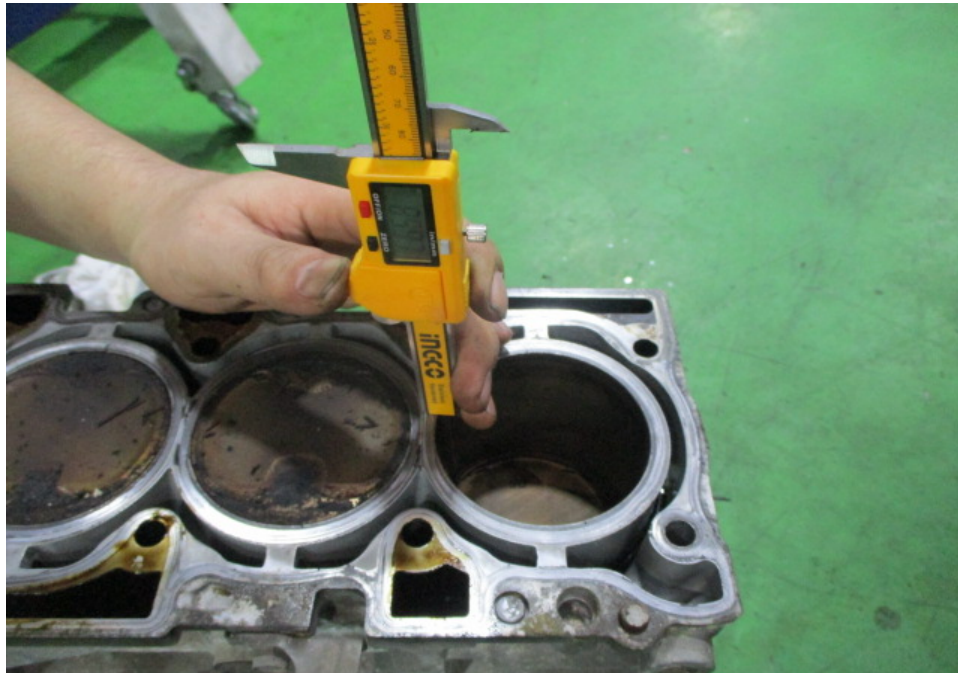
**Photo 18** shows measurement being carried out to the stroke of cylinder 4 of the Mitsubishi engine. The bore and stroke measurements of the Mitsubishi engine were carried out using a digital Vernier Caliper that was calibrated prior to the start of measurements.

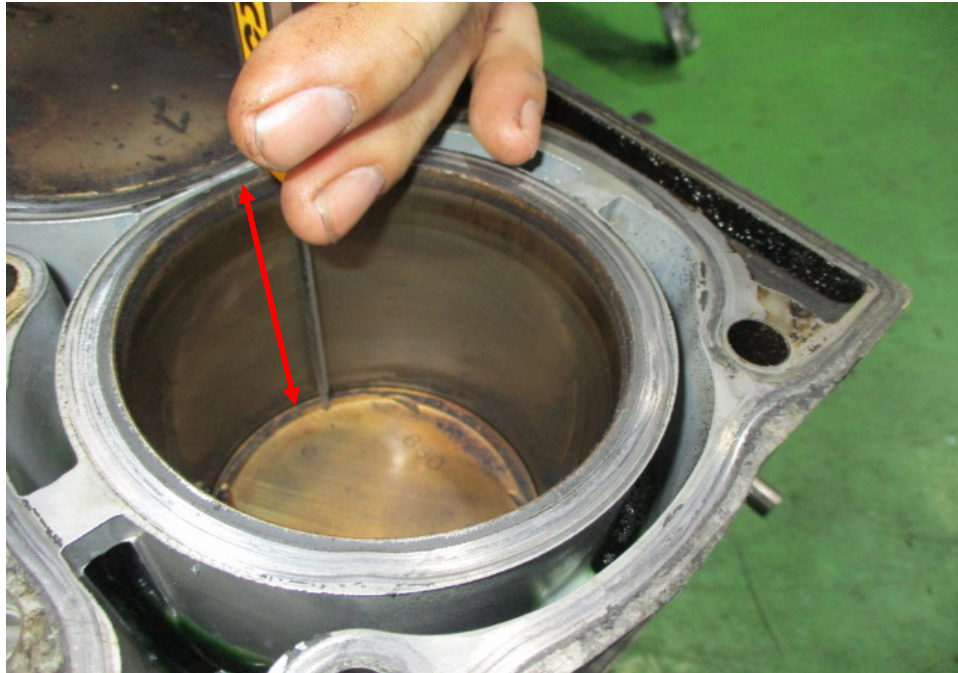
**Photo 19** shows measurement being carried out to the stroke (arrowed) of cylinder 4 of the Mitsubishi engine. The bore and stroke measurements of the Mitsubishi engine were carried out using a digital Vernier Caliper that was calibrated prior to the start of measurements.

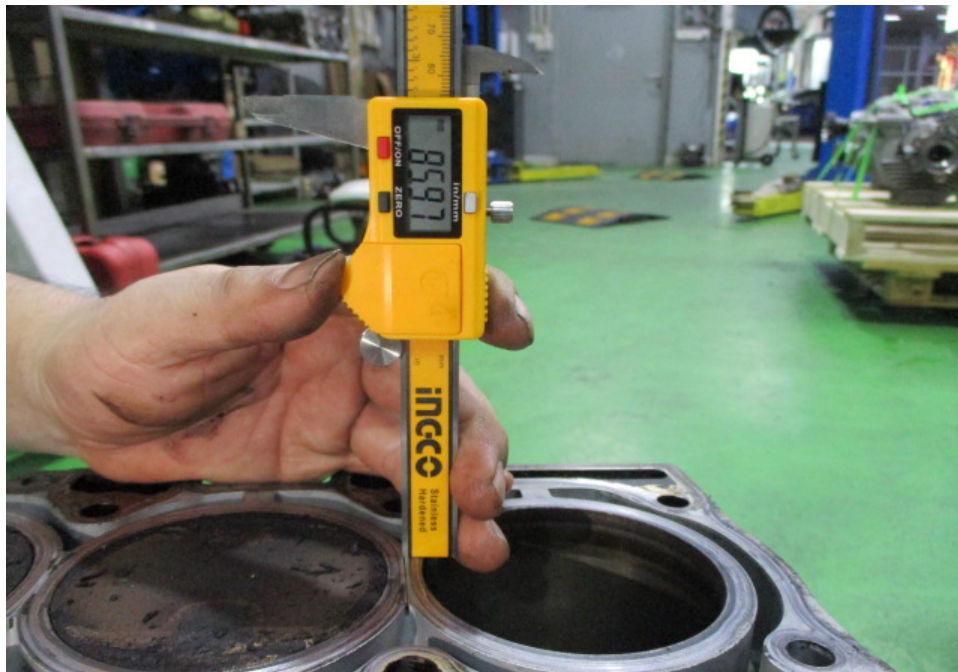
**Photo 20** shows the stroke measurement of cylinder 4, which was recorded to be 85.97mm.
