## VEHICLE DETAIL

## REPAIR DESCRIPTIONS

## PHOTOS OF DAMAGED PARTS

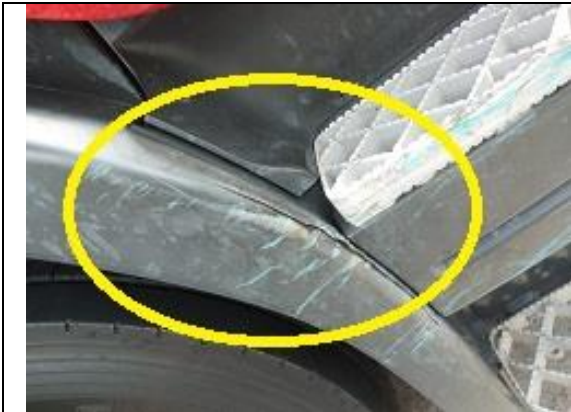
(pic 7)

- 1) Remove & replace dented winch housing chequered sticker( pic 1 )
- 2) Remove & wash winch housing sticker adhesive residues (1)
- 3) Panel beat dented winch housing & RH door (pic 1-2)
- 4) Putty & respray RH winch housing & RH door
- 5) Remove & replace damaged front RH corner bumper (pic 3)
- 6) Remove & replace damaged front RH rear view mirror full assy & blind spot mirror (pic 4)
- 7) Remove & replace damaged RH mudguard (pic 5)
- 8) Remove & replace RH boarding step (pic 6)
- 9) Remove & replace RH head lamp ( pic 7 )
- 10) Remove & replace RH signal lamp ( pic 7 )
