ACCIDENT INVOLVING FU 1111A / GBK 8763Y ON 10.09.2022 AT NEAR BLK 701 WOODLANDS DRIVE 40

VEHICLE INSPECTION REPORT

Registration No	: FU 1111 A	Year / Capacity	: 2021 / 155 cc
Make / Model	: Yamaha Nmax 155	Colour	: Black
Chassis No	: MH3SG5680MK086264	Mileage	: 46605
Engine No	: G3L8E0606190

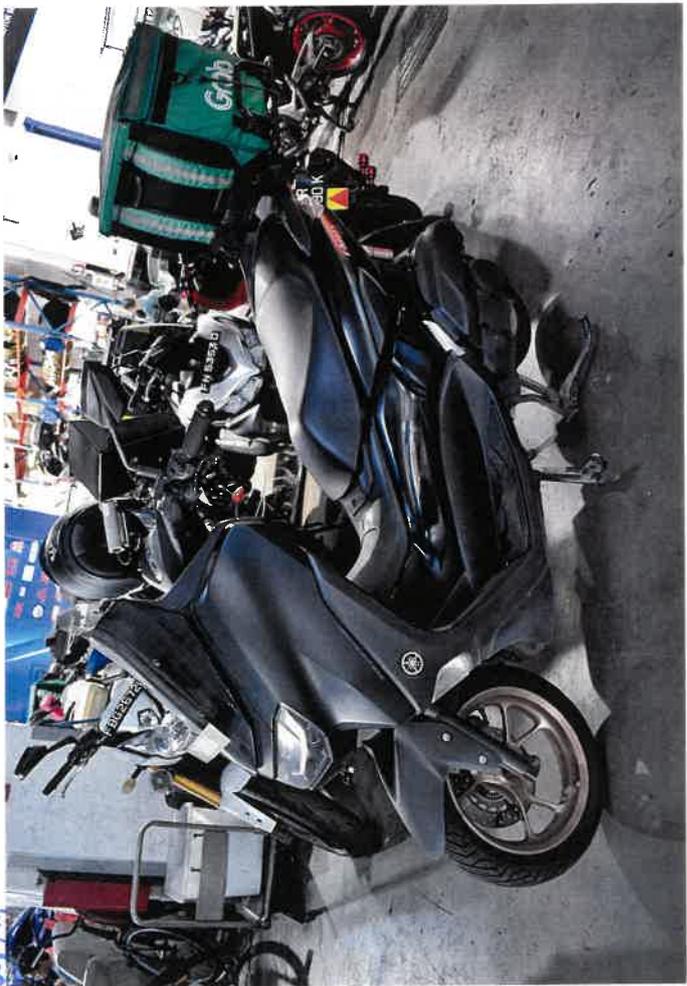
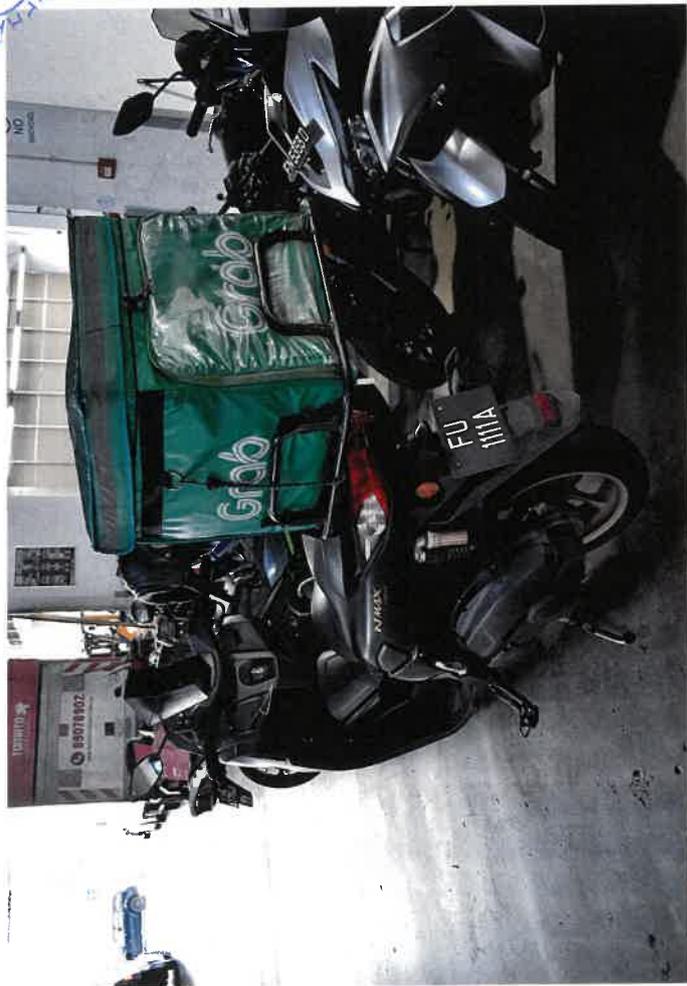
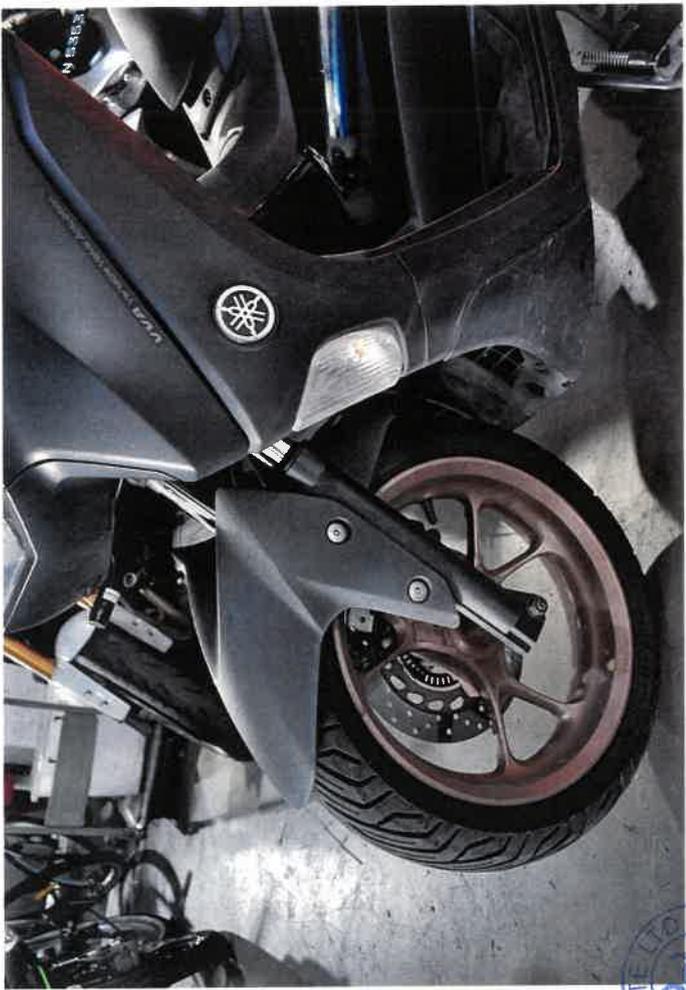
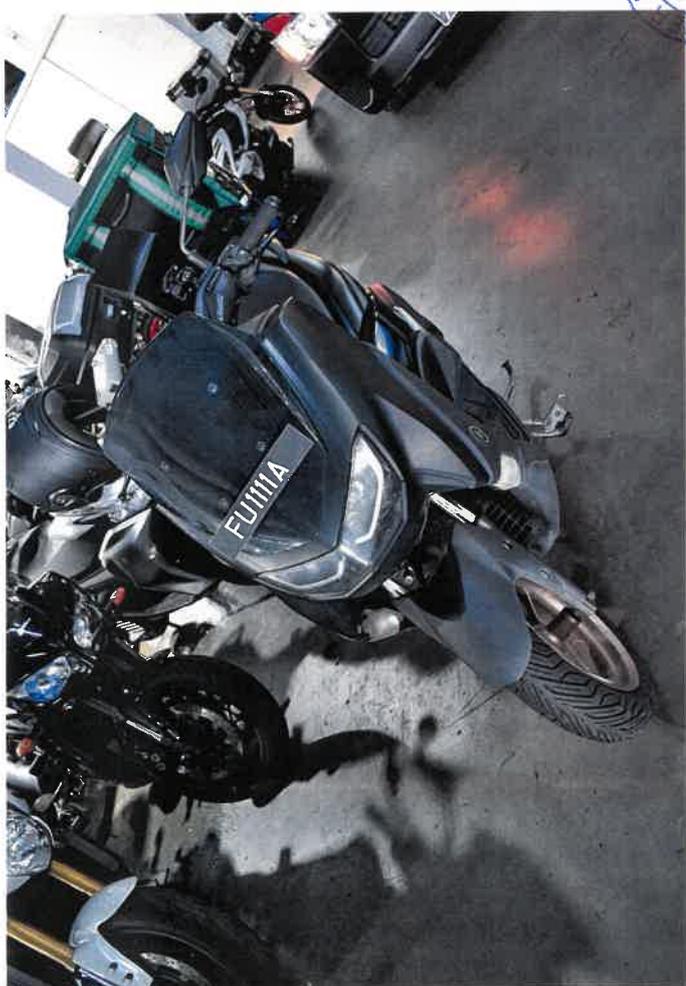
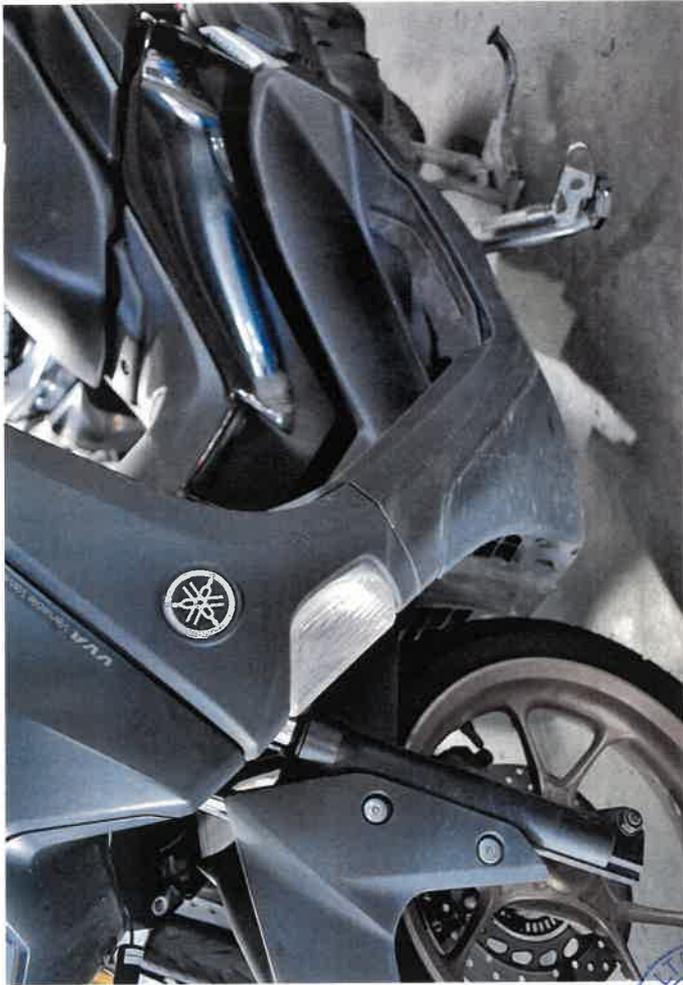
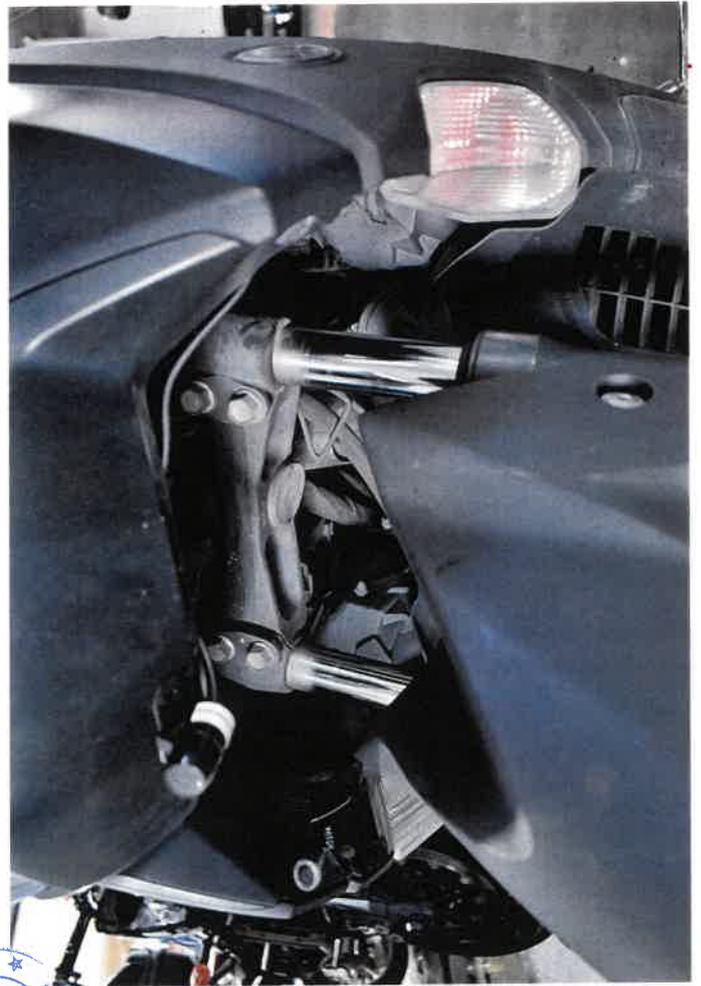
The impact damages sustained on the vehicle at the time of inspection is on the rear and n/s portion.
(Details refer to the photographs attached)

The repairer has agreed to undertake the job at a **Lump Sum of \$4,800.00** on a contractual basis.

Under normal circumstances, the repair period would be about 7 (Seven) working days.
