Your Ref: Honda Engine
(number L15A5124612)
Our Ref : CI/TP22012679/D

INSPECTION REPORT OF A HONDA ENGINE WITH NUMBER L15A5124612

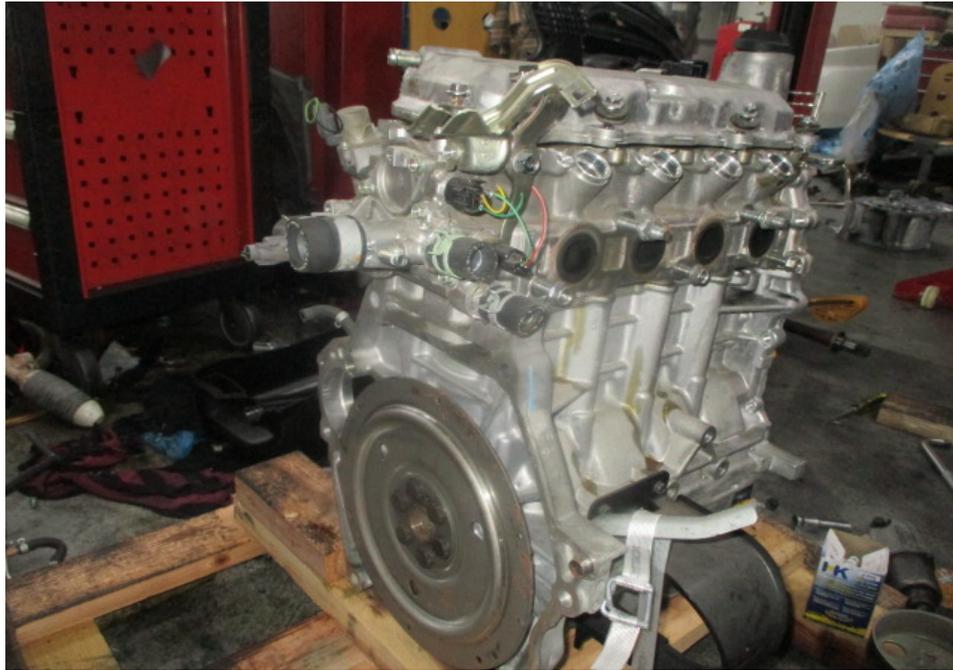
Photo 1 shows a general view of the Honda engine that I had inspected. The Honda engine was observed to be a used engine and was not fitted on any motor car. It was also observed to be a complete assembly with all mechanical parts still intact, within the engine housing.

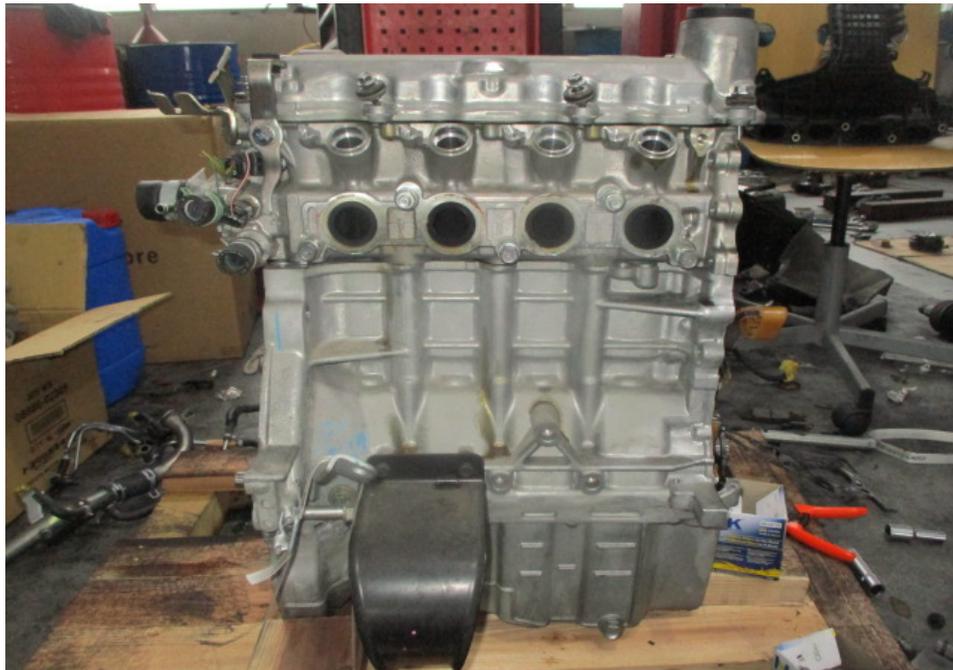
Photo 2 shows a general view of the Honda engine that I had inspected. My visual examination of the engine housing revealed the housing to be of serviceable/satisfactory condition. There was no crack and/or hole observed on the engine housing.

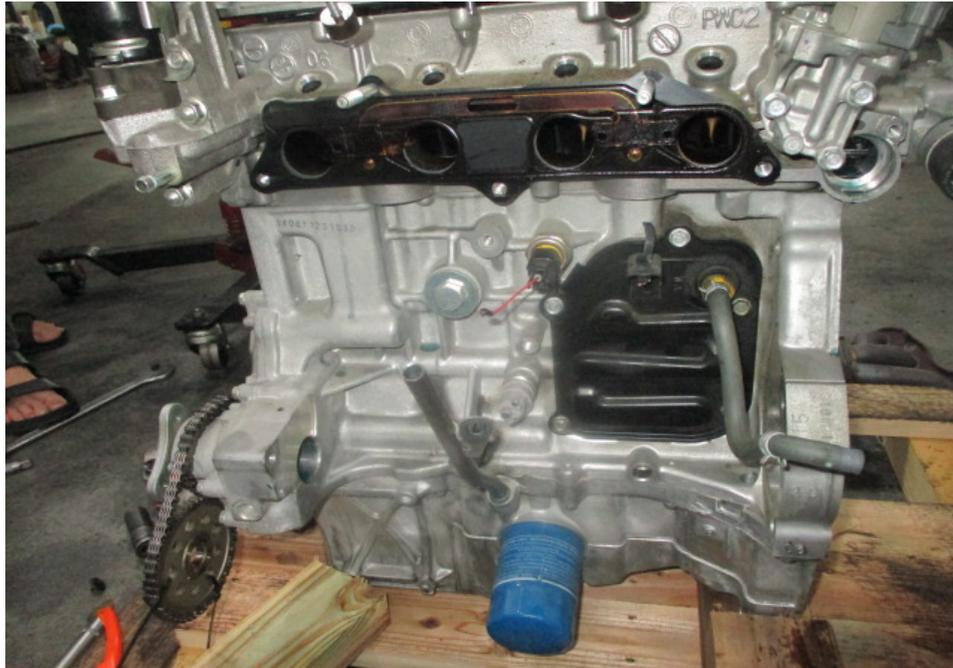
Photo 3 shows a general view of the Honda engine that I had inspected. My visual examination of the engine housing revealed the housing to be of serviceable/satisfactory condition. There was no crack and/or hole observed on the engine housing.

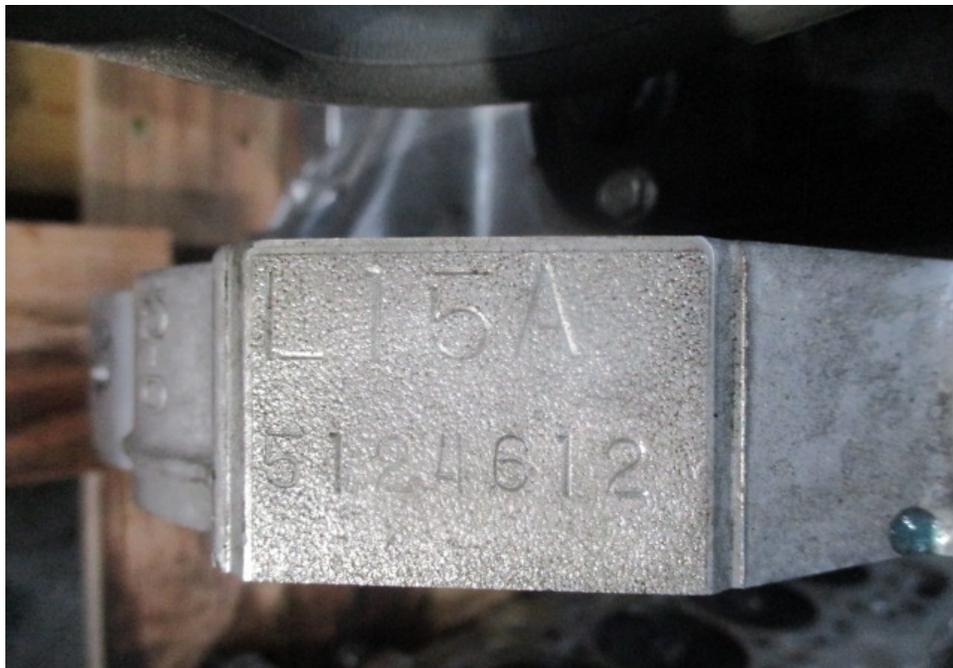
Photo 4 shows the engine number engraved on the housing of the Honda engine that I had inspected. The engine number was L15A5124612.

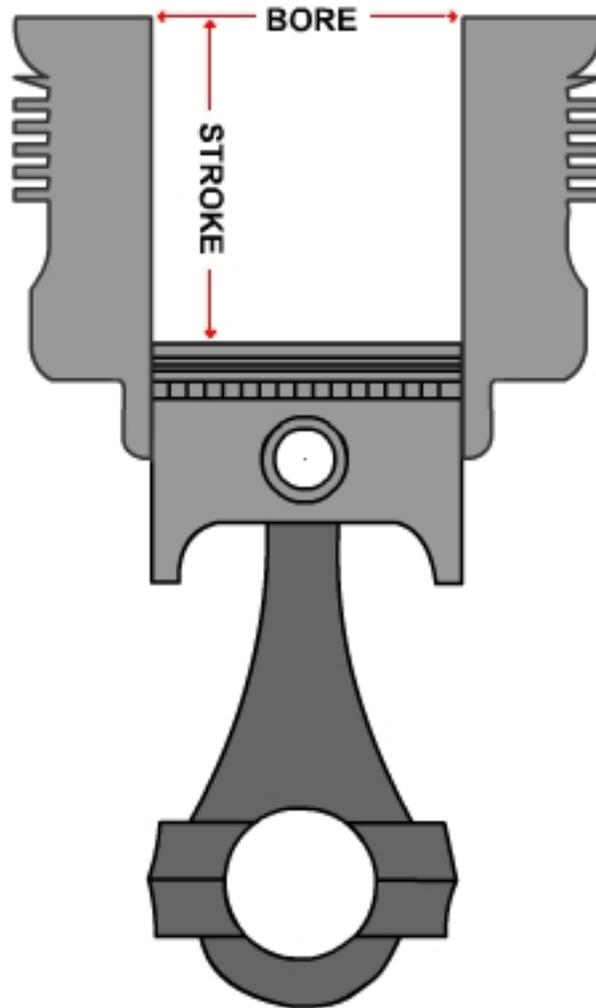
9. The bore refers to the measurement of the inside diameter of the cylinder while the stroke refers to the distance the piston moves in one direction of upward or downward movement in the cylinder. See diagram below for illustration purposes.

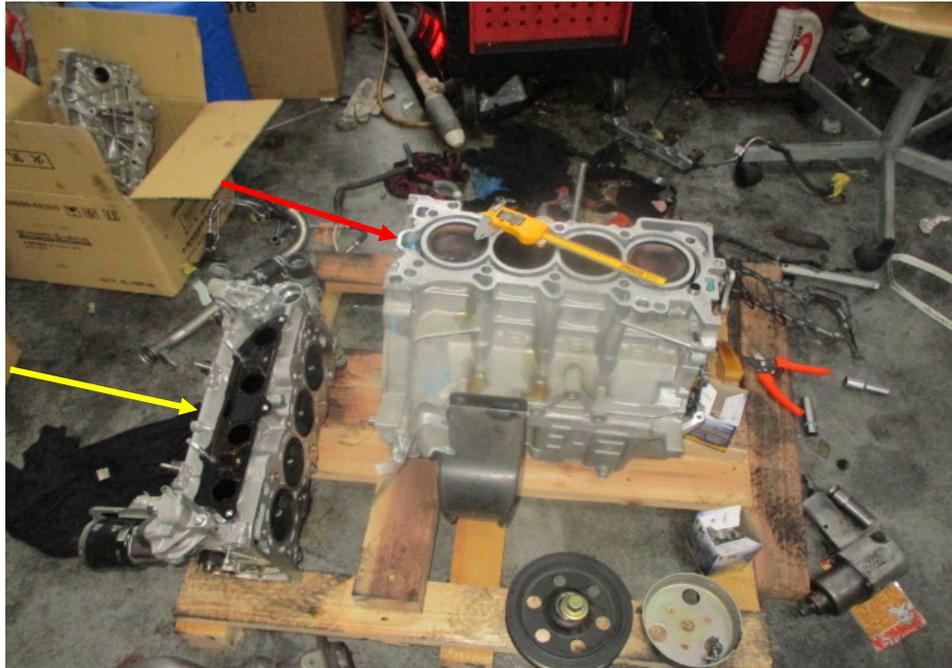
Photo 5 shows the top block (yellow arrow) of the Honda engine separated from its bottom block (red arrow). This was to enable me to carry out measurements of its cylinders, in particular the bore and stroke measurements of each cylinder, which typically can be used to determine the engine displacement or more commonly referred to as engine cc.

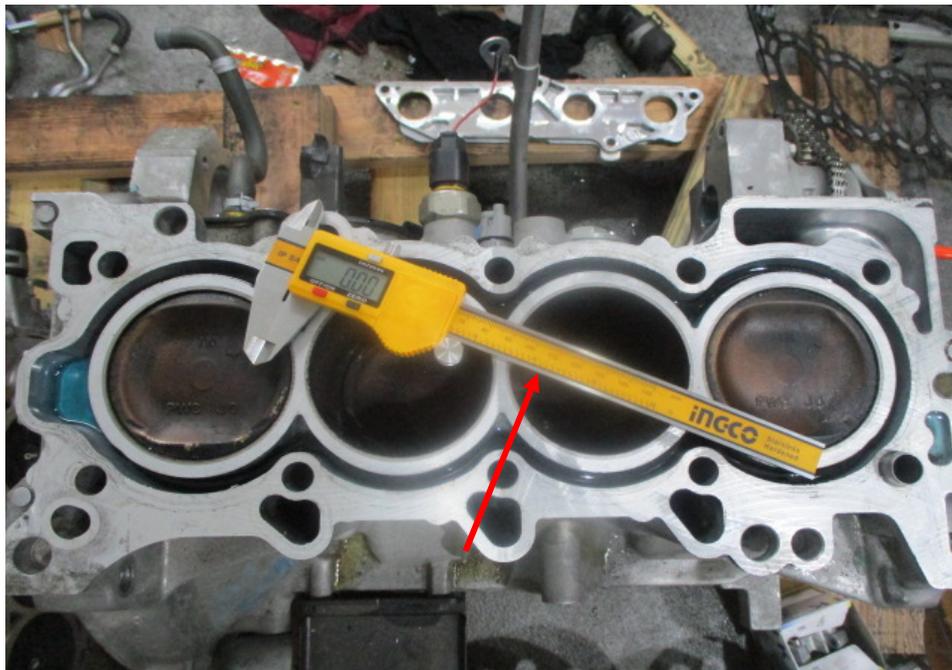
Photo 6 shows the bottom block of the Honda engine and the digital Vernier Caliper (arrowed) that was used to measure the bore and stroke measurements of each cylinder, which typically can be used to determine the engine displacement or more commonly referred to as engine cc. The digital Vernier Caliper was calibrated before the start of the measurements.

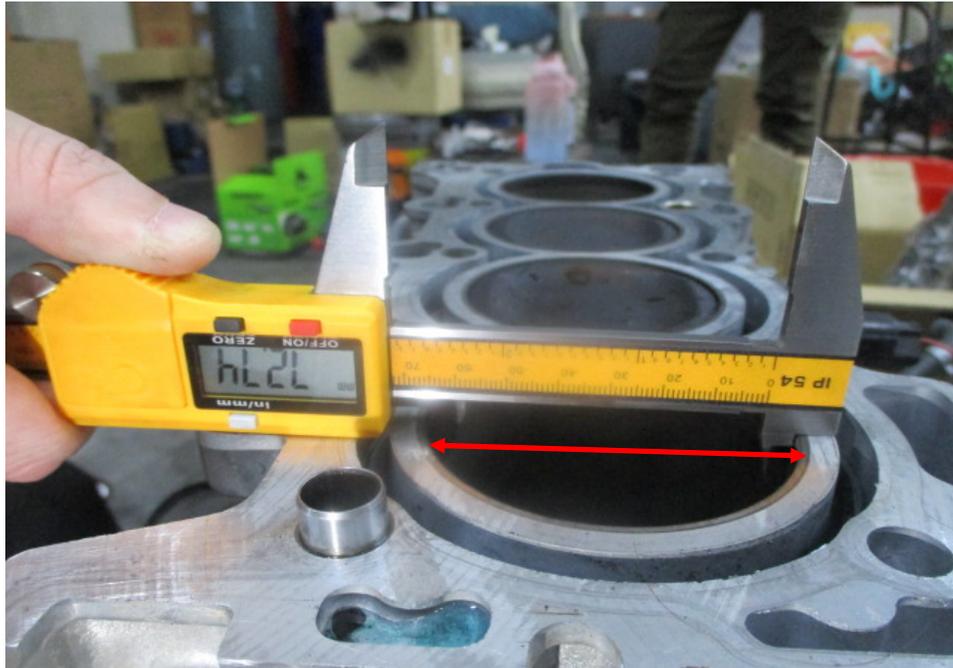
Photo 7 shows measurement being carried out to the bore (arrowed) of cylinder 1 of the Honda engine. The bore measurement of cylinder 1 was recorded to be 72.74mm.

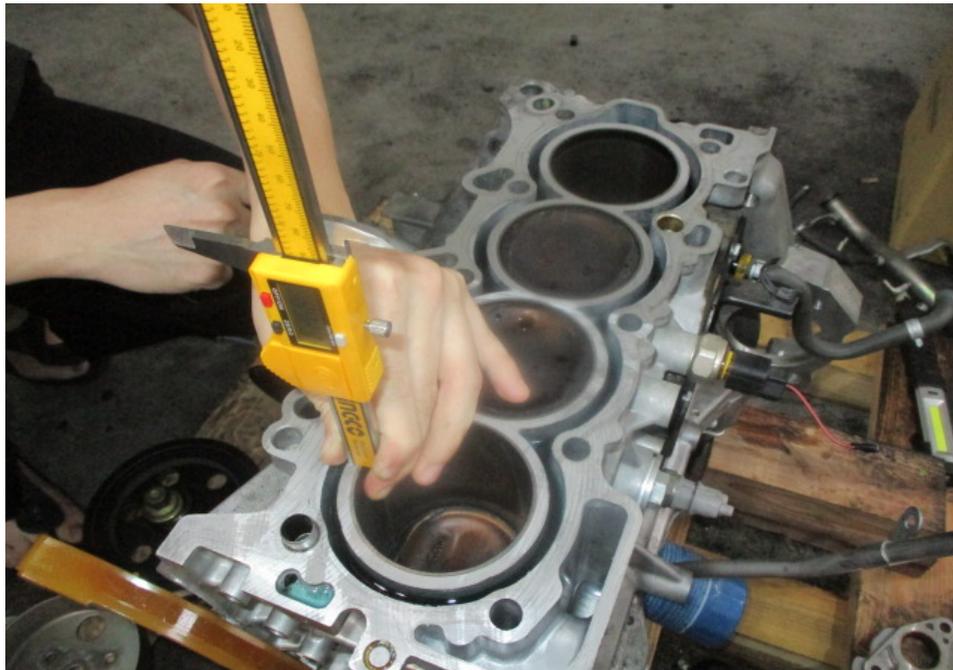
Photo 8 shows measurement being carried out to the stroke of cylinder 1 of the Honda engine. The bore and stroke measurements of the Honda engine were carried out using a digital Vernier Caliper that was calibrated before the start of the measurements.

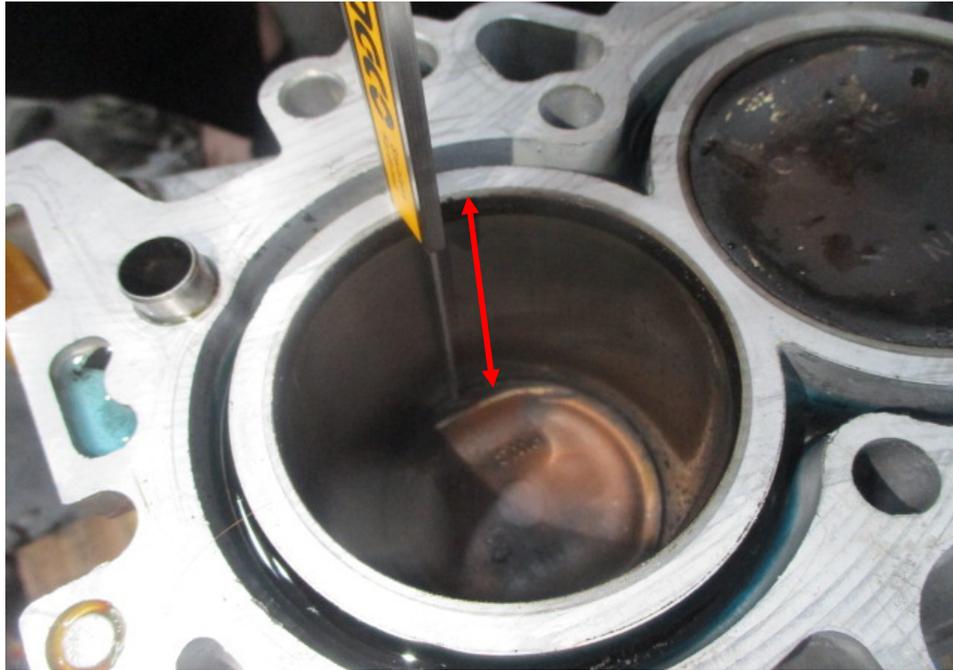
Photo 9 shows measurement being carried out to the stroke (arrowed) of cylinder 1 of the Honda engine. The bore and stroke measurements of the Honda engine were carried out using a digital Vernier Caliper that was calibrated before the start of the measurements.

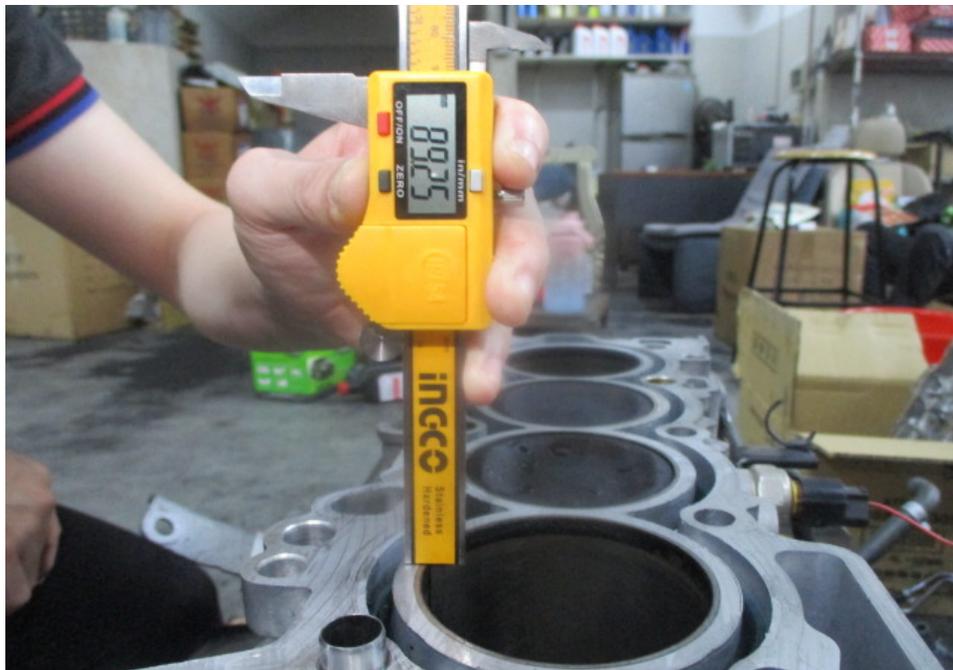
Photo 10 shows the stroke measurement of cylinder 1, which was recorded to be 89.25mm.

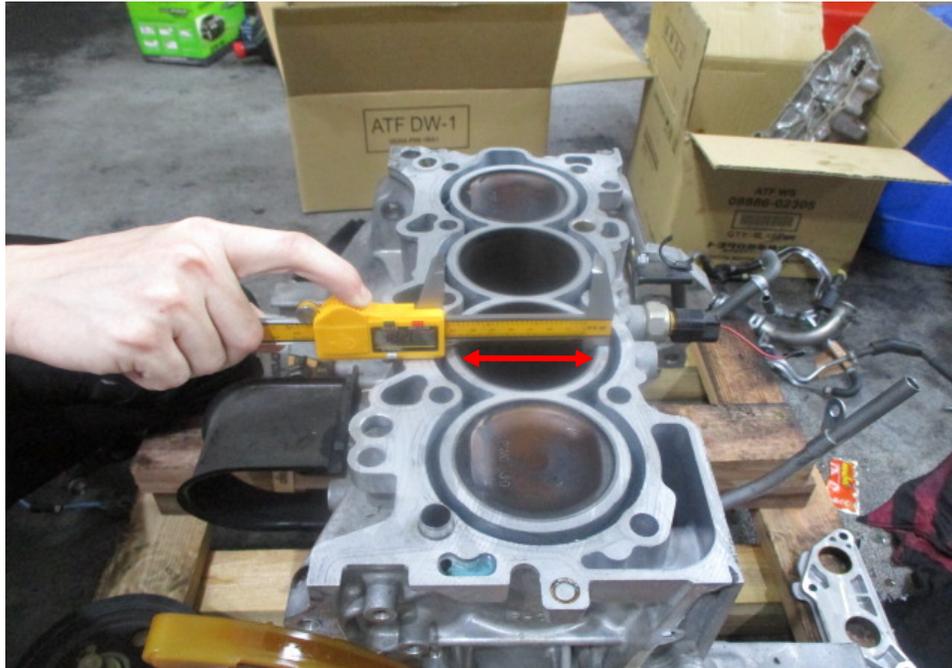
Photo 11 shows measurement being carried out to the bore (arrowed) of cylinder 2 of the Honda engine. The bore and stroke measurements of the Honda engine were carried out using a digital Vernier Caliper that was calibrated before the start of the measurements.

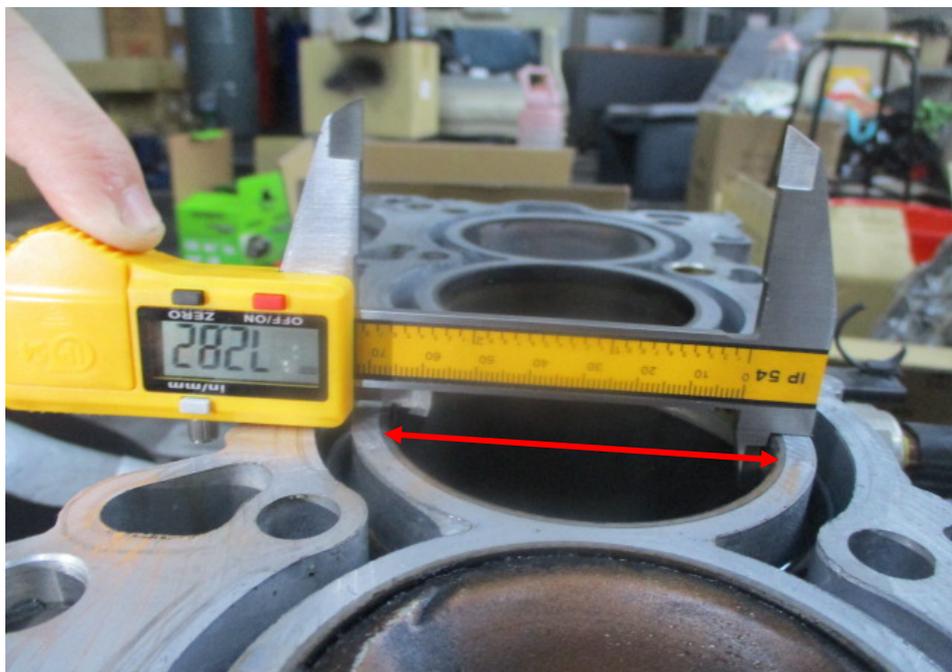
Photo 12 shows measurement being carried out to the bore (arrowed) of cylinder 2 of the Honda engine. The bore measurement of cylinder 2 was recorded to be 72.82mm.

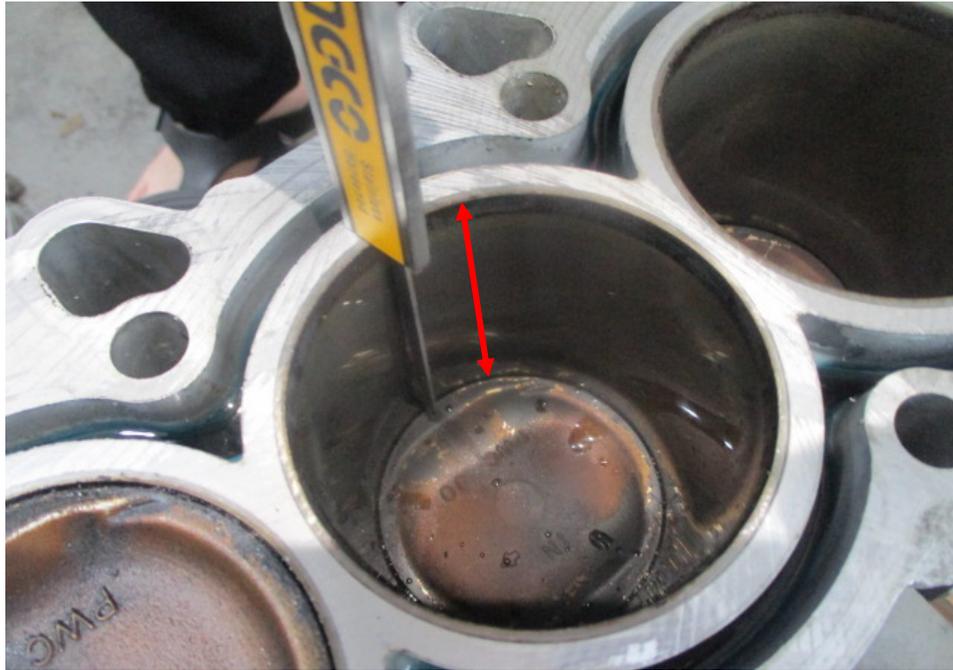
Photo 13 shows measurement being carried out to the stroke (arrowed) of cylinder 2 of the Honda engine. The bore and stroke measurements of the Honda engine were carried out using a digital Vernier Caliper that was calibrated before the start of the measurements.

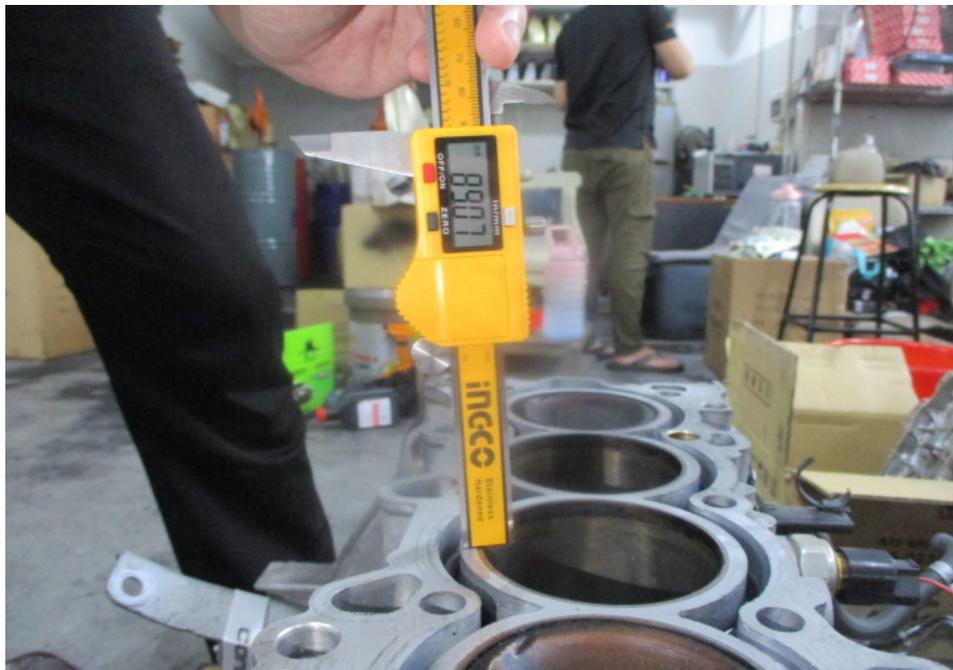
Photo 14 shows the stroke measurement of cylinder 2, which was recorded to be 89.07mm.

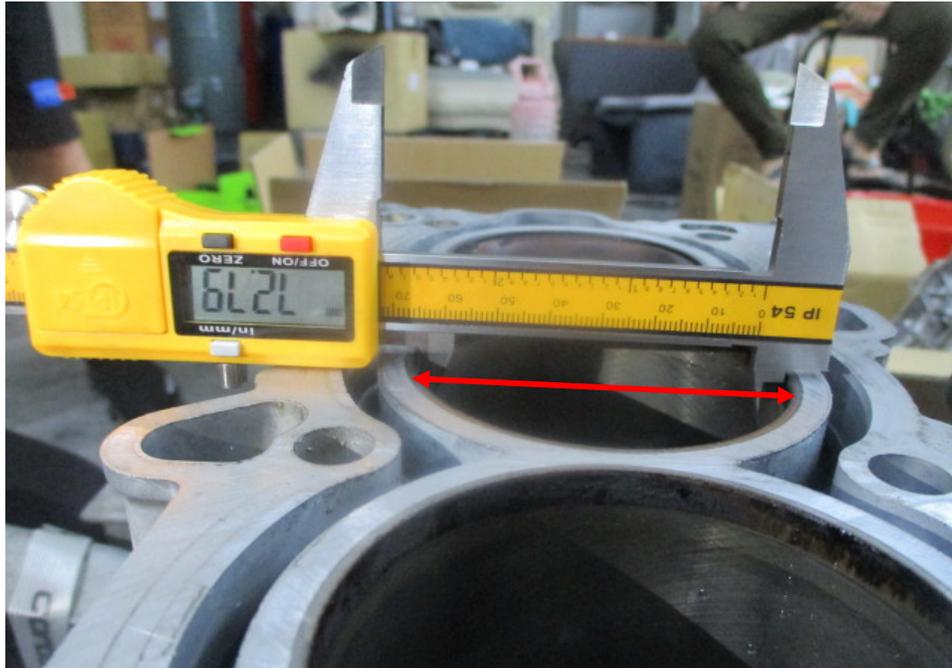
Photo 15 shows measurement being carried out to the bore (arrowed) of cylinder 3 of the Honda engine. The bore measurement of cylinder 3 was recorded to be 72.79mm.

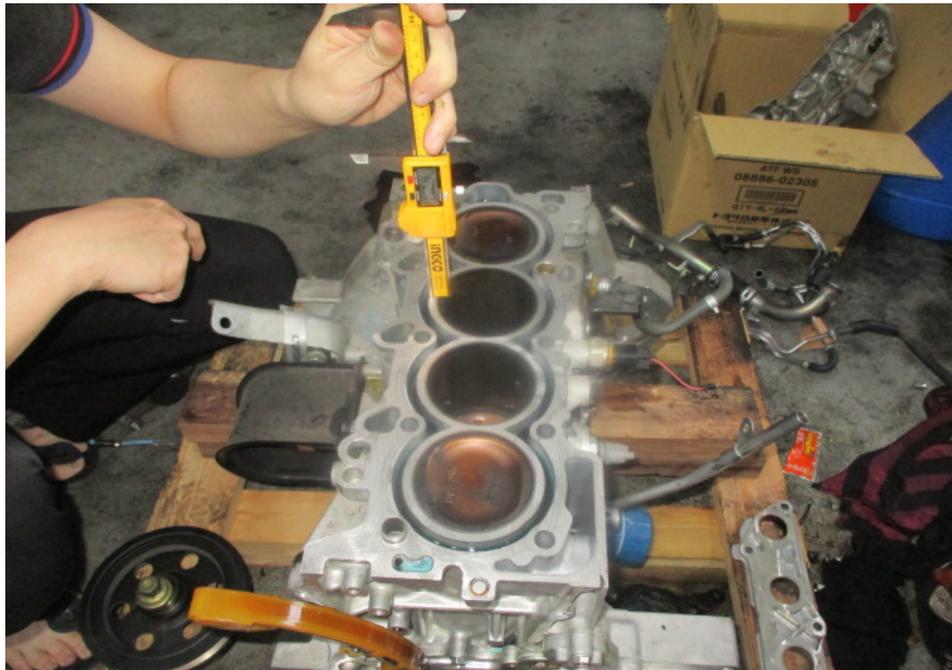
Photo 16 shows measurement of the stroke of cylinder 3 of the Honda engine that I had inspected. The bore and stroke measurements of the Honda engine were carried out using a digital Vernier Caliper that was calibrated before the start of measurements.

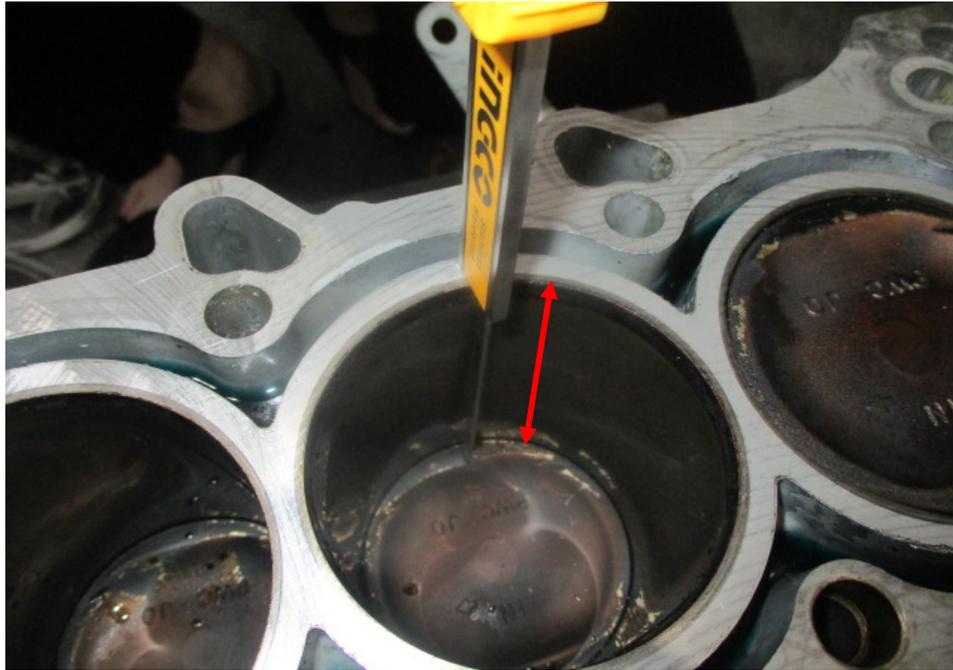
Photo 17 shows measurement being carried out to the stroke (arrowed) of cylinder 3 of the Honda engine. The bore and stroke measurements of the Honda engine were carried out using a digital Vernier Caliper that was calibrated before the start of the measurements.

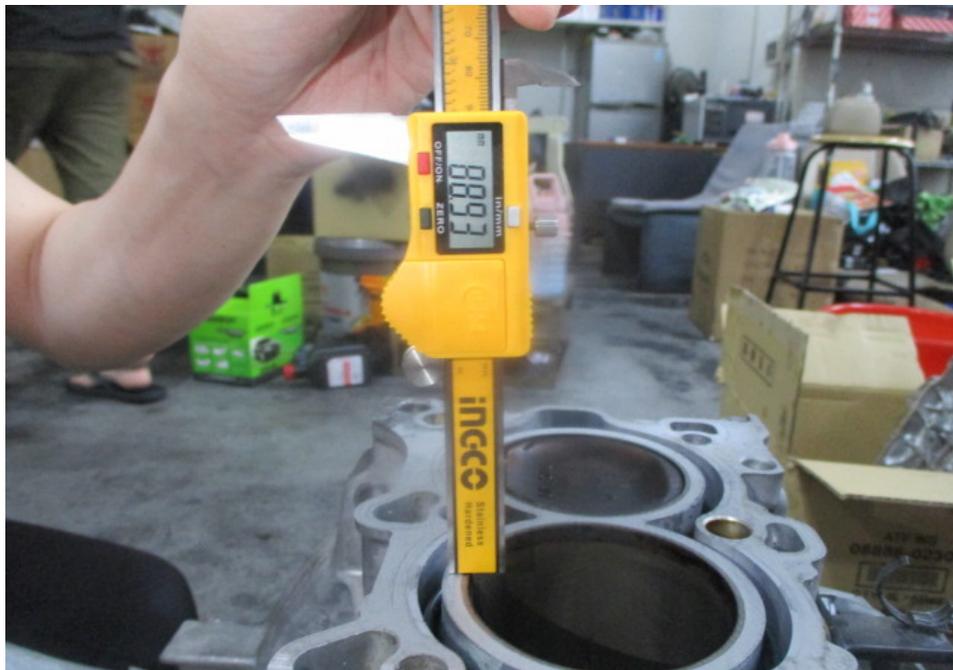
Photo 18 shows the stroke measurement of cylinder 3, which was recorded to be 88.93mm.

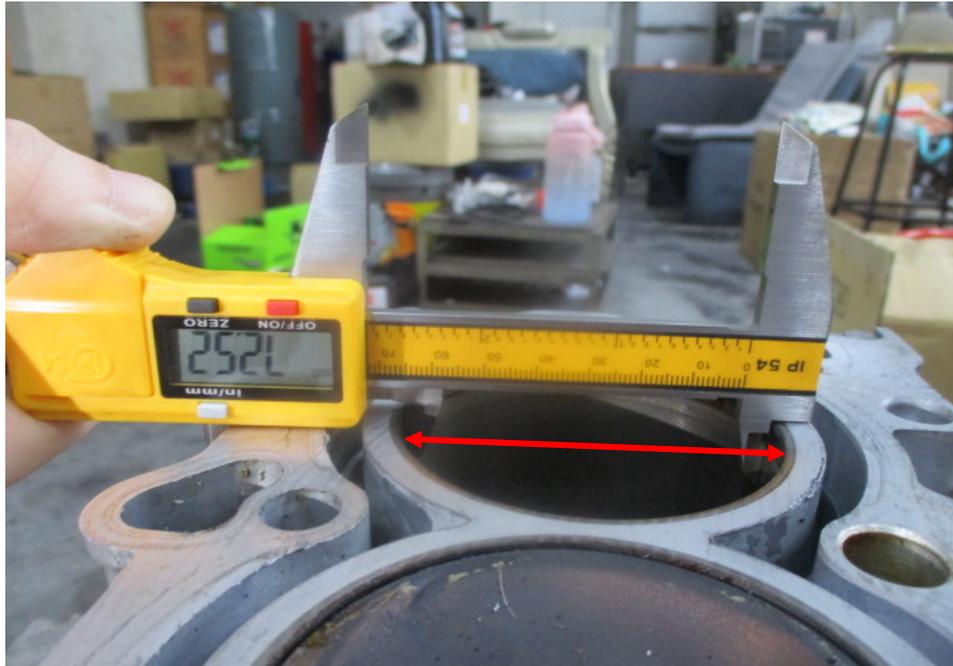
Photo 19 shows measurement being carried out to the bore (arrowed) of cylinder 4 of the Honda engine. The bore measurement of cylinder 4 was recorded to be 72.52mm.

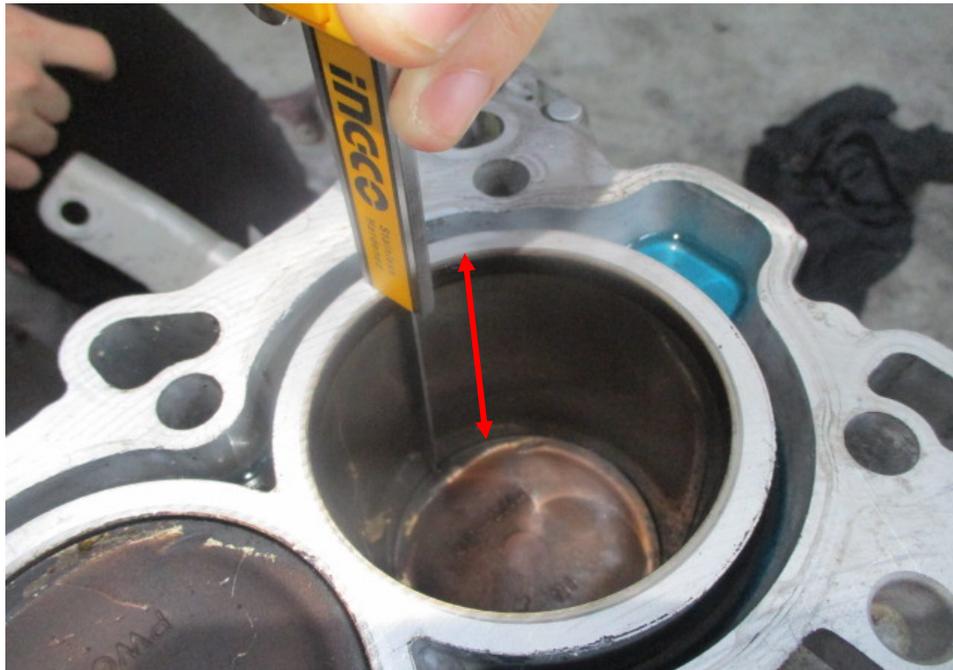
Photo 20 shows measurement being carried out to the stroke (arrowed) of cylinder 4 of the Honda engine. The bore and stroke measurements of the Honda engine were carried out using a digital Vernier Caliper that was calibrated prior to the start of measurements.

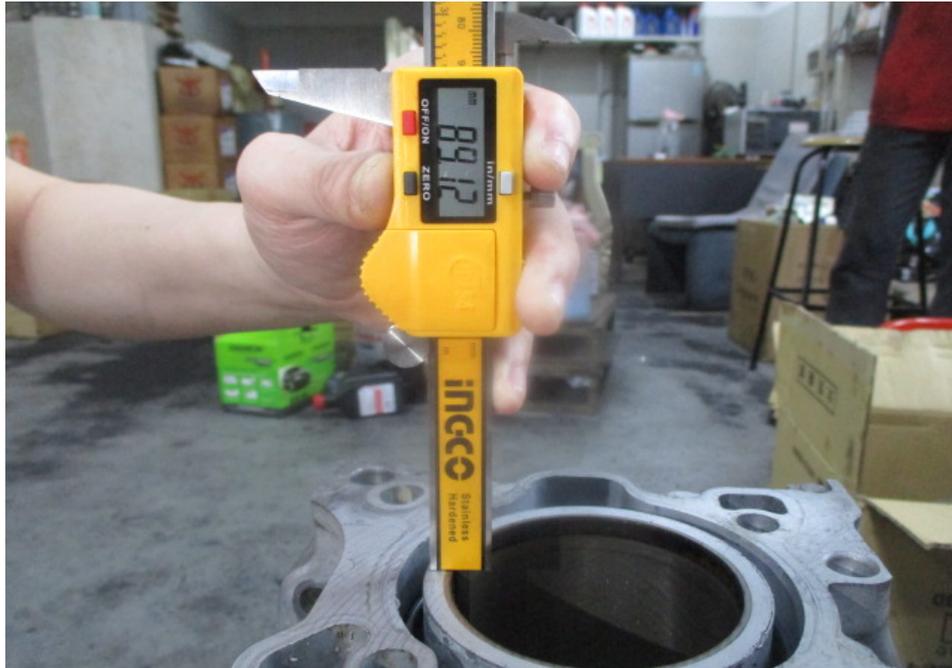
Photo 21 shows the stroke measurement of cylinder 4, which was recorded to be 89.12mm.
