ACCIDENT ON 26.10.2022 ALONG KIM SENG WALK INVOLVING MOTOR VEHICLES GBE 4050D AND SLS 5273D

VEHICLE DAMAGE ASSESSMENT REPORT

Ref No	: 2022/10060	Date of Report	: 7/11/2022
Claim Type	: Third Party	Date of Request	: 27/10/2022
Third party vehicle	: GBE4050D	Date of Accident	: 26/10/2022
Insured Vehicle	:	Date of Inspection	: 27/10/2022

Registration Plate No	: GBE4050D	Engine Modification	: NIL
Model / Make	: Toyota Dyna	Pre-accident damage	: NIL
Colour	: Silver	General Condition	: Good
Manufacturing Year	: 2015	General Paint Work	: Good
Engine No	: 1KD2553622	Steering	: Serviceable
Engine Capacity	: 3000cc	Handbrake	: Serviceable
Chassis No	: KDY2318021471	Footbrake	: Serviceable
Odometer No	: 144868		
Transmission	: Auto

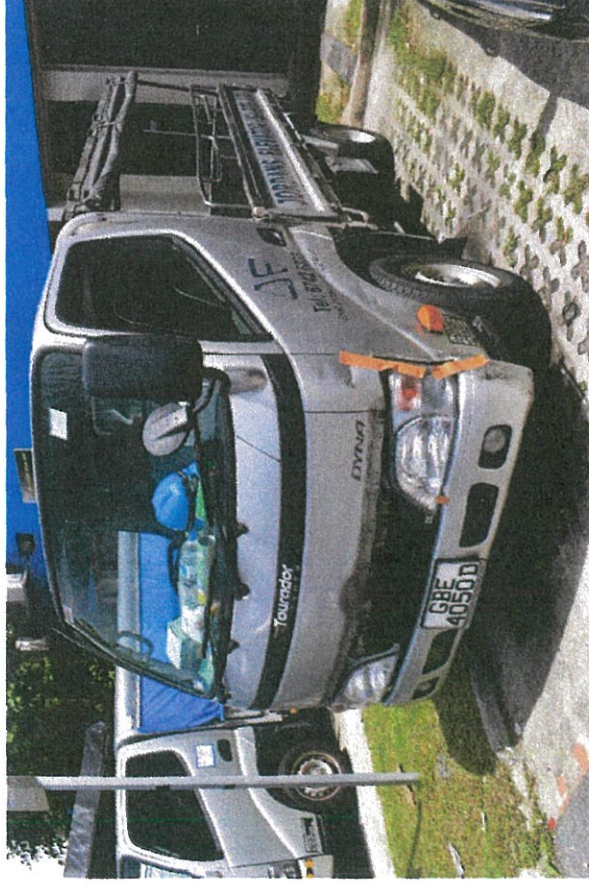
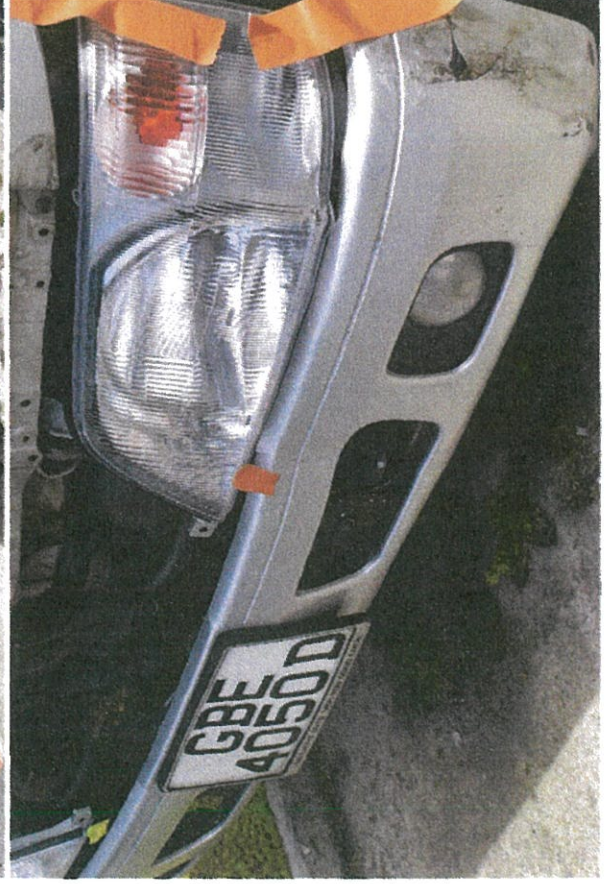
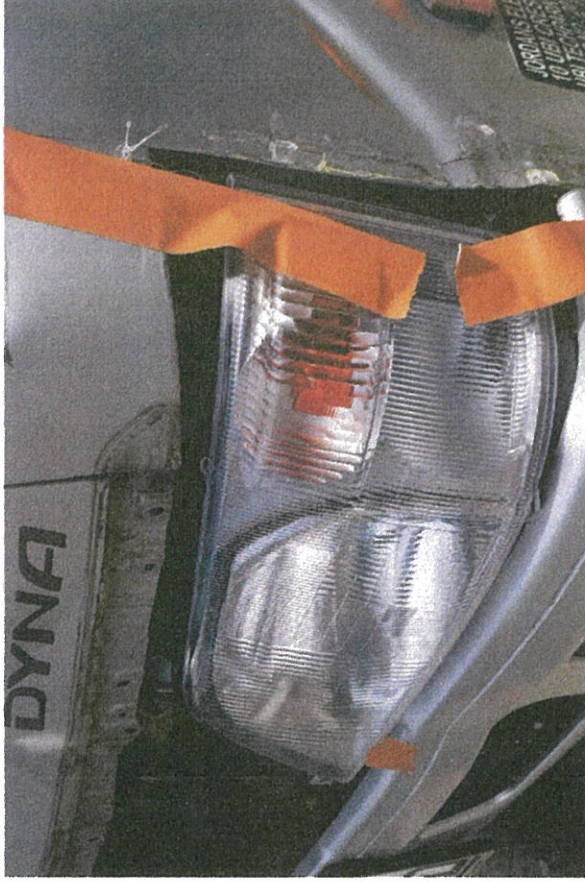
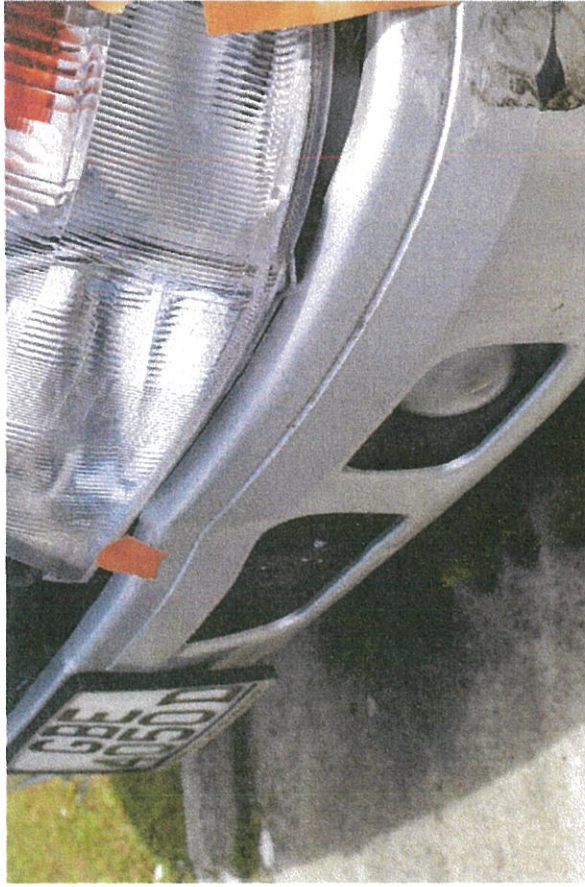
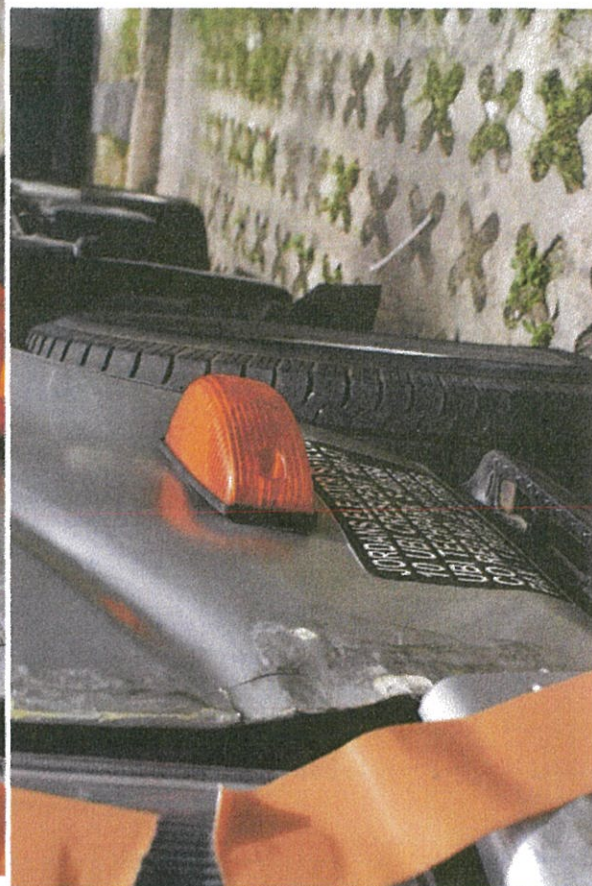
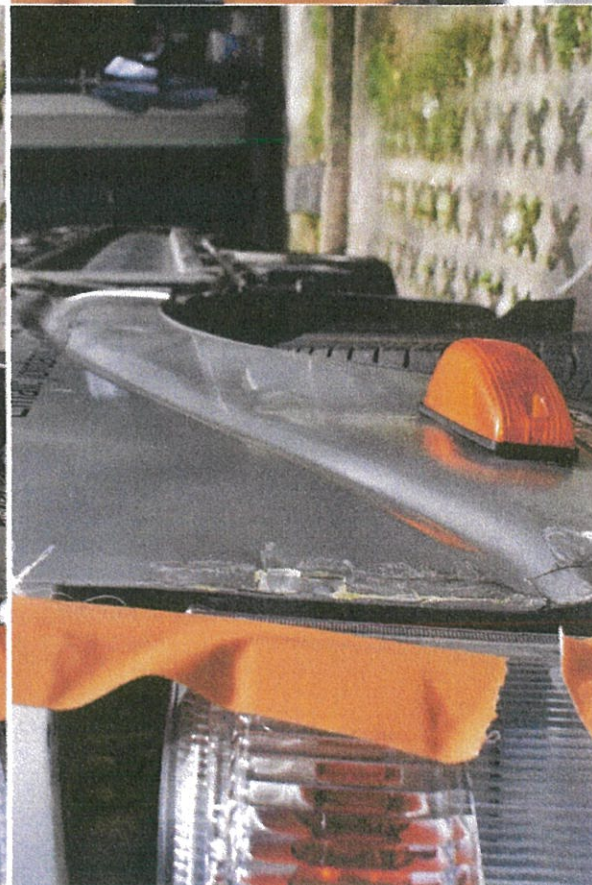
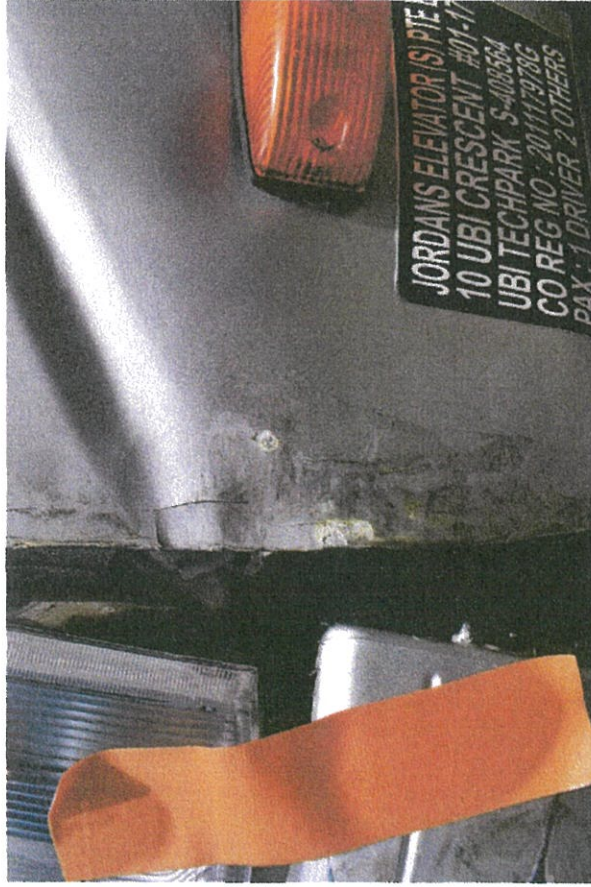
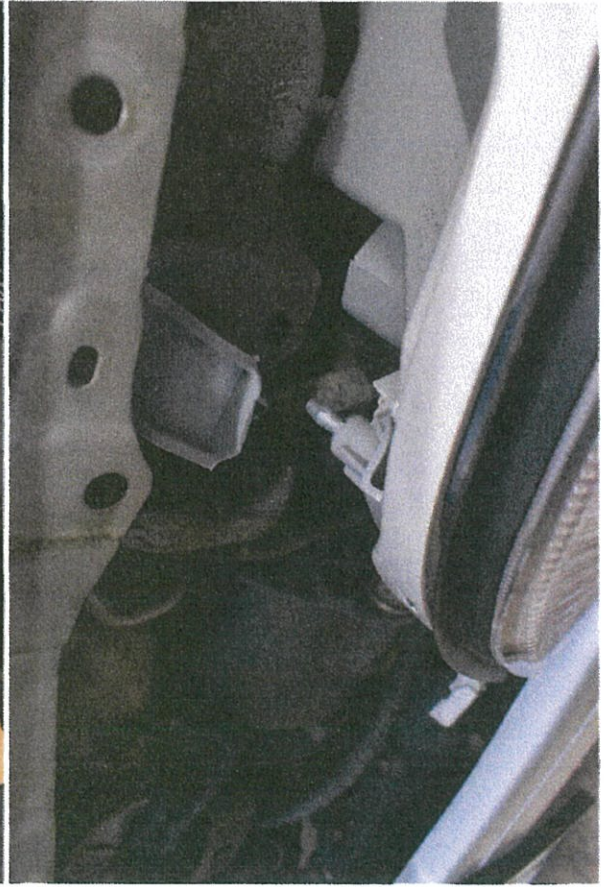
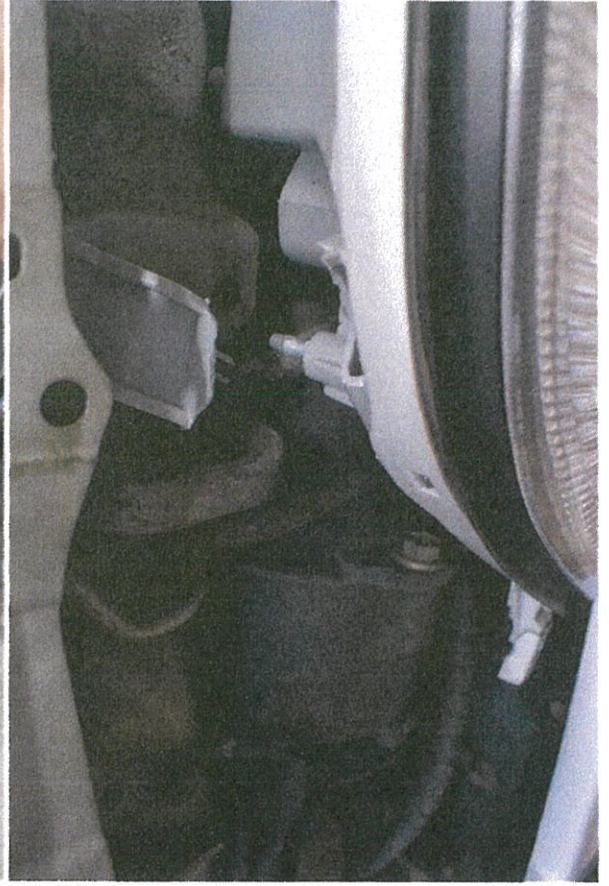
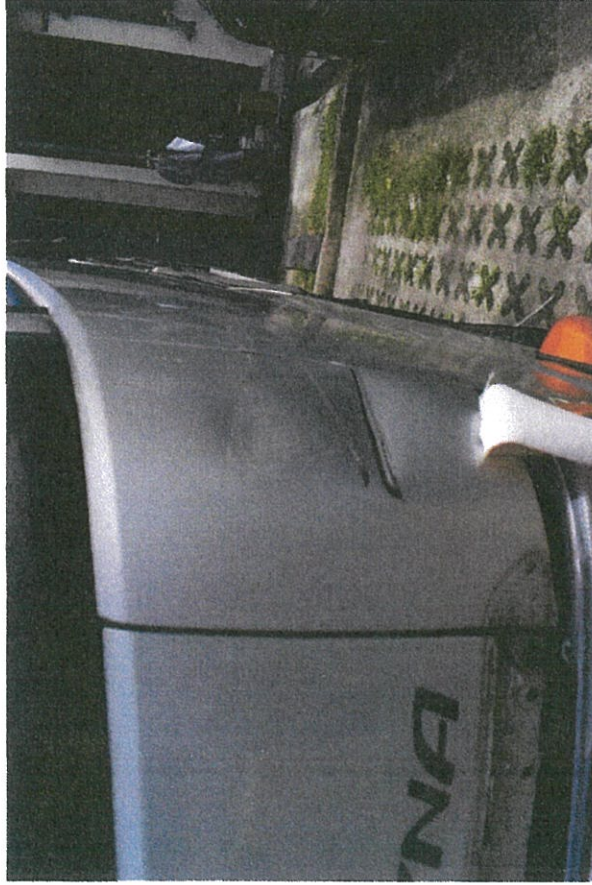
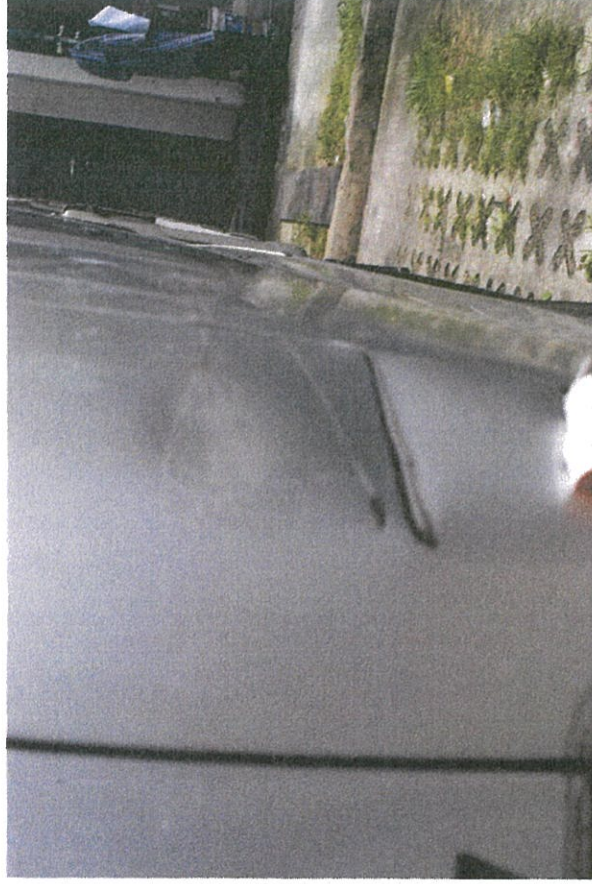
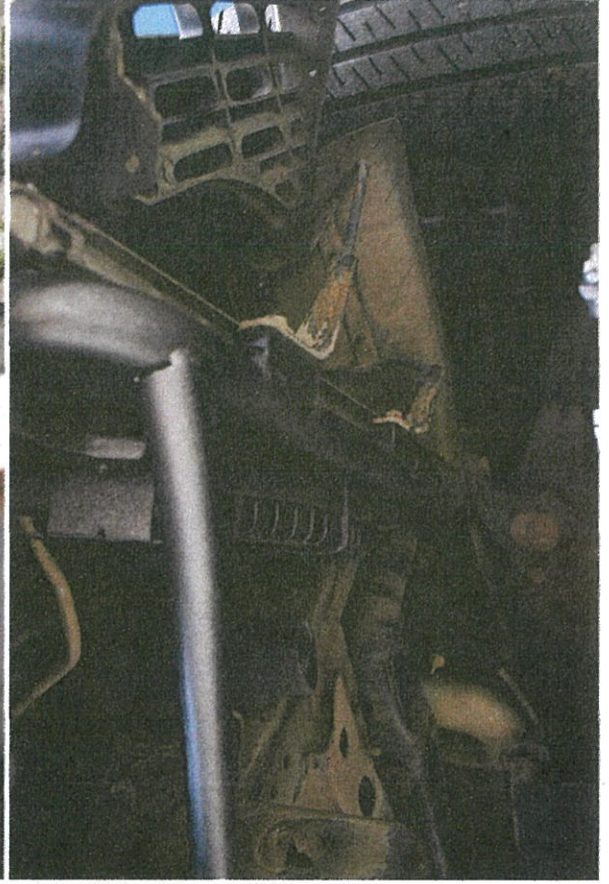
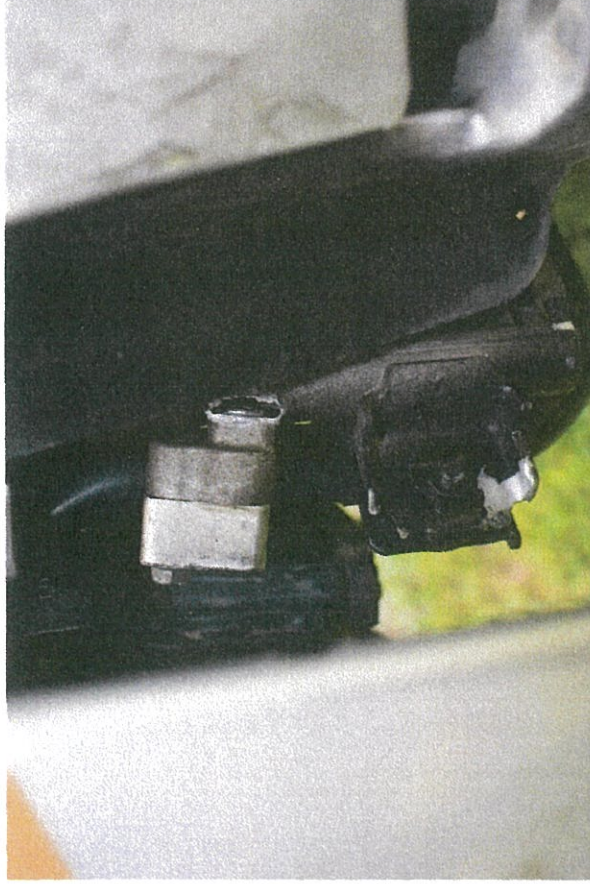
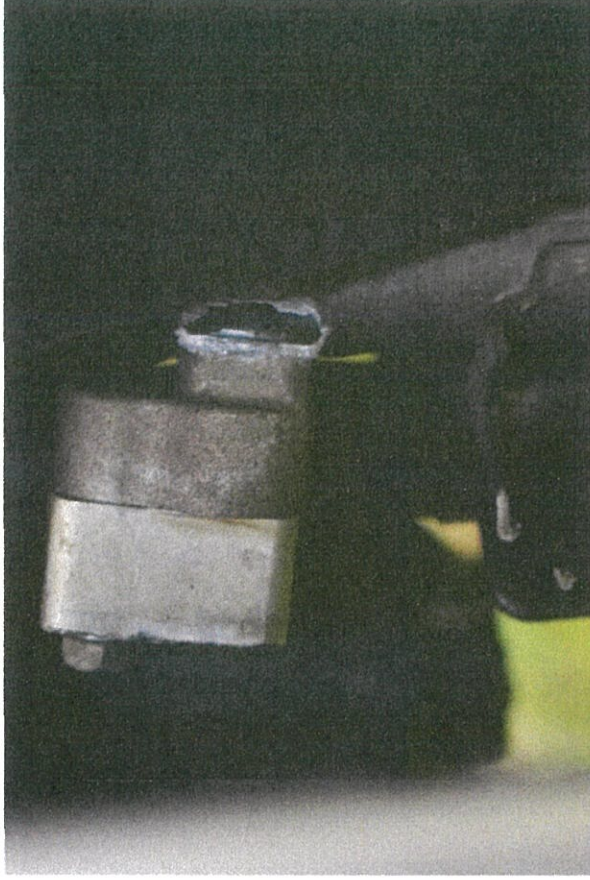
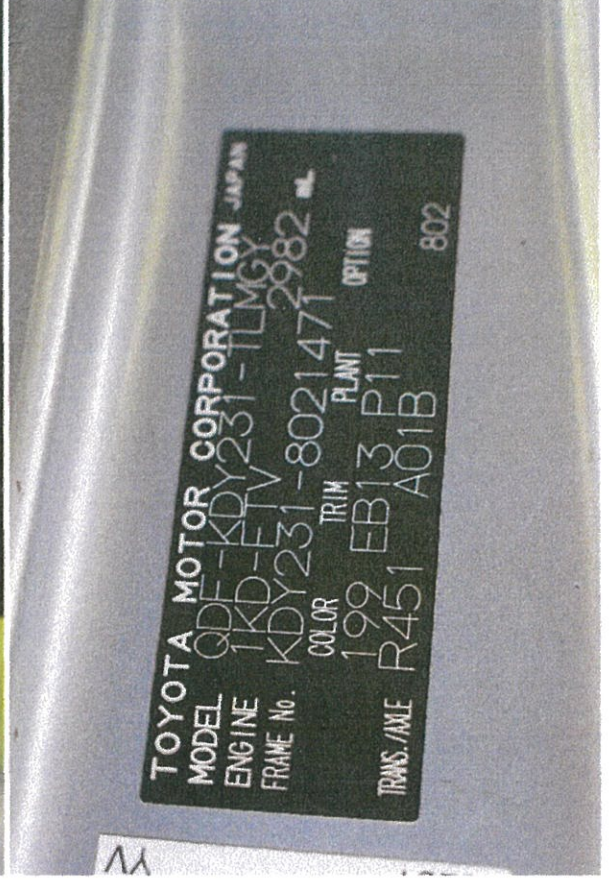
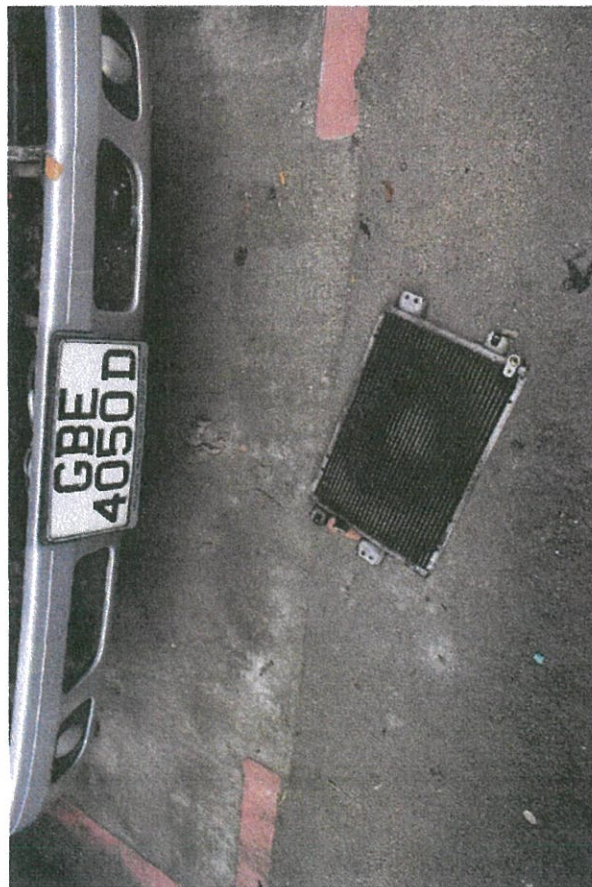
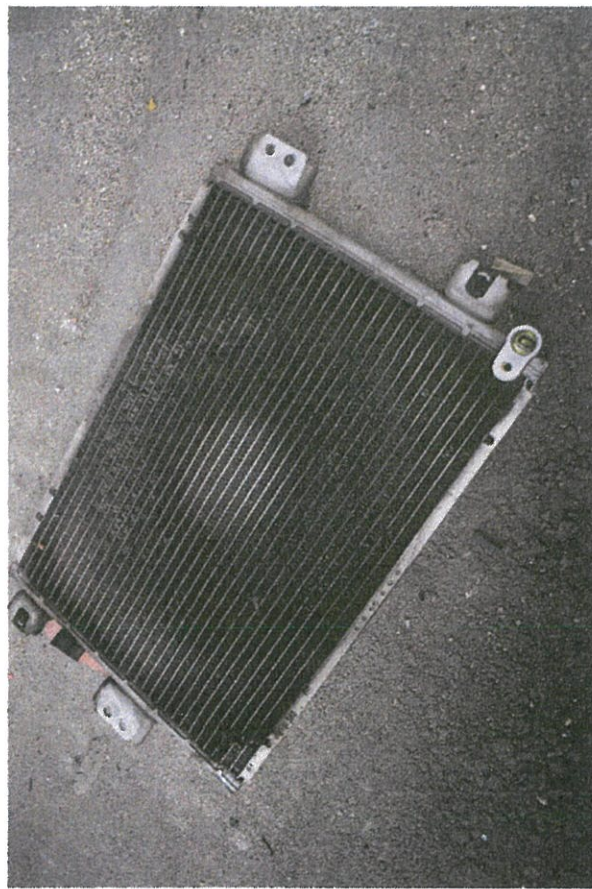
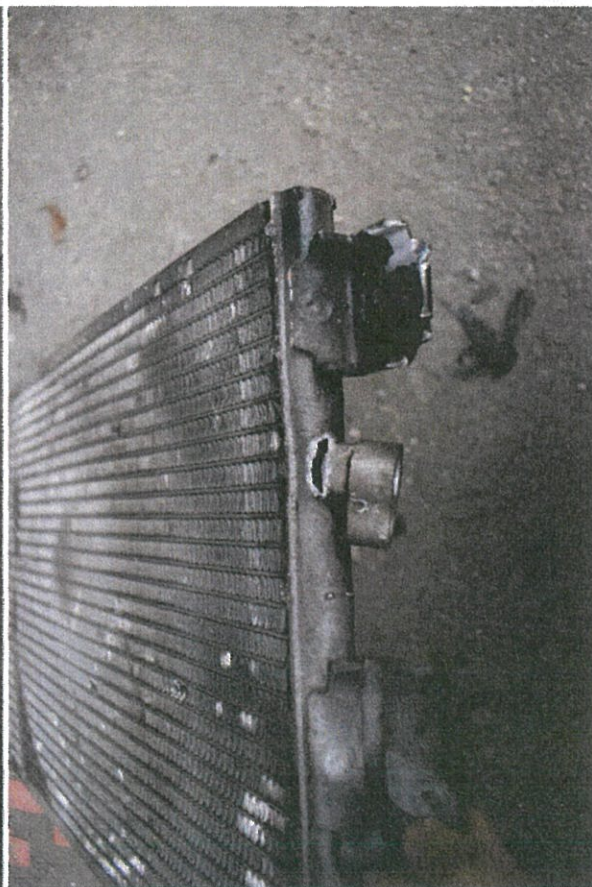
INSPECTION PHOTOS

At the time of inspection, this vehicle sustained damages to the **Front Lh Portion**.

Front bumper, lh corner panel, front lh door dented, front lh windscreen pillar push in, lh headlamp broken etc.

The workshop has agreed to undertake the repair on a Lump Sum Basis, and/or use of ex-stock/reconditioned parts whichever is possible (having taken into consideration to repair instead of replacements).

The final adjusted Lump Sum contract amount is **S\$6,000**.

Under normal circumstances, the repair period would be about 6 working days.
